Rebuilding of Screw Pump

Application:	Rebuilding of Screw Pump
Place:	ASMAR, Valparaiso, Chile
Date:	April 2011
Job and report done by:	ASMAR and Danish Business Ltda, Chile
Wencon products used:	Rapid, Coating white & blue, Cleaner, appl. tools

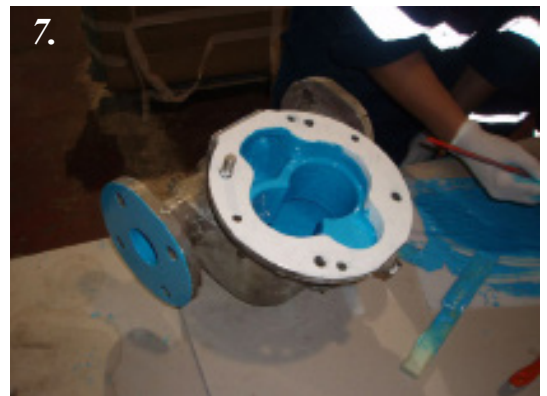
8. Like the pump housing, the end cover was sandblasted twice, sweating out water and salt in between, degreased twice with Wencon Cleaner and applied two layers of Wencon Coating.

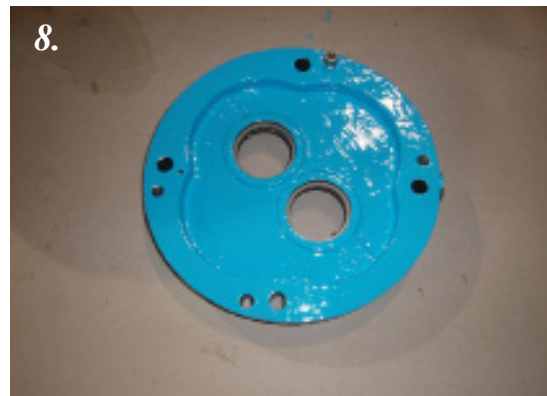
9. Next day, pump is placed in a lathe and the precise center of the two cylinders, are determined using the end cover of the pump. Afterwards, the excess Wencon Coating is machined away. Machining was done with low speed and a sharp steel tool in order to keep temperature down.

Also the coated flanges were machined to make a 100% even surface.

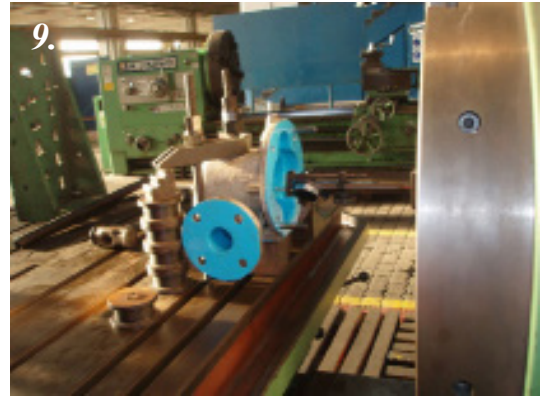
10. During machining, the full layer of blue Coating was removed in certain areas, and another layer of Wencon Coating, blue - thickness 0,4mm - was applied in the two cylinders.

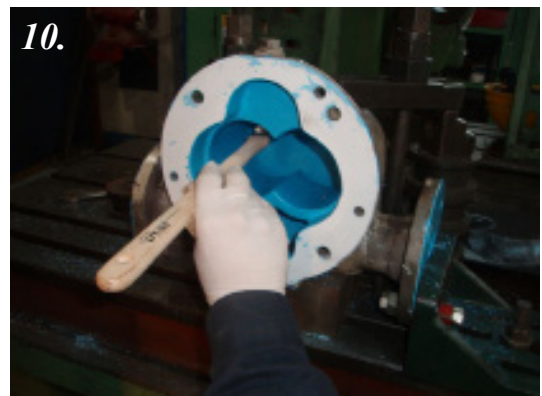
11. During the night, heat was applied in order to speed up the curing process.

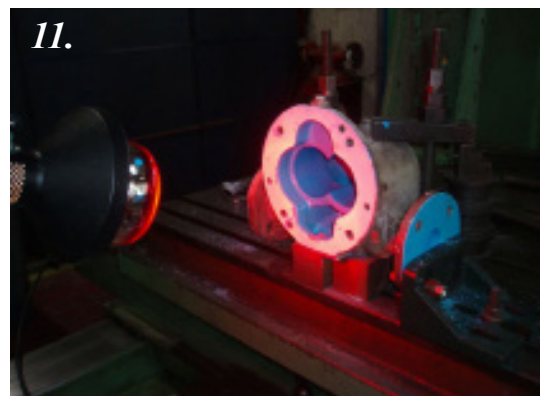
12. Next day 0,1 mm was machined away leaving a layer of 0,3 mm of both Wencon Coating white and blue.

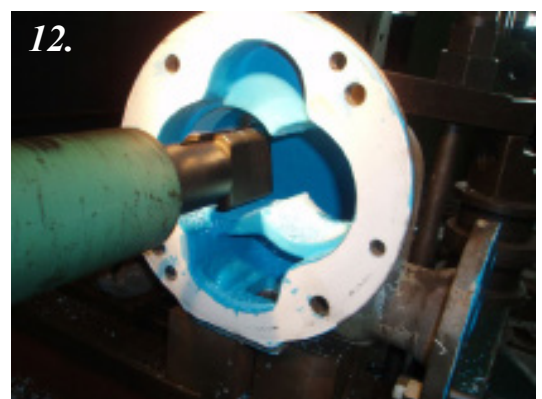
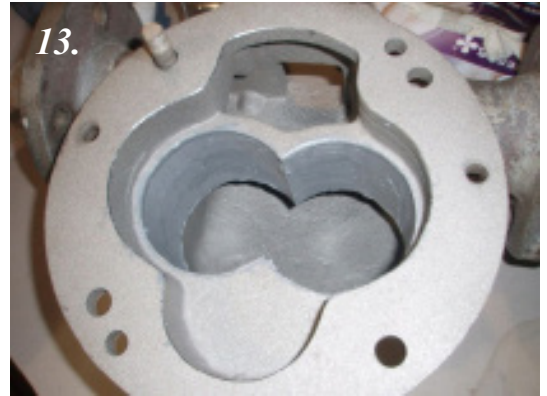
13. Final result

After final layer of Coating, the two cylinders had to be machined and centered according to the two new screws. The two screws machined to a diameter of 0,1mm, less than the diameter of the cylinders.
