Fibre glass Pipe, leaking

Application: Repair of leaking fibre glass pibe

Place: Atlantic Ocean, On-site job

Job and report done by: Repair Management Nederland B.V.

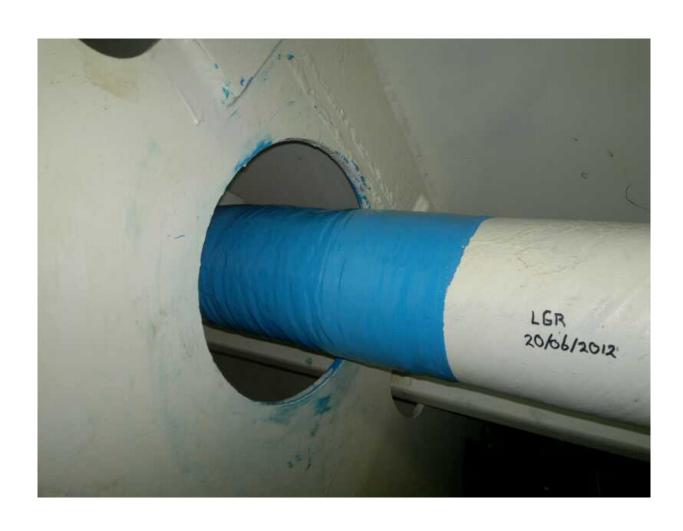
GRP Pipe damaged and starts leaking.
GRP pipes are aften not available on "normal" stock and can therefore not be replaced like normal steel pipes. Besides, it requires special training to work with this type of pipes.

After removing the emergency Pipe Repair Tape and cleaning the surface, a leak was visible. Leak in GRP pipe is caused by burning, due to hot work. Surface cleaned, rough and degreased. Here the burned and damaged parts are very visible.

First a layer of Wencon Coating White is applied and in wet coating Wencon Reinforcement tape is wrapped around the pipe with an overlap of 50%. A second layer of Wencon Coating is applied over the tape. This process is repeated 2 times. For extra safety the coated and reinforced area is at least 15 cm wider as the damaged area. 2 colours of Wencon Coating visible. Each layer, to ensure that everything is covered.

Final layer of Wencon Coating blue, and after curing pipe is ready for many years of service.
