### Rebuilding of Stern Boss flange

Job executing contractor: Gemak Shipyard

Report done by: PI-ES Marine AS

Date: 29.06.2020

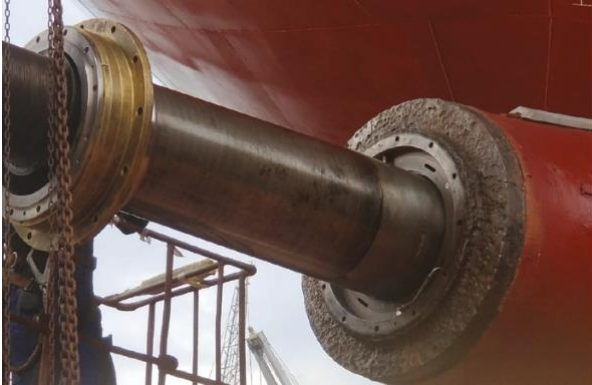
1. Rope Guard removed.  
Oil drained and propeller dismantled.  
Stern tube seal box and flange ring has been protected with rubber gasket a plastic tape before blasting.  
Stern boss corroded parts have been grit blasted to SA 2½ / 75 µm.

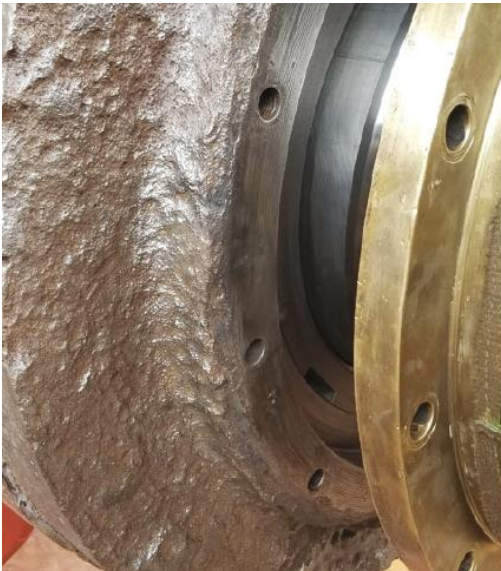
2. Seal box prepared and positioned on shaft.

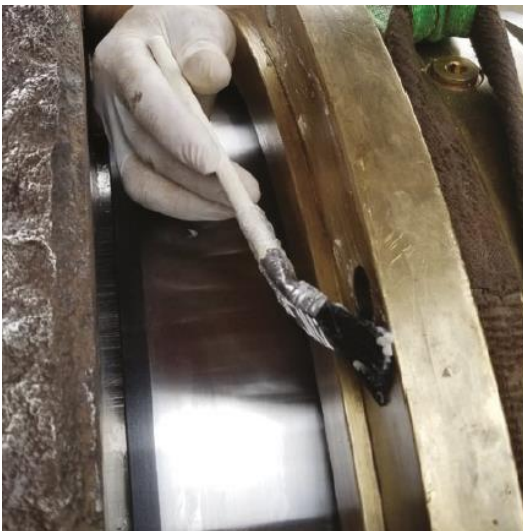
3. Release agent applied by brush to the flange ring surface and remain for about 20-25 min.

Thereafter rubbed with clean clutch and polished.

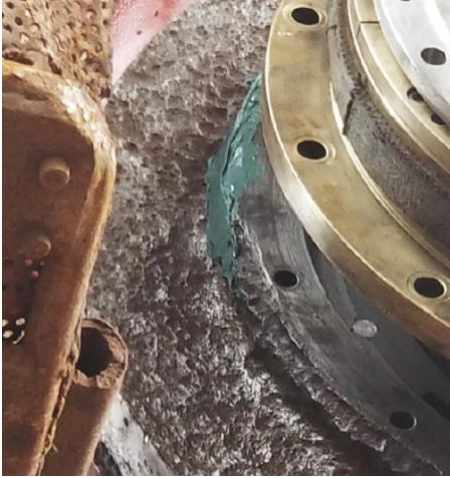
4. Wencon ceramic cream mixed in accordance to instructions in the box and applied to the corroded parts of the boss.

The thickness of the ceramic cream was about 1-3 mm close to the bolt holes and were getting thicker towards outer diameter.

The thickness rebuilds using Wencon Ceramic Cream. was about 10 mm at max diameter of the flange seat.

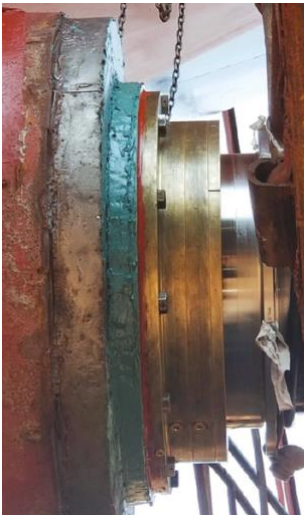
5. Flange ring is bolted without gasket and tightened firmly while the Wencon Ceramic Cream was still wet.

Excess material is cleaned by scraper and left for curing over the night.

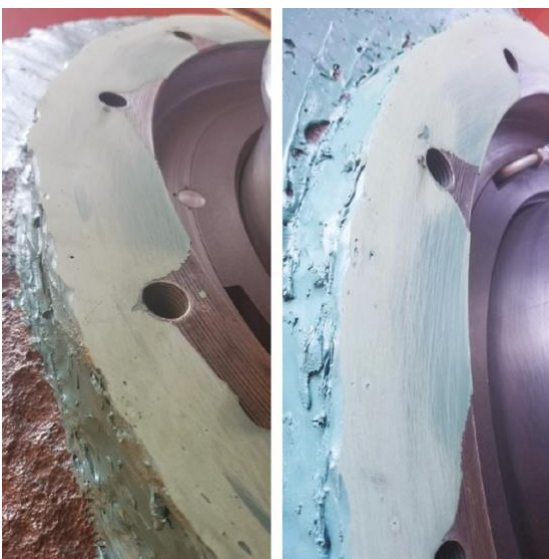
6. In the morning, which is about 16 hrs. of curing, flange ring is dismantled.

Excess material pop-up on the flange surface & the lubricating holes were recovered by hand to original shape and size.

Those areas and the exit material around the flange edge were sanded flush by power disc and sandpaper.

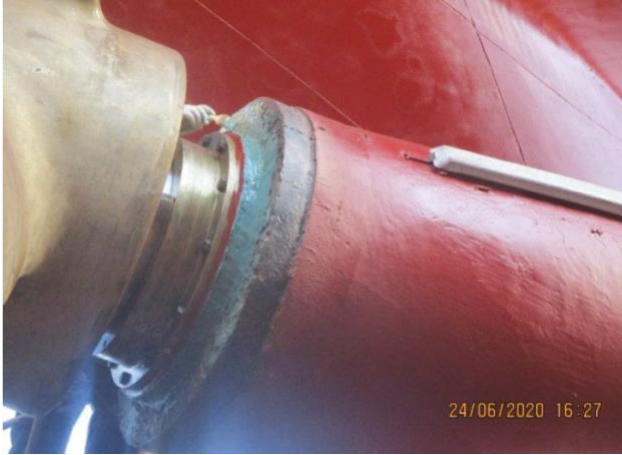
7. Seal box has been put back with new gasket and red silicone underneath. Bolts are tightened in accordance with the required torque.

Seal box refitted and Oil Filled and tested for leaks.

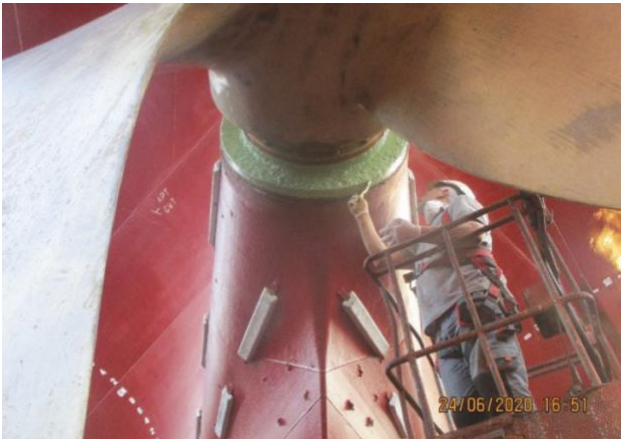
8. Wencon protective coating is applied to the remaining corroded surface of the stern boss from flange rings up to the fwd. edge of the rope guard.

The first coat is applied about 300 microns. Second coat is applied about 1 hr. of curing with the same thickness.

After 4 hrs. of curing, rope guard welded in place.

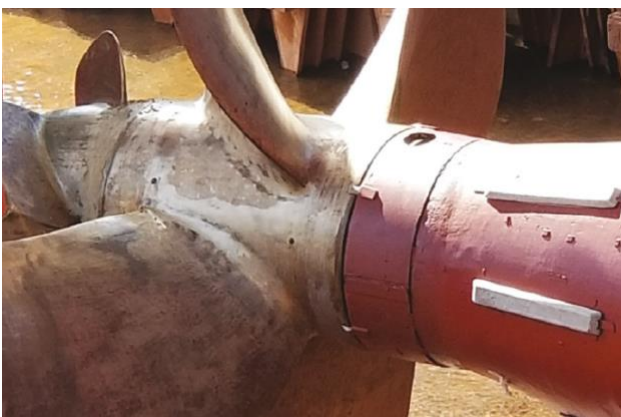
9. Completed.
