Rebuild of Bow Thruster Casing

Application: Refurbishment of Bow Thruster Casing.

Place: Istanbul, TR

Date: May 2022

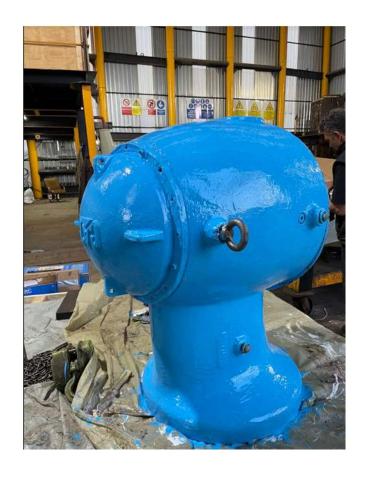
1. & 2.

The casing is heavily damaged, corroded and pittings are visible
