## Heating Coils manifold

## Introduction:

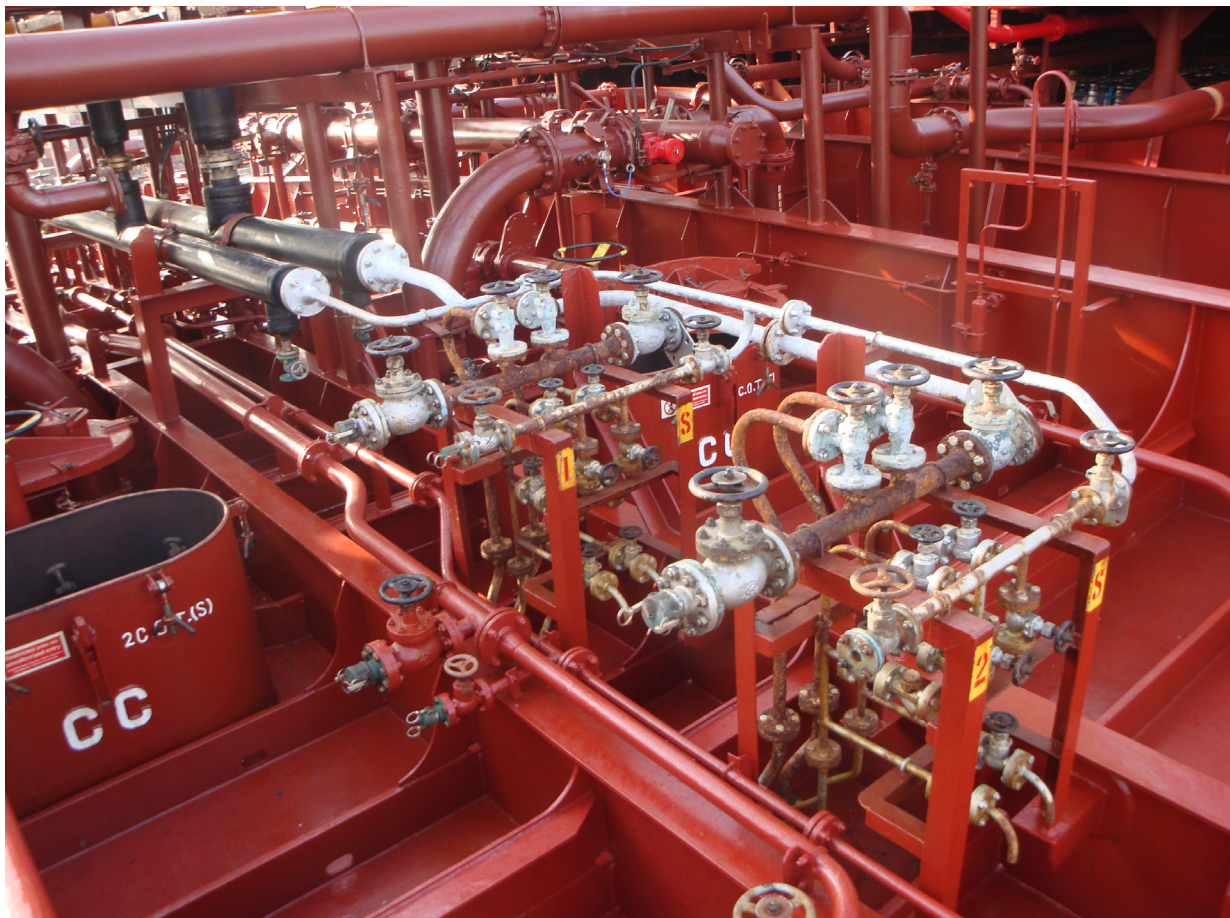
<b>Application:</b>	Heating Coils manifold suffering from external corrosion.
<b>Place:</b>	Tuzla, Turkey
<b>Date:</b>	November 2014
<b>Job and report done by:</b>	Clients crew
<b>Wencon products used:</b>	1088 light + 1088 dark, Reinforcement Tape, Cleaner, Perago disc, appl. tools

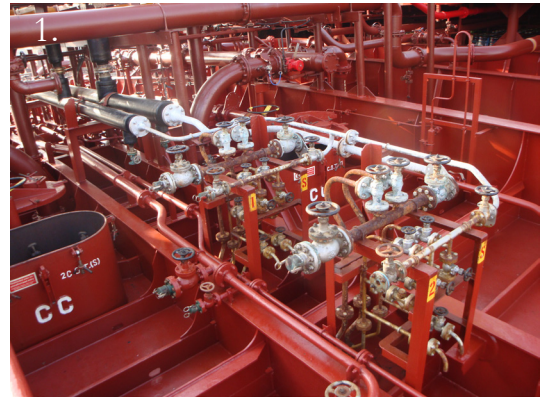
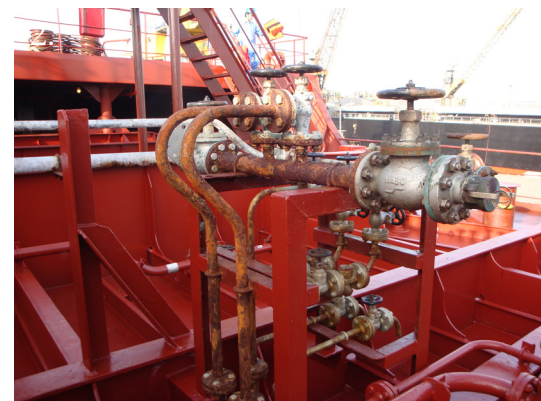
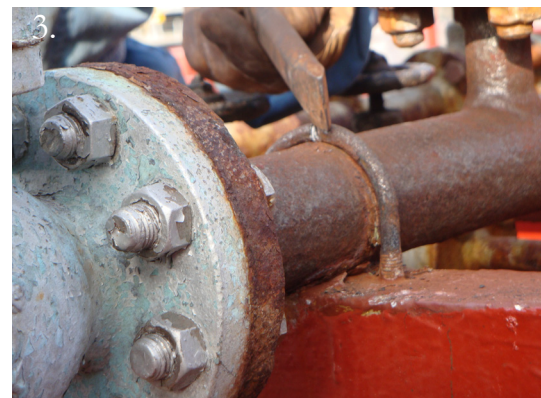
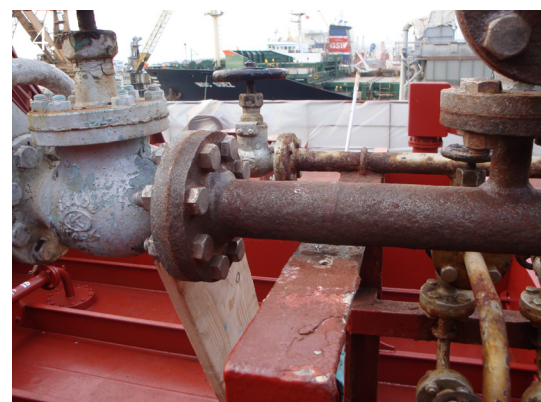
5. To prepare the surface, a Needle gun is used for chipping the complete surfaces - a very time-consuming task. It is a crucial factor, to ensure the best adhesion possible, under these working conditions.

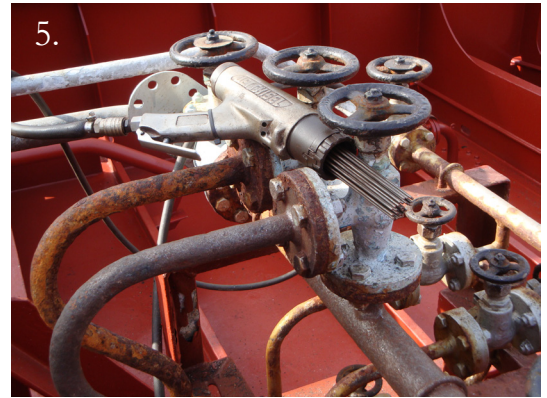
6. By chipping it is very clear, that piping locally suffers from heavy corrosion.

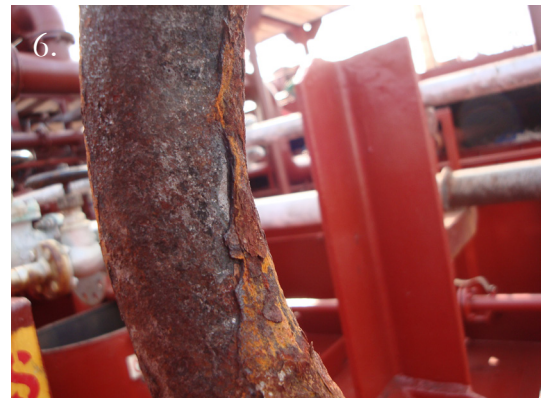
7. Close up picture during chipping.

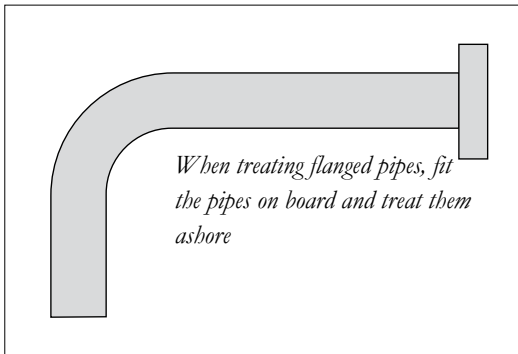
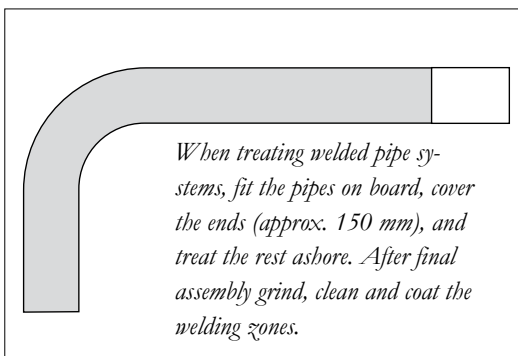
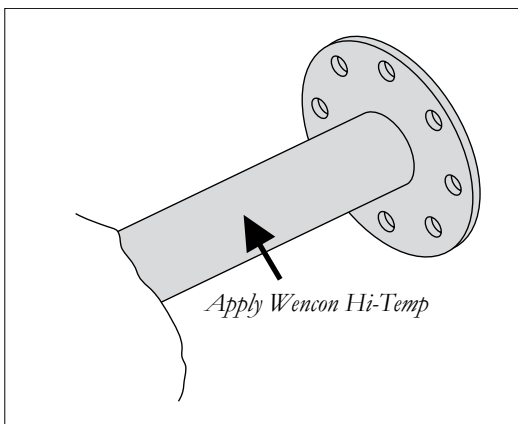
Hot-water, hot-oil or steam pipes will often be exposed to corrosion on the outer side, due to moisture or water in the insulation. Wencon can eliminate this breakdown with a coat of Wencon Hi-Temp.
