Rebuilding of Screw Pump

Introduction:

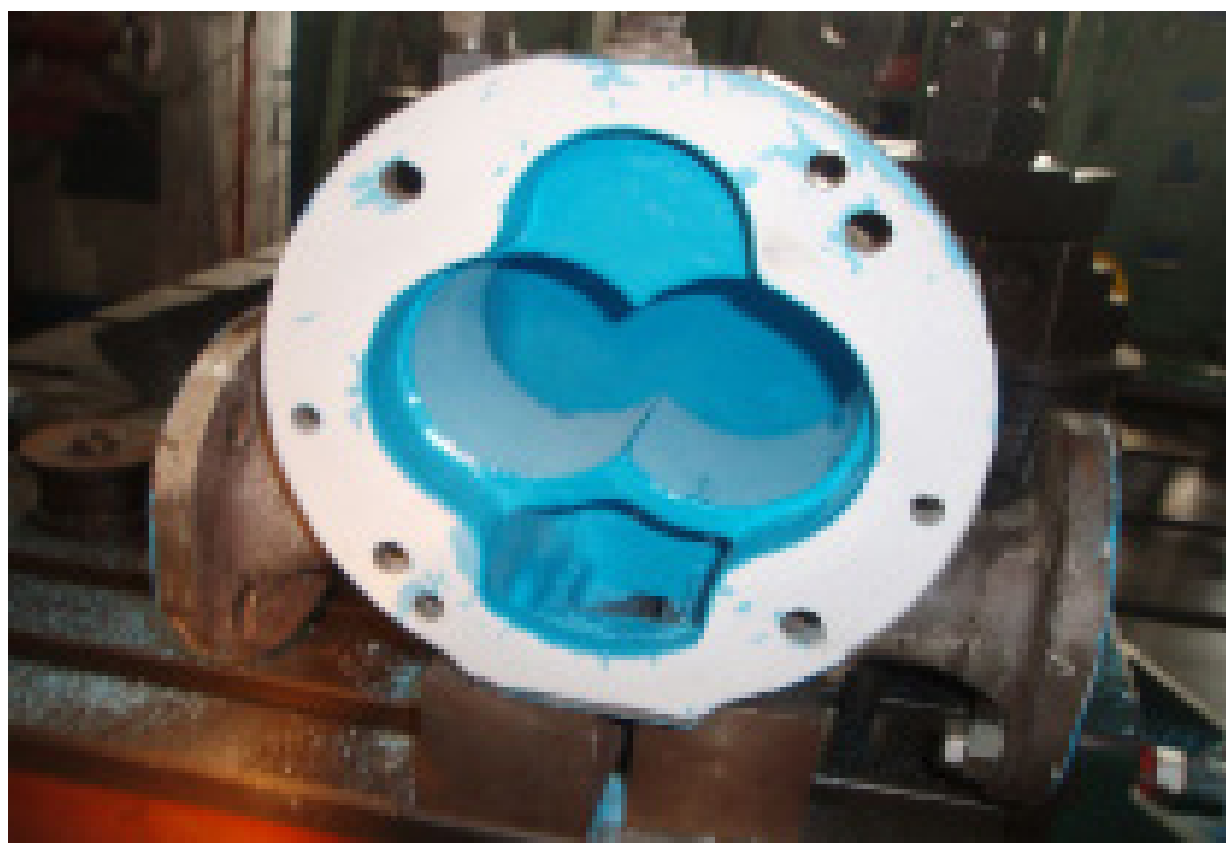
Application:	Rebuilding of Screw Pump
Place:	ASMAR, Valparaiso, Chile
Date:	April 2011
Job and report done by:	ASMAR and Danish Business Ltda, Chile
Wencon products used:	Rapid, Coating white & blue, Cleaner, appl. tools

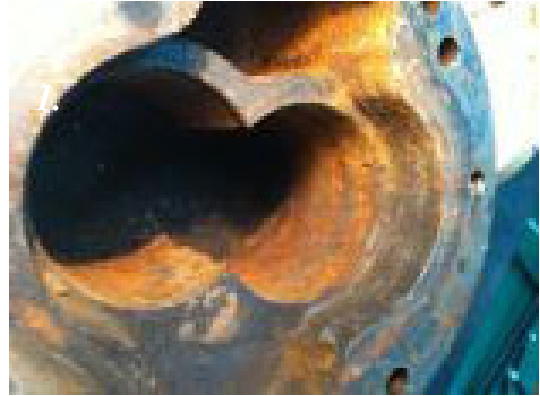
Due to heavy corrosion the screw pump had lost pressure, and therefore not able to pump waste oil, from ship to the pier.
Job was to rebuild the pump using Wencon products.

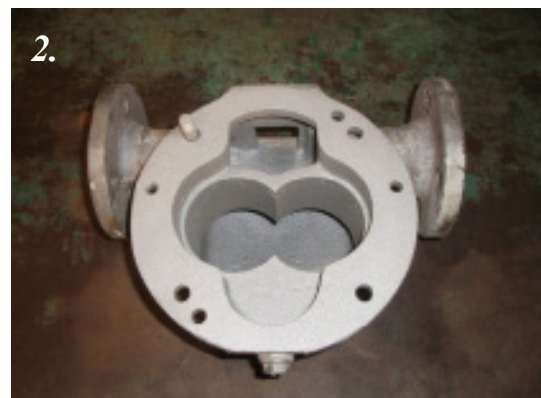
3. Close up photo showing heavy corrosion, reducing performance of the pump.
Before pump is cleaned twice with Wencon Cleaner, all sharp edges are rounded with a Dremel grinder, in order to increase the surface areas of the edges.

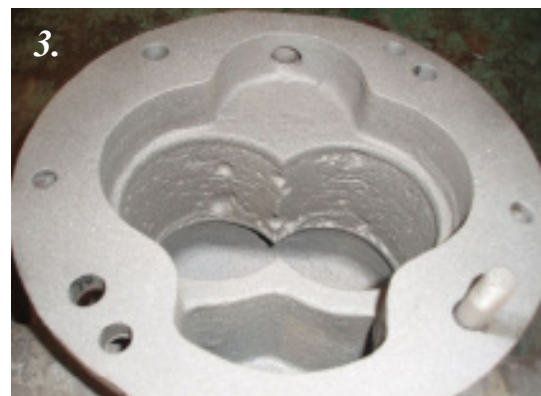
4. Surface is rebuild using Wencon Rapid. Only surfaces in the two cylinders are heavily corroded - rest of the pump only coated with Wencon Coating.

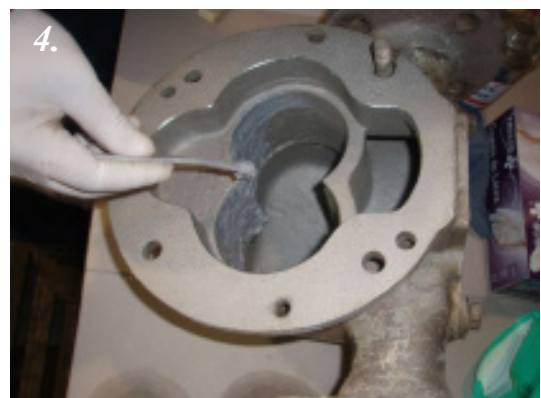
5. Pump after applying Wencon Rapid. The pump now needs to cure for approximately 30 minutes before applying Wencon Coating.
