Cooler Covers

All covers in a very poor condition, due to bi-metallic corrosion.

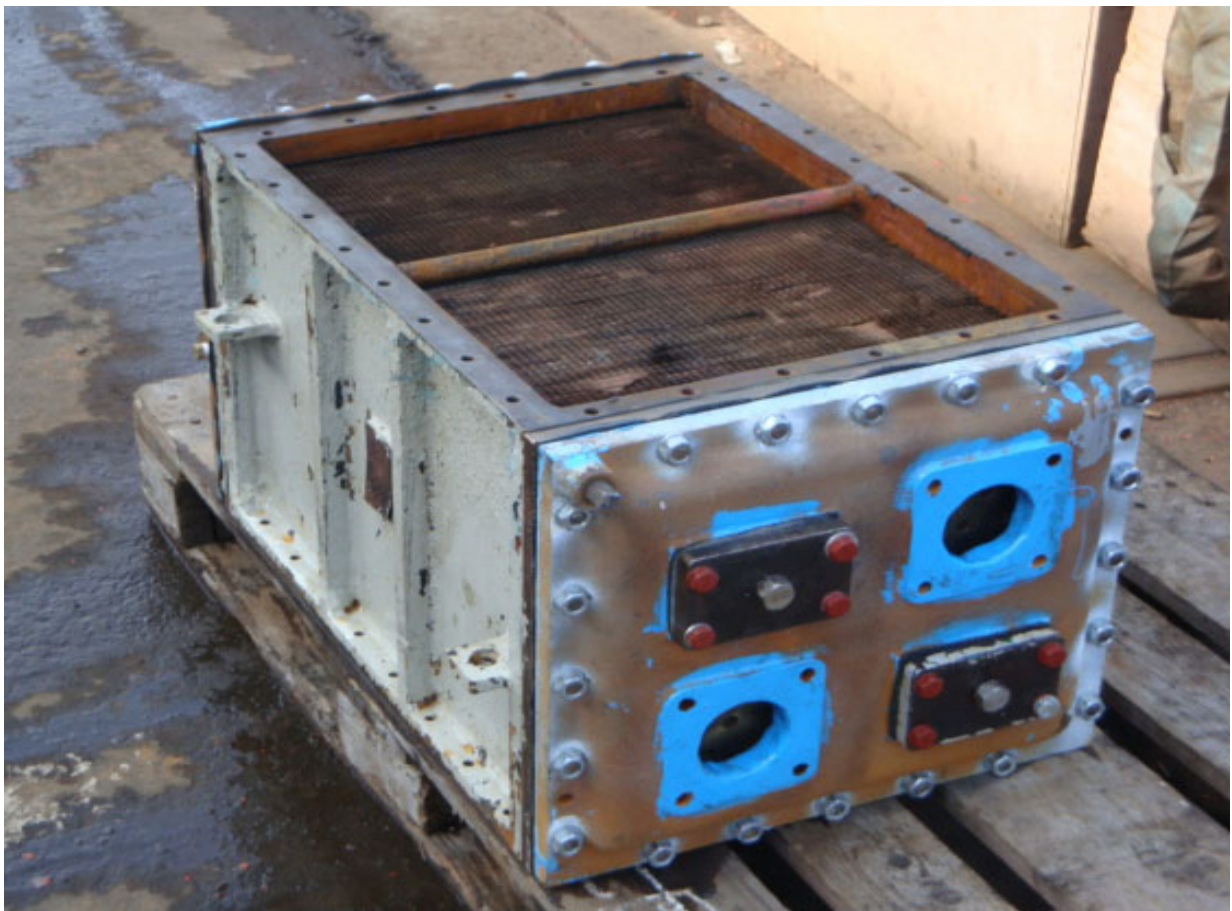
Application:	Rebuilding & coating of Cooler Covers
Place:	Dales Marine Service, Aberdeen Scotland
Date:	April 2010
Job and report done by:	Dales Marine Service / Wencon Denmark
Wencon products used:	Rapid, Coating white & blue, Cleaner, appl. tools

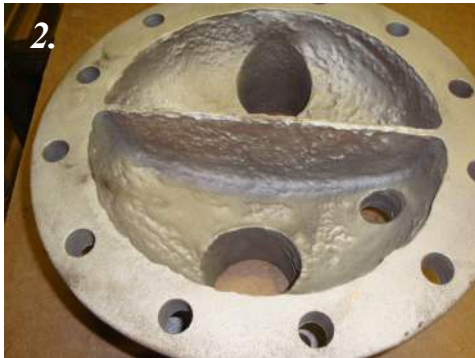
Damage became very visible, after surface preparation.

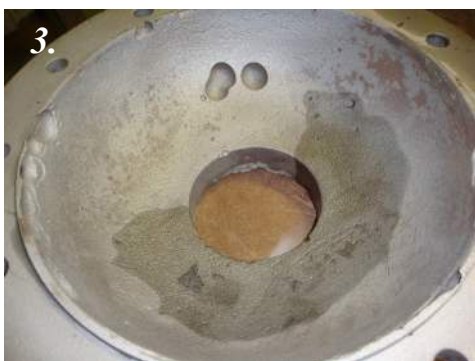
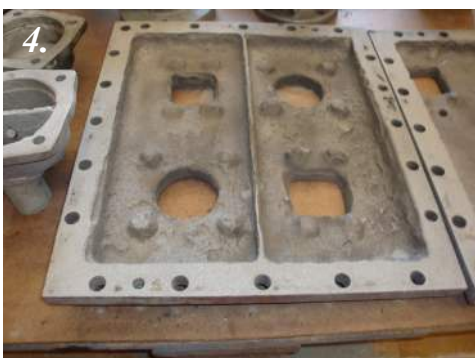
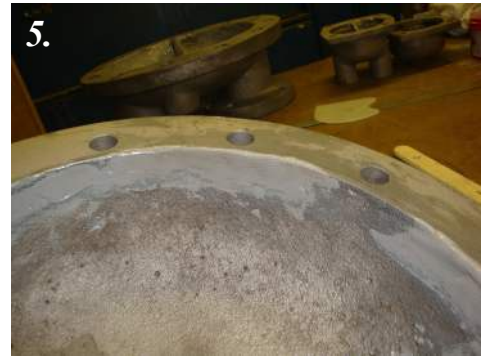
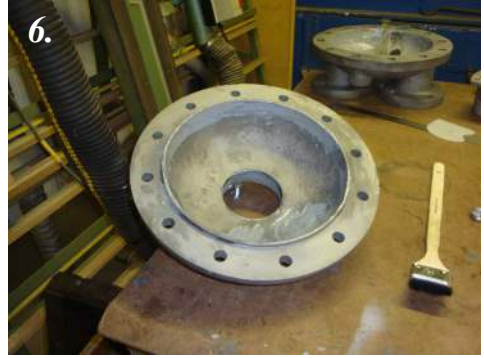
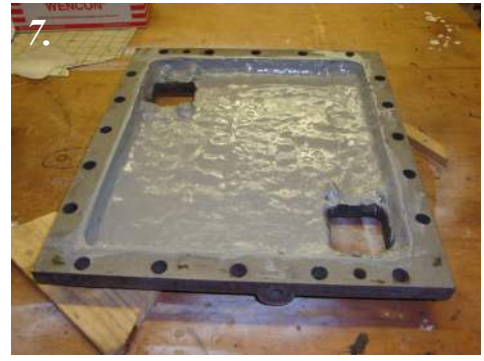
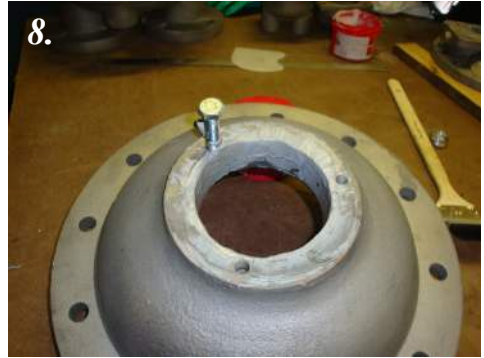
After a thorough surface preparation, all dents and holes were rebuilt to original size and shape, using Wencon Rapid.

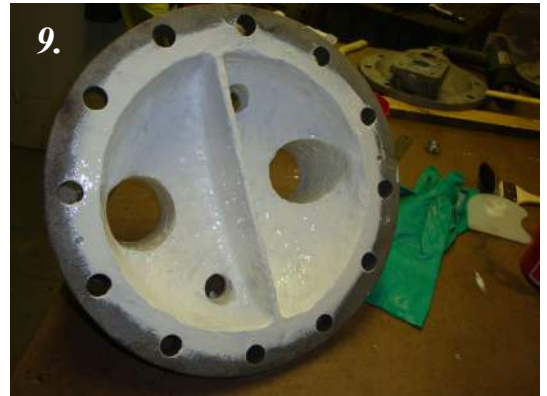
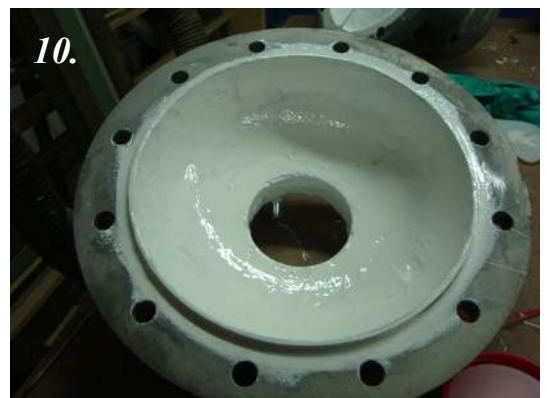
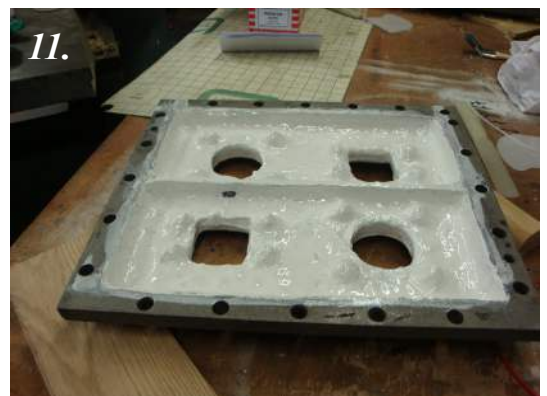
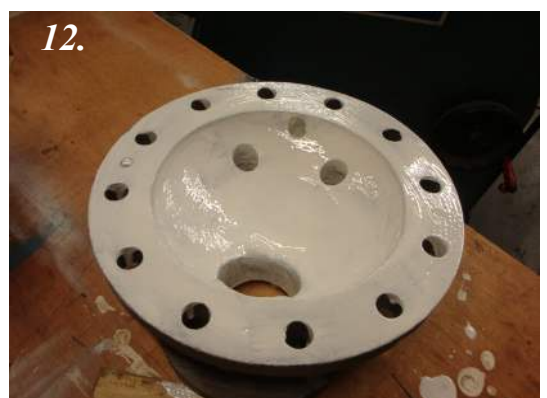
First layer of Wencon Coating applied with a brush, and then left for semi curing app. 1 ½ hours.

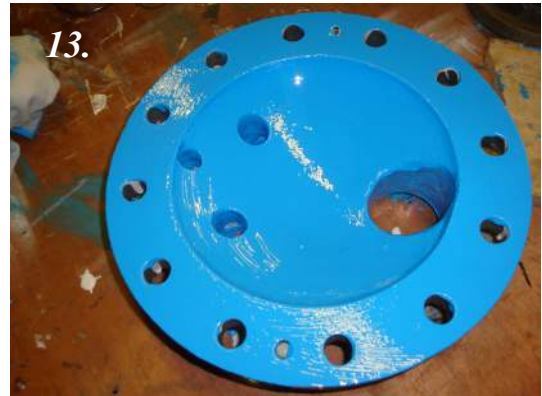
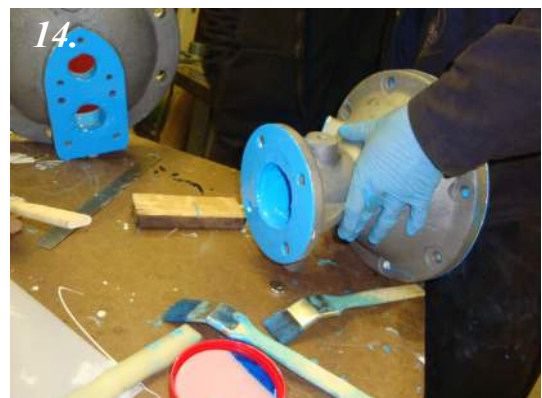
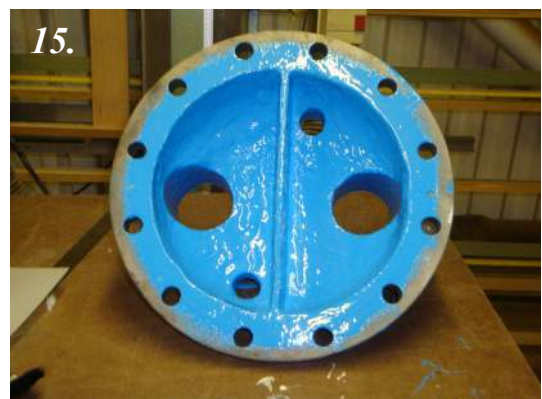
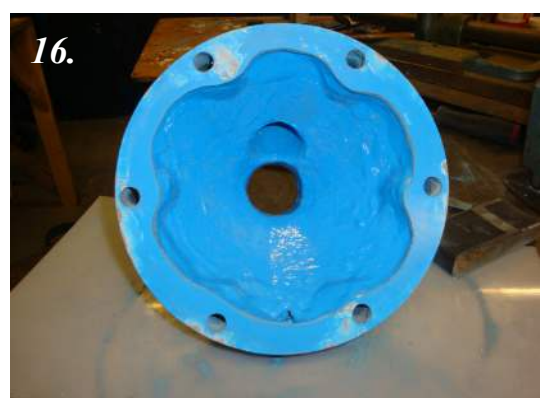
Final result; seawater is now separated from the steel by Wencon Coating and the covers are now protected against bi-metallic corrosion. Another reason, why this solution is often much better and cheaper than purchasing new covers.

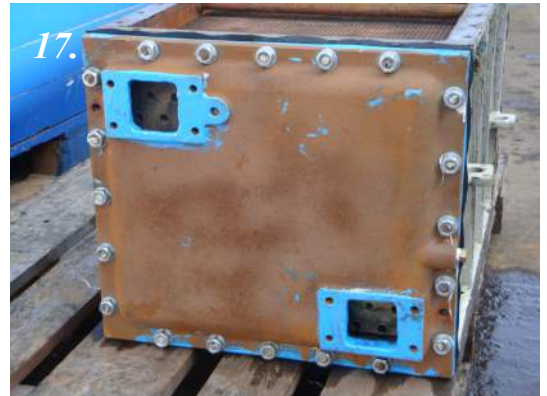
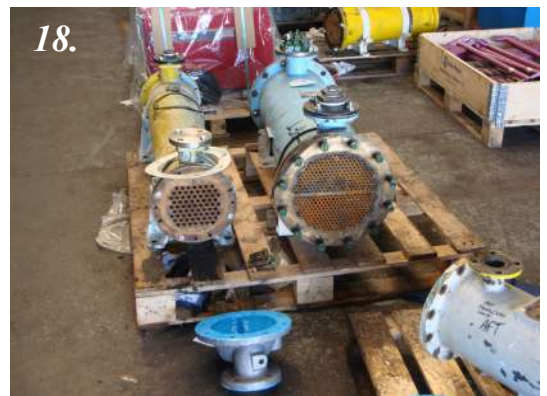
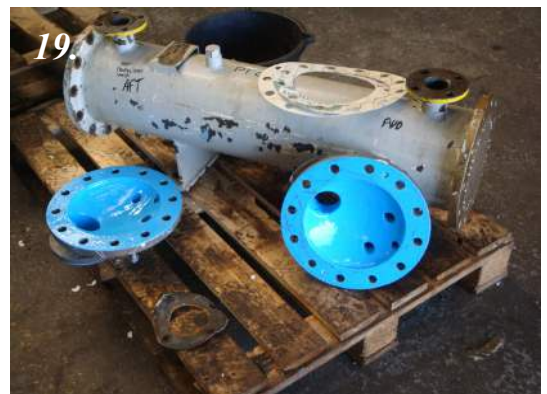
Choose the relevant surface preparation, according to the nature of the job. Seek advice from a Wencon Technician if needed.

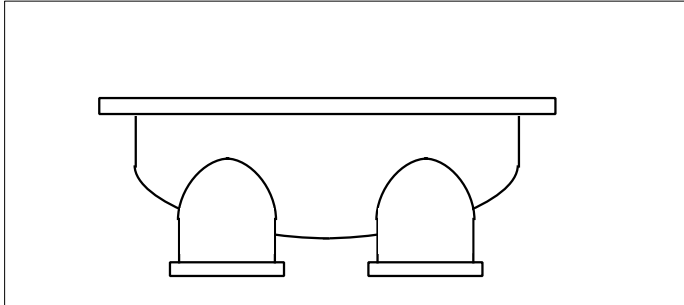
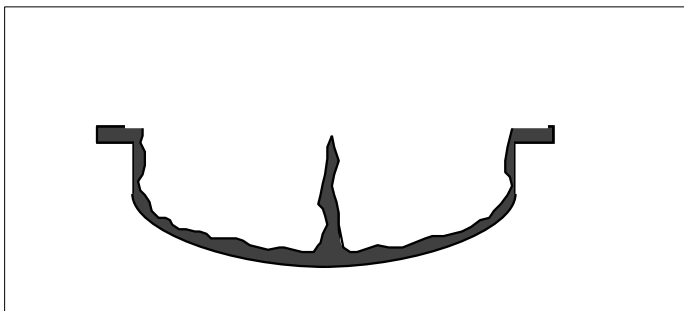
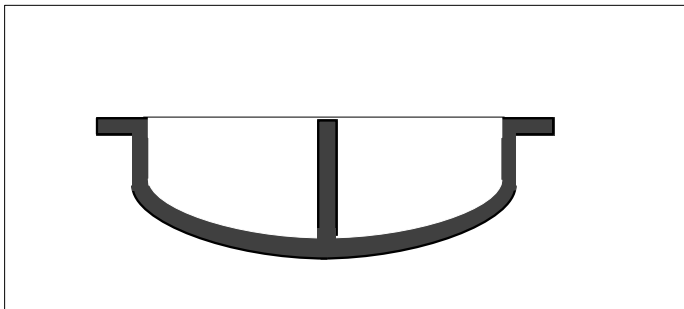
Corroded cooler end covers are very common problems on board a ship. There are several ways of dealing with this. A temporary repair can be made, or the repair can be of a longer lasting nature. The latter method necessitates shot blasting, which as a rule is undertaken ashore. Grinding or needle gunning are other means of carrying out the preparatory work. It is important to remove the graphite as the aim is to obtain a clean metal surface. The inlet and outlet end cover is shown here.
