Fibre glass Pipe, leaking

Application:	Repair of leaking fibre glass pipe
Place:	Atlantic Ocean, On-site job
Date:	June 2012
Job and report done by:	Repair Management Nederland B.V.
Wencon products used:	Coating white and blue, Reinforcement Tape, appl. tools

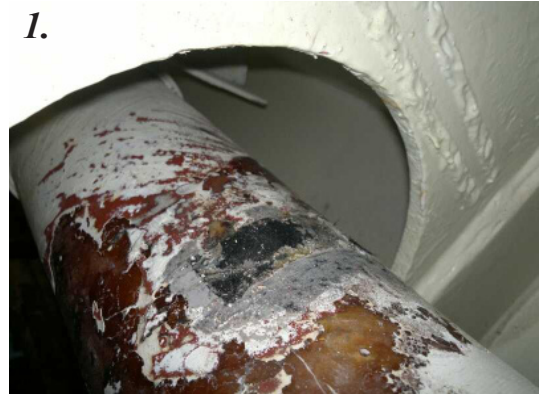
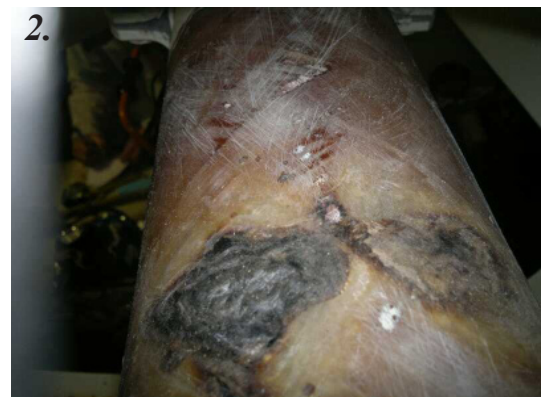
1. & 2.

After removing the emergency Pipe Repair Tape and cleaning the surface, a leak was visible. Leak in GRP pipe is caused by burning, due to hot work. Surface cleaned, rough and degreased. Here the burned and damaged parts are very visible.
