## Water Jet intake

## Introduction

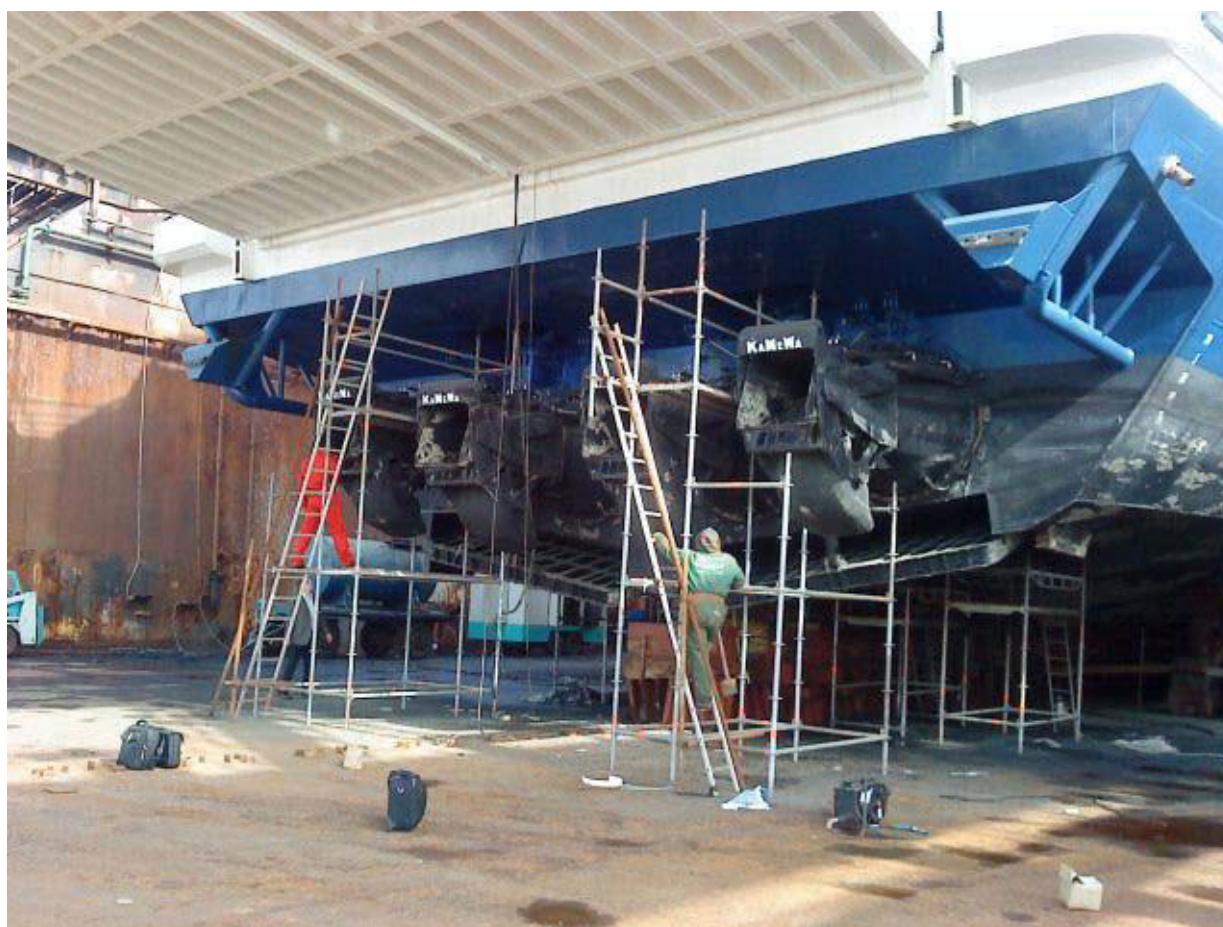
<b>Application:</b>	Protection of 4 Water Jet intake tunnels
<b>Place:</b>	Greece
<b>Date:</b>	February 2010
<b>Job and report done by:</b>	KME, Greece
<b>Wencon products used:</b>	Rapid, Coating white & blue, Cleaner, appl. tools

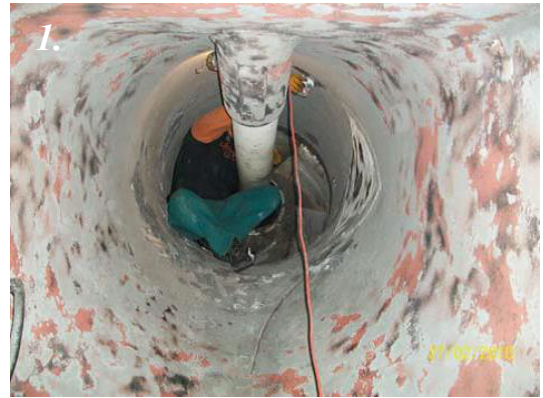
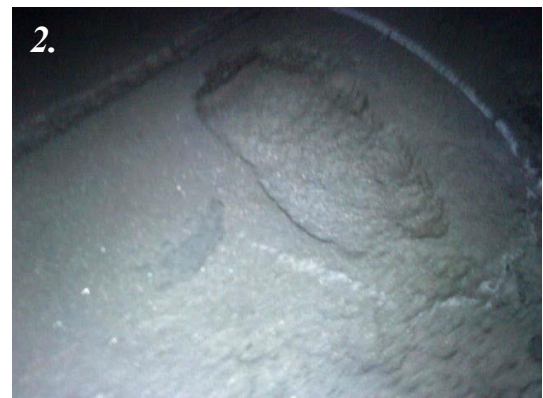
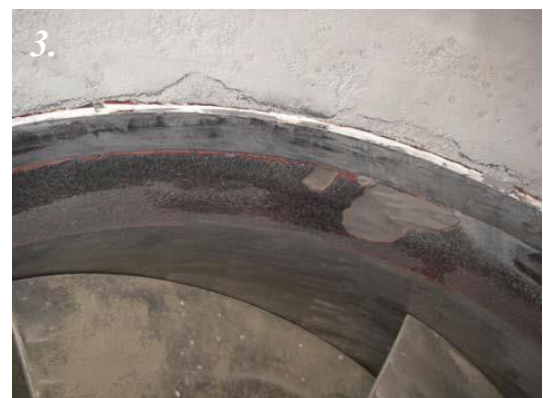
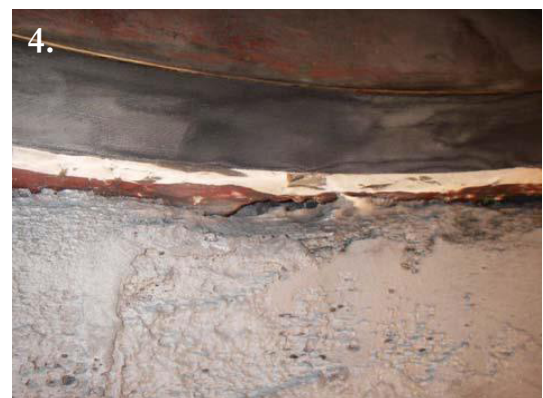
5. Hull area close to anode equipment, suffering from bi-metallic corrosion.

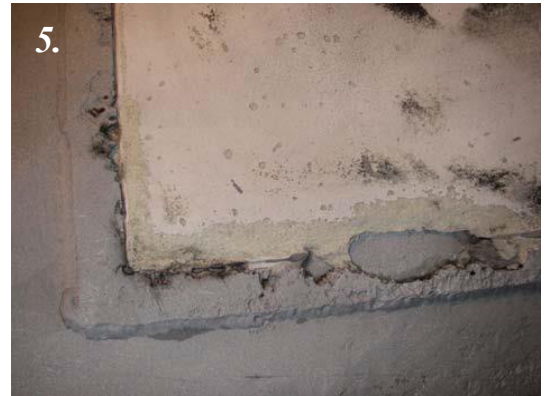
6. All tunnels full blasted to SA 2 1/2 microns, and hereafter degreased with Wencon Cleaner.
