## Stern tube corroded

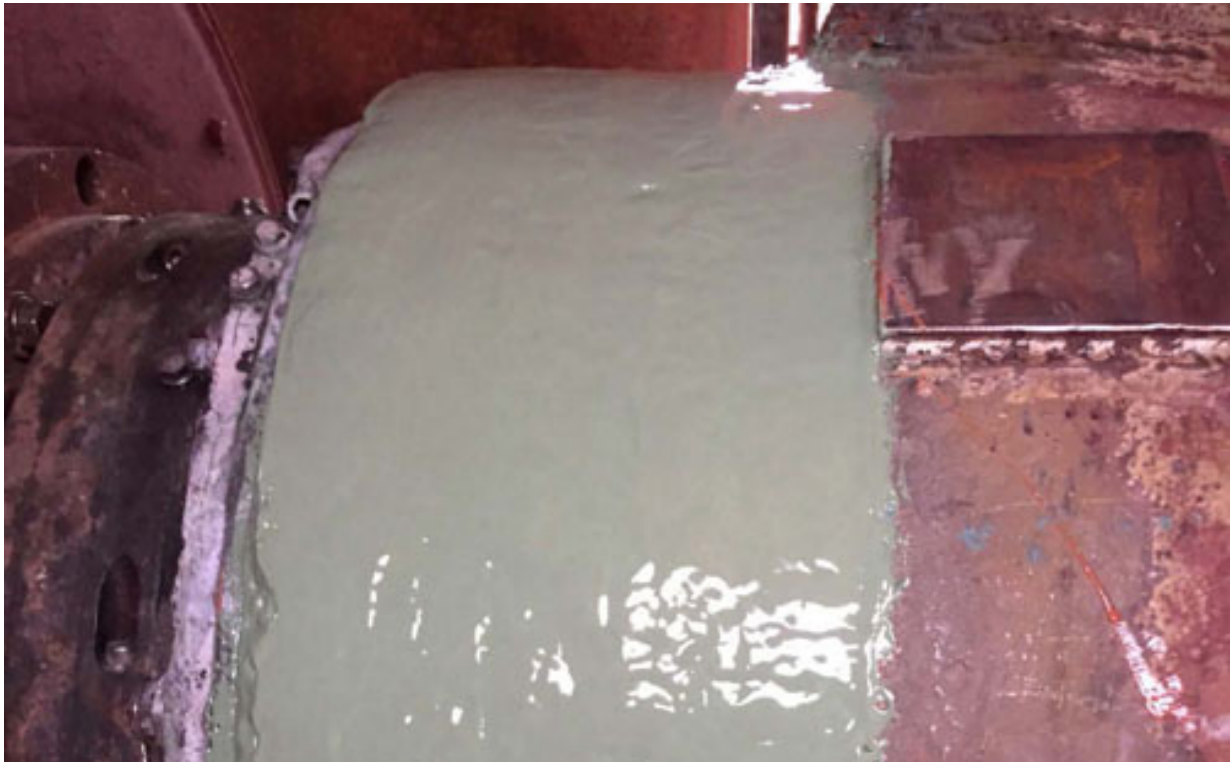
<b>Application:</b>	Rebuilding of corroded stern tube during dry-dock
<b>Place:</b>	The Netherlands
<b>Date:</b>	September 2017
<b>Job and report done by:</b>	Venus & de Waard as Wencon Service Partner in the Netherlands
<b>Wencon products used:</b>	UW Coating, Ceramic Cream, Ceramic Coating, Cleaner, appl. tools

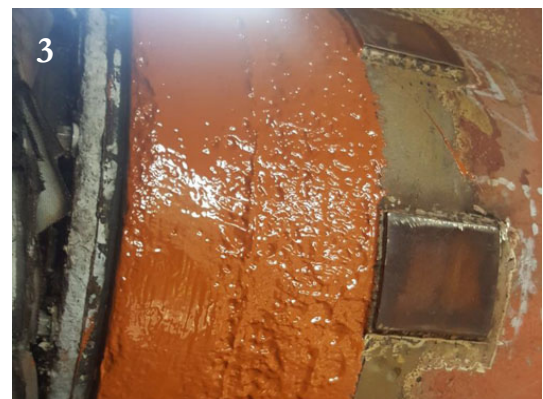
Note: To be applied wet in wet, meaning one layer must be sticky when next layer is applied.

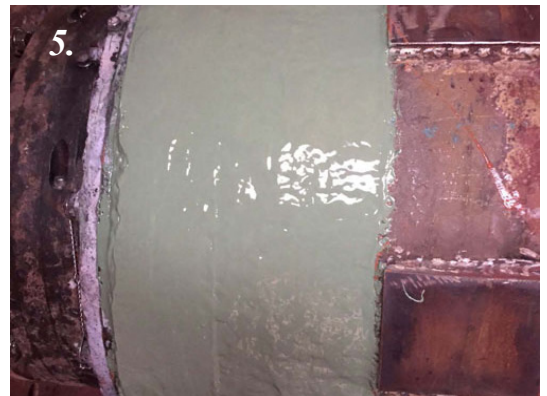
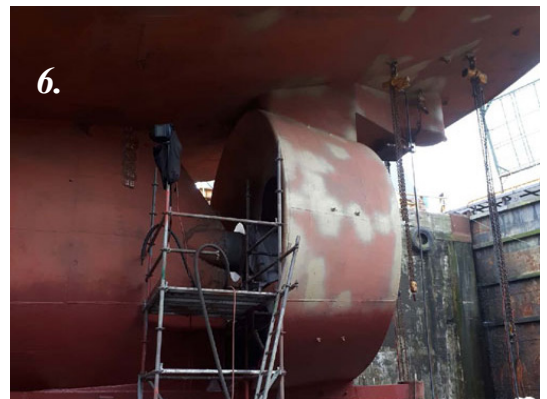
At last one layer of Wencon Ceramic Coating has been applied to achieve a smooth surface. The benefit of Wencon Ceramic Coating is the strength and wear resistance, which is as good as Ceramic Cream.
