Splitcase Pump

Corroded seat of pump housing is grit blasted, before refurbishment with Wencon.

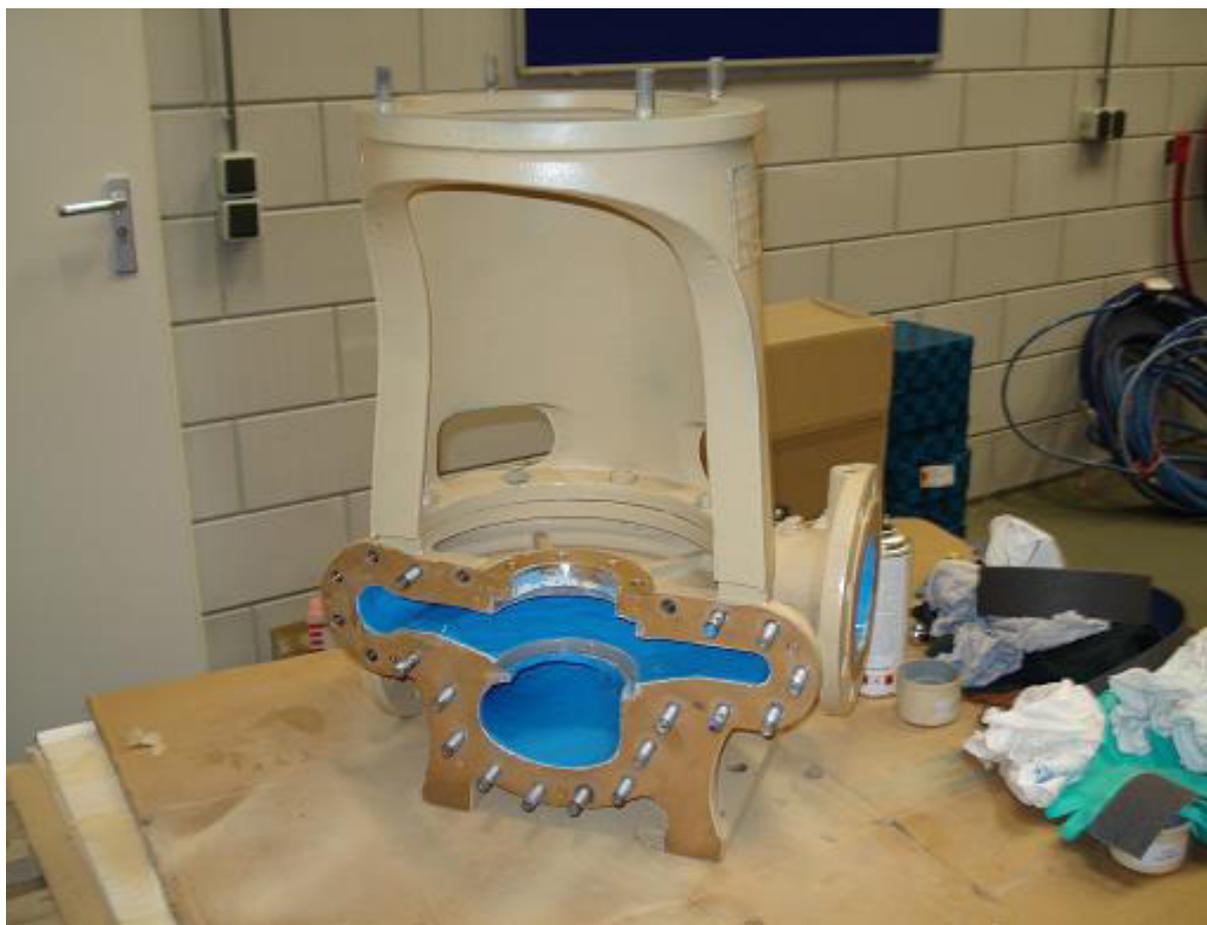
Application:	Repair of splitcase pump
Place:	Ridderkerk, NL
Date:	June 2009
Job and report done by:	Repair Management Nederland B.V.
Wencon products used:	Rapid, Coating white & blue, Release Agent, Cleaner, appl. tools
