Rebuild of Thruster Gear Housing

Application:	Refurbishment of Thruster Gear Housing.
Place:	Rotterdam, NL
Date:	January 2011
Job and report done by:	CC World Wide / Repair Management, NL
Wencon products used:	Rapid, Coating white, Coating blue, Cleaner, appl. tools.

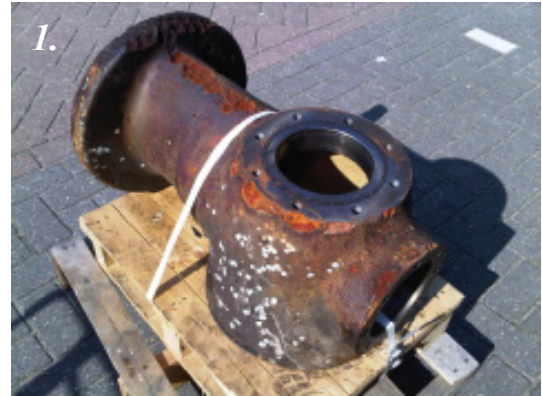
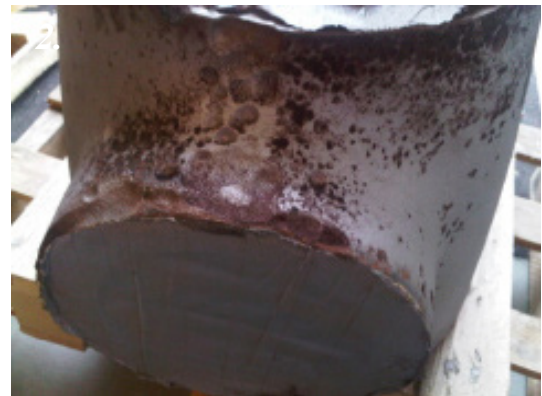
1. & 2.

Unit is blasted to SA 2 1/2 using sharp-edged blasting media, to a roughness of minimum 75 microns. Then salt is sweated out in a warm place for at least 12 hours. Blasted again to SA 2 1/2, immediately before the application. Photos show the gear housing before 1st and 2nd blasting.

For parts containing water and salt, it may be necessary to repeat the surface preparation, until the surface remains light grey for at least 2 hours after blasting. Most companies will understand a specification like this, but it may be necessary to check the blasting prior to the application. If there are any signs of salts, parts must be blasted again.

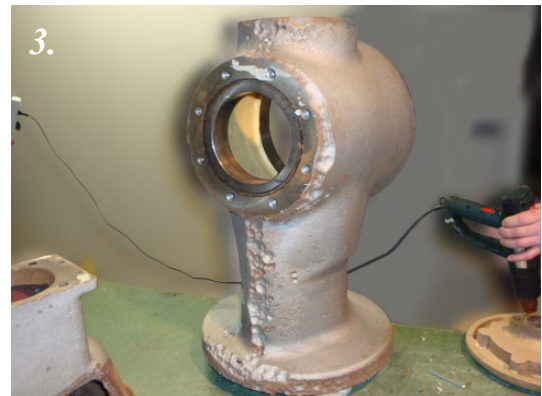
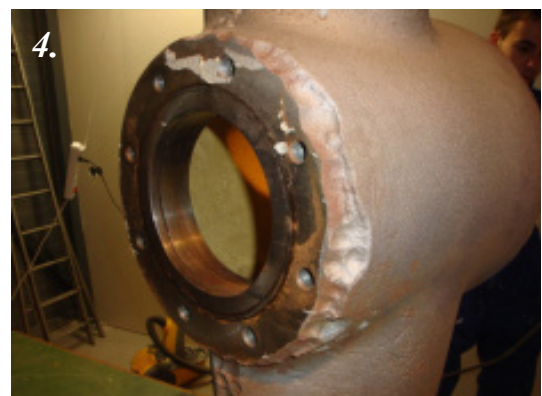
3 & 4.

Unit blasted shortly, before commencing application, ready to clean using Wencon Cleaner.

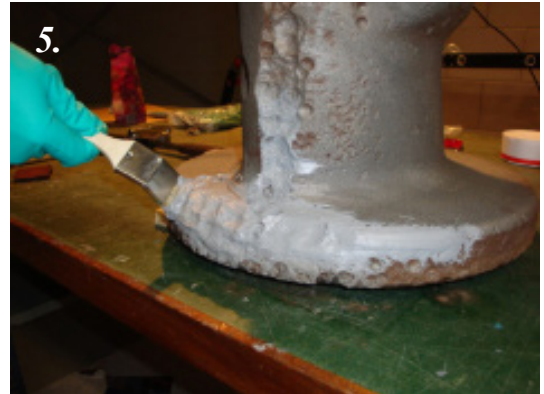
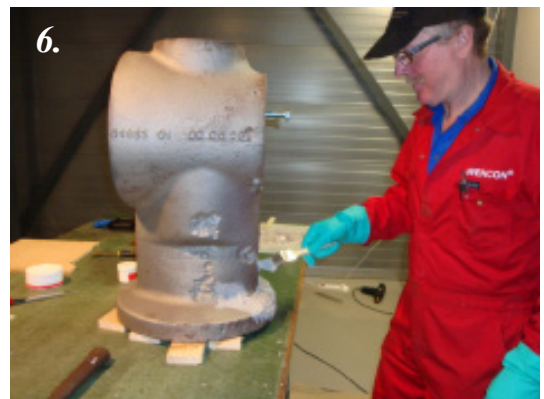
5. & 6.

The damage is very deep and therefore brush is used. This is to ensure that Wencon Rapid is in contact with the metal, in even the deepest holes and corners.

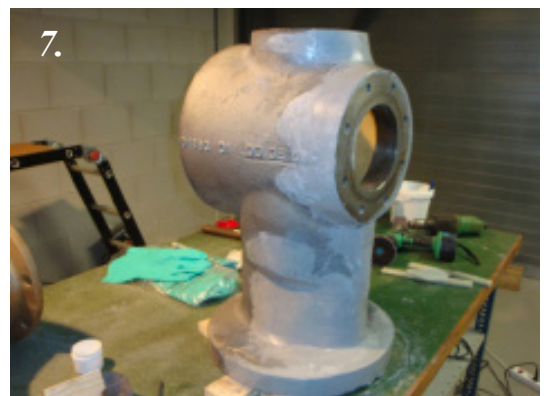
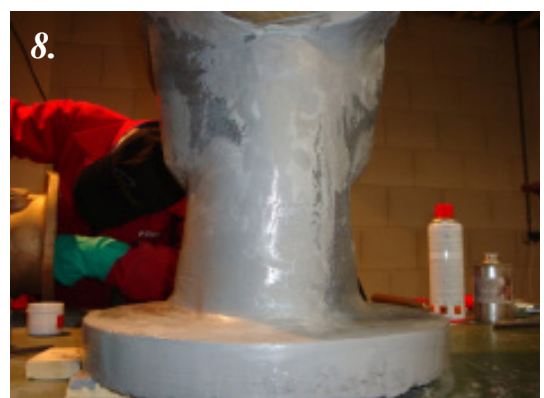
7. & 8.

Using a spatula, the housing is rebuilt layer by layer to original shape. Wencon Rapid exhibits many of the characteristics of metals, which together with outstanding adhesion to all metallic surfaces, makes the repair compound highly suitable for repair of corroded and worn metals.

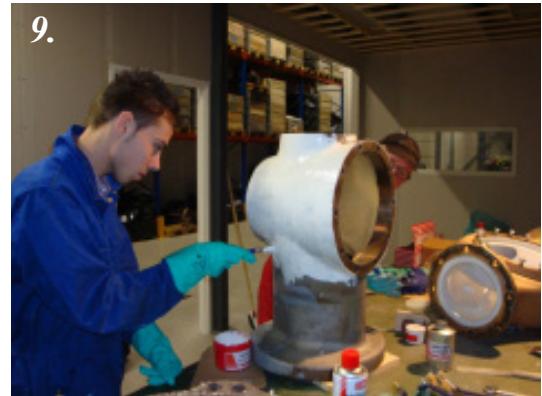
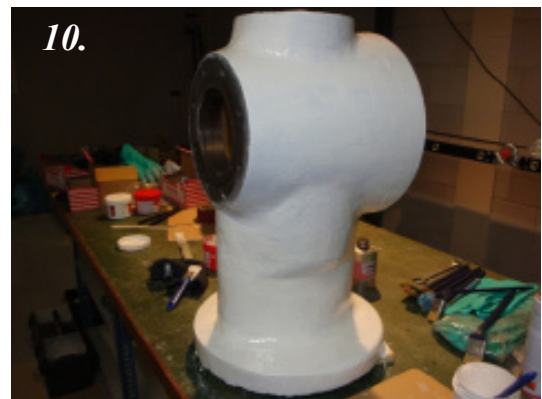
9. & 10.

To avoid similar damage in the future, it is decided to protect the unit against corrosion using Wencon Coating in a two layer system. First layer, applied with a brush.

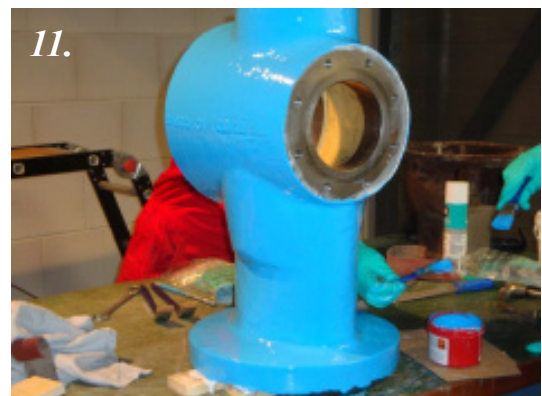
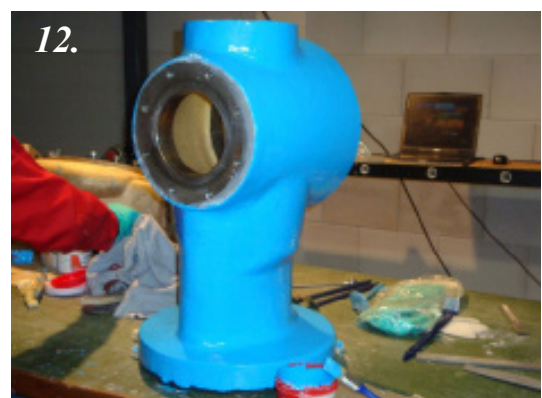
11. & 12.

Second layer also applied with a brush.

Wencon Coating offers resistance to oil, water, saltwater and most diluted acids and alkalis as well as a range of solvents. Heat resistance ranges from 60° C (140°F) in corrosive and heavy load environments and up to 250° C (482°F) when applied as a filling compound.

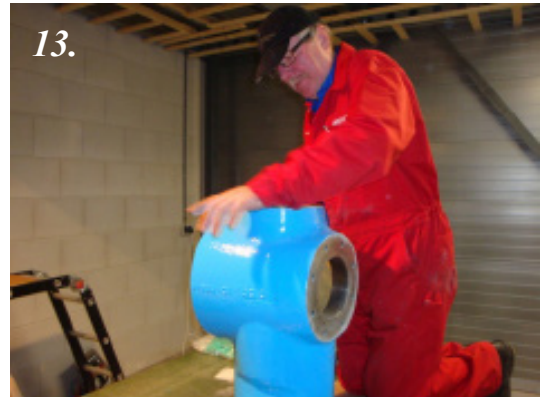
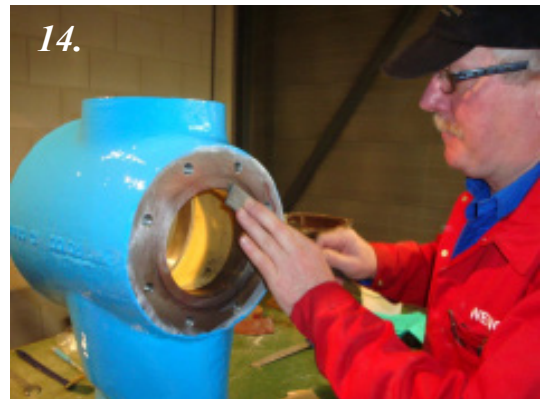
13. & 14.

After curing over night, only the after works remains. The Wencon materials used at this job can be machined, drilled and worked like metal, after curing.

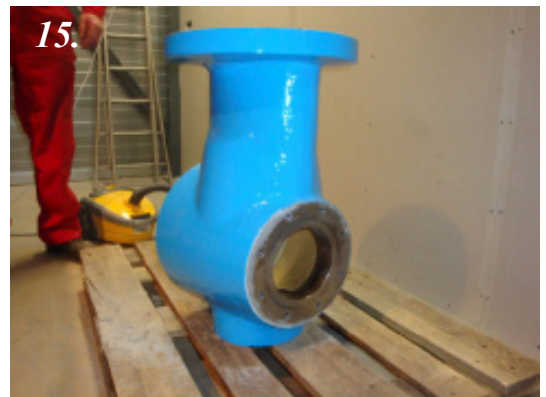
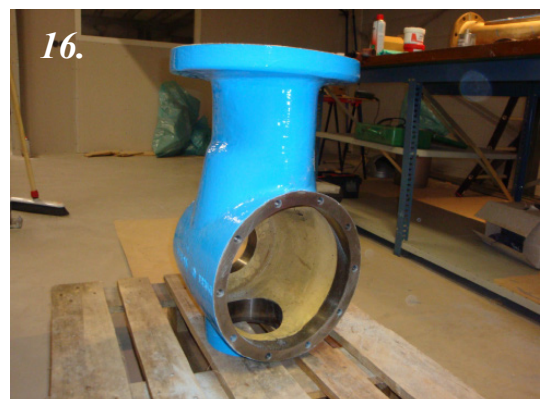
15. & 16.

Note the contact surface, which was heavily damaged; is now rebuild to original shape.

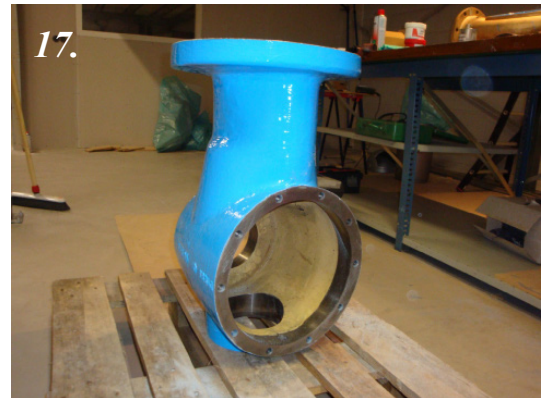
17.

The steel is now separated from the seawater, and will not be attacked by bimetallic corrosion for many years. It is better protected than a new unit.
