## Cooler end cover, corroded

1. Emergency repair of cooler end cover from the outside, to stop the leakage.

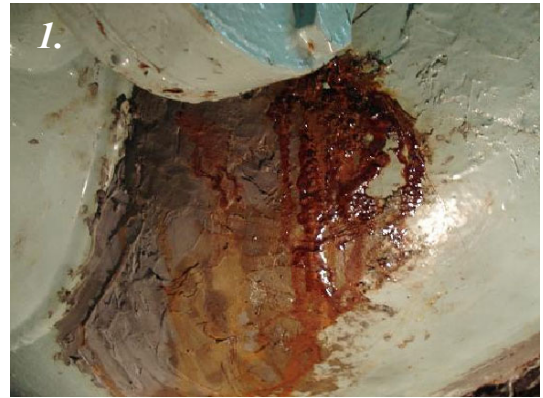
2. & 3. Surface cleaned with Perago Disc and Wencon cleaner to achieve a rough surface, for a good adhesion of the Wencon material. Wencon UW Cream was applied, due to dripping water and adhesion on a wet surface was needed.

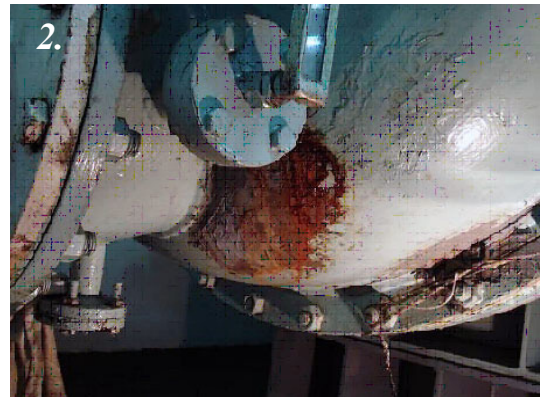
A small spot slowly dripping was discovered after ended application. Presumably caused by pressure on the end cover from the inside. Wencon recommended to add some extra layers of Wencon UW Cream on top, to stop the leakage completely.
