Waste oil pipe in ballast tank

Application:	Waste oil pipe in ballast tank
Place:	Rotterdam
Date:	November 2009
Job and report done by:	Repair Management Nederland B.V.
Wencon products used:	Rapid, Coating, Cleaner. appl. tools

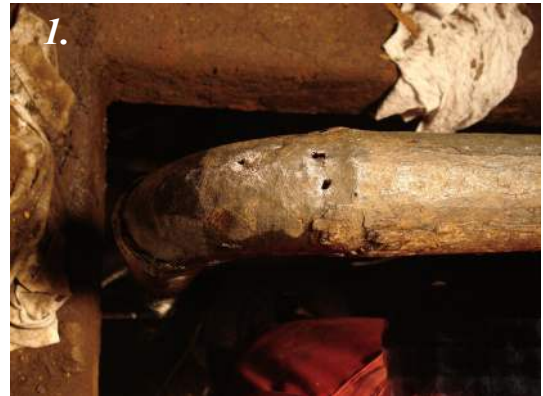
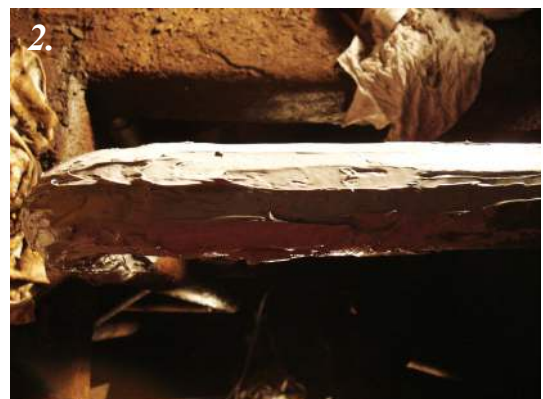
Several leaks found on pipe. Pipe cleaned with special cleaning disc and Wencon Cleaner. Applied a thick layer of Wencon Rapid on the clean surface.

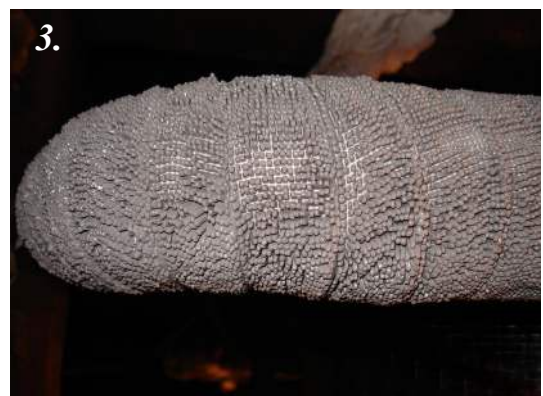
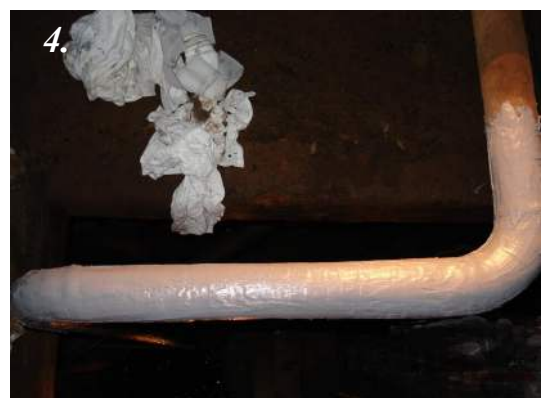
Wencon Coating applied as a primer layer.

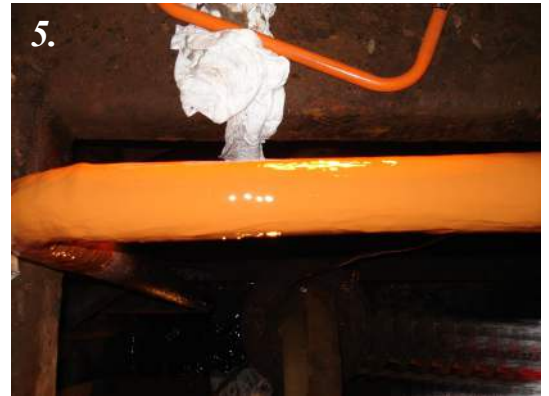
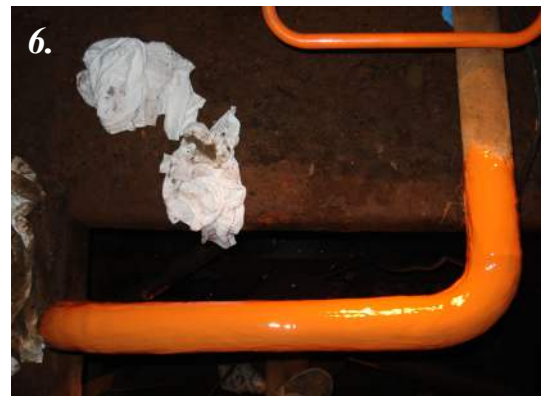
Wencon Coating light applied on the Wencon Rapid, to make the repair more resistant to oil and chemicals.
