## Water Jet intake

## Introduction

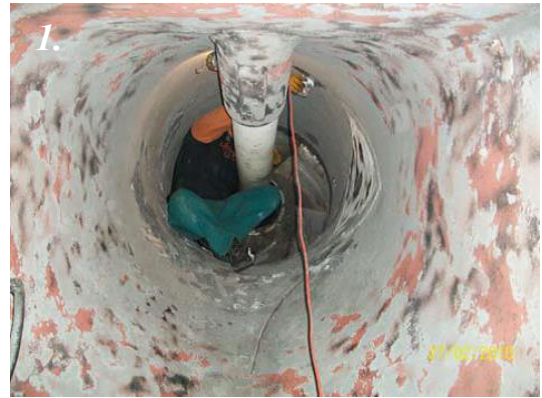
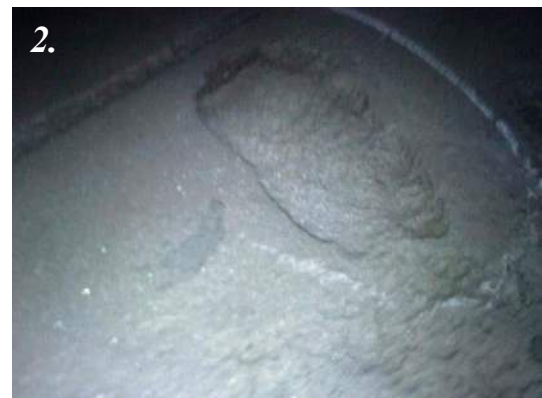
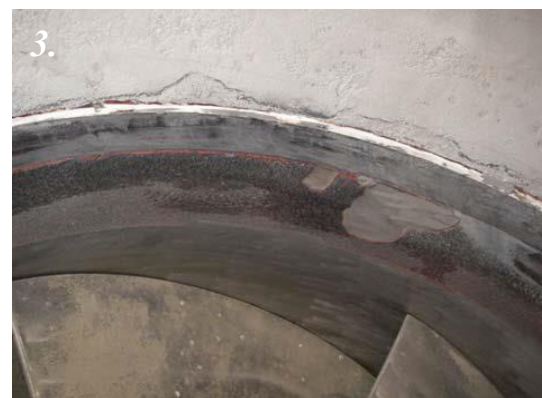
5. Hull area close to anode equipment, suffering from bi-metallic corrosion.

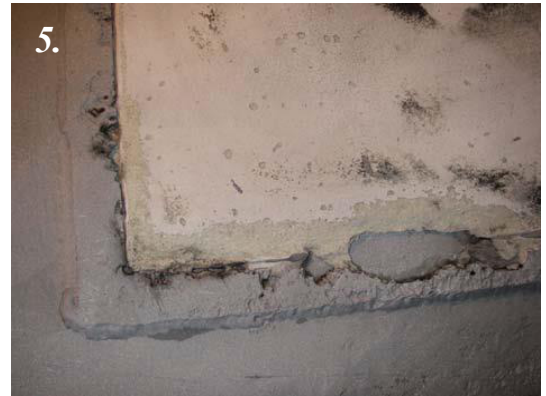
6. All tunnels full blasted to SA 2 1/2 microns, and hereafter degreased with Wencon Cleaner.
