## Rebuilding of wet liners in main engine

<b>Application:</b>	Rebulding of corroded seal surface
<b>Place:</b>	St. Johns, Canada
<b>Date:</b>	September 2009
<b>Job and report done by:</b>	Local workshop, St. Johns
<b>Wencon products used:</b>	Hi-Temp, Cleaner, appl. tools

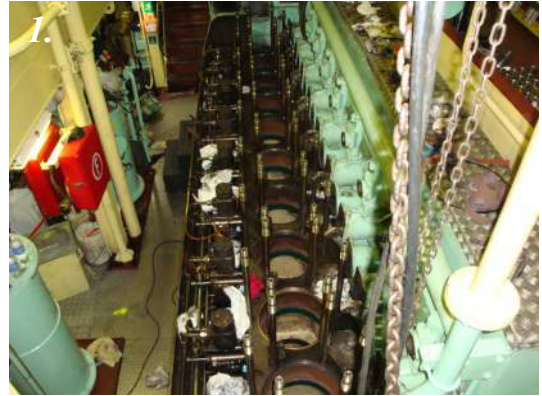
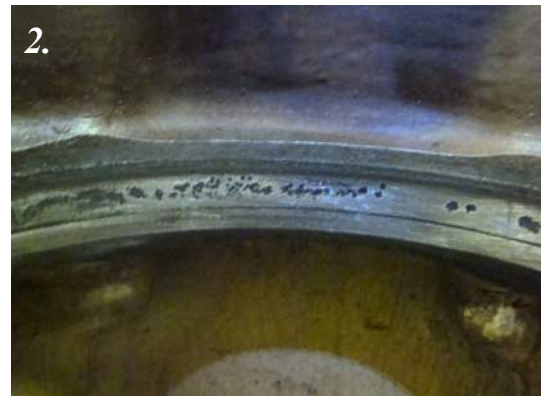
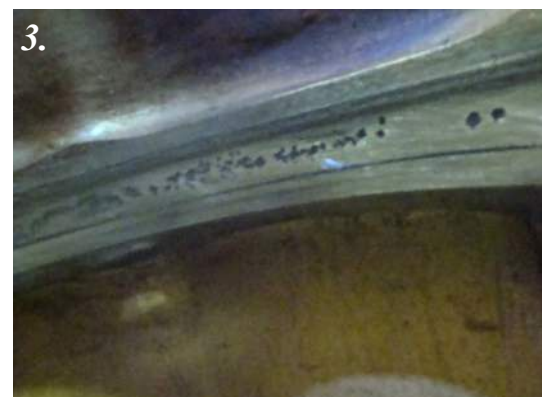
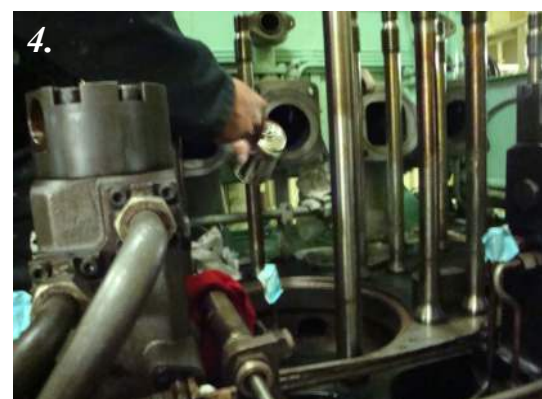
Wet liner seal surfaces in all 9 cylinders found in very bad condition, due to corrosion.

To make surface clean and rough, it is prepared with grinder, except for grooves/dents which will be filled with Wencon. Then cleaned with Wencon Cleaner, heated up with an electric heating gun and cleaned again.

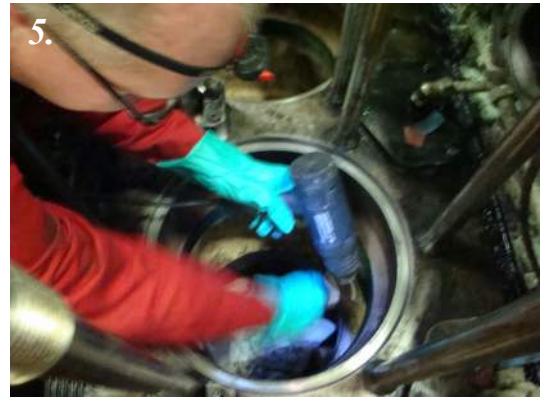
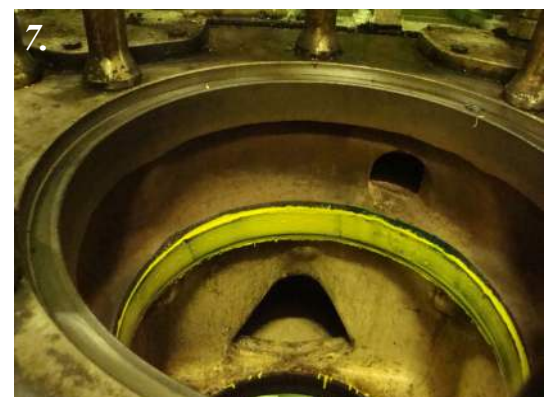
Wencon Hi –Temp is applied with a spatula. To reduce the viscosity of Hi-Temp, a heating gun is used. This way, the Wencon Hi-Temp easily find it's way into the bottom of the dents.

To make sure all dents are filled to the same level as the original surface, a second layer is applied.

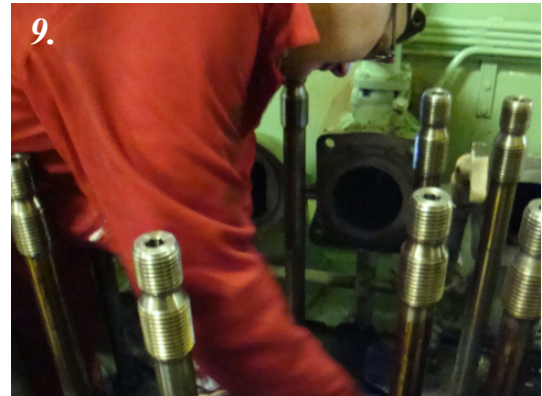
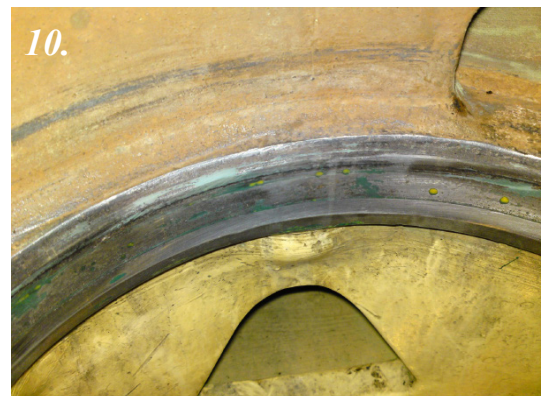
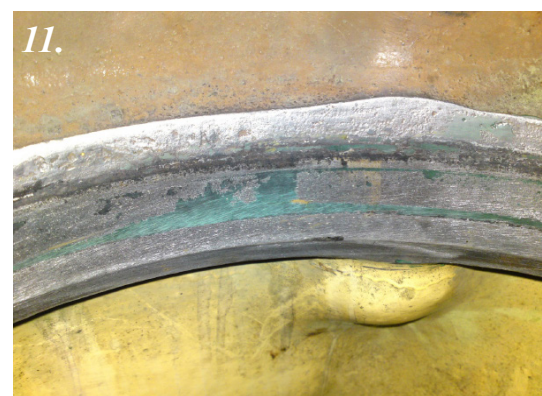
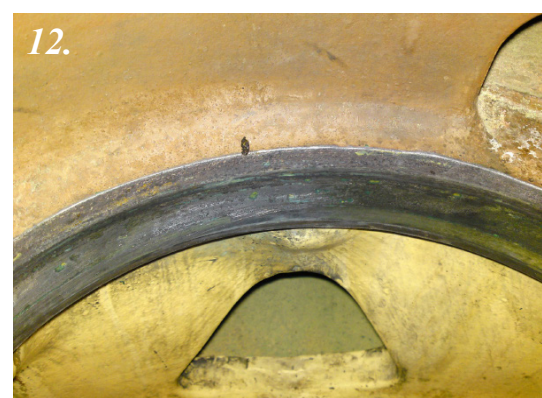
***Final result:***

Using sand paper, all surfaces are grinded to original size and shape.

All dents are filled to original level.
