Repair of leaking horizontal multitubular Condensers

Surface preparation: Old epoxy products removed from all 6 ends – all surfaces now clean and smooth. Photo clearly shows bi-metallic corrosion and leaks.

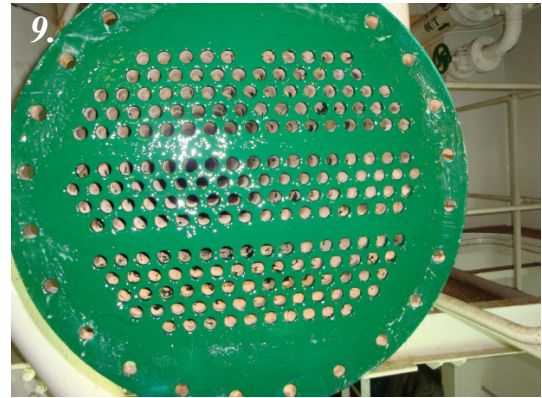
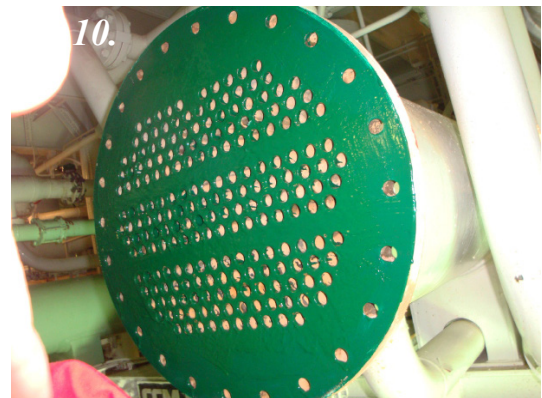
Pressure: 5 bars and no leaks.
