Propeller Shaft repair

Due to a leaking o-ring, the seawater has been penetrating and caused corrosion at the flange

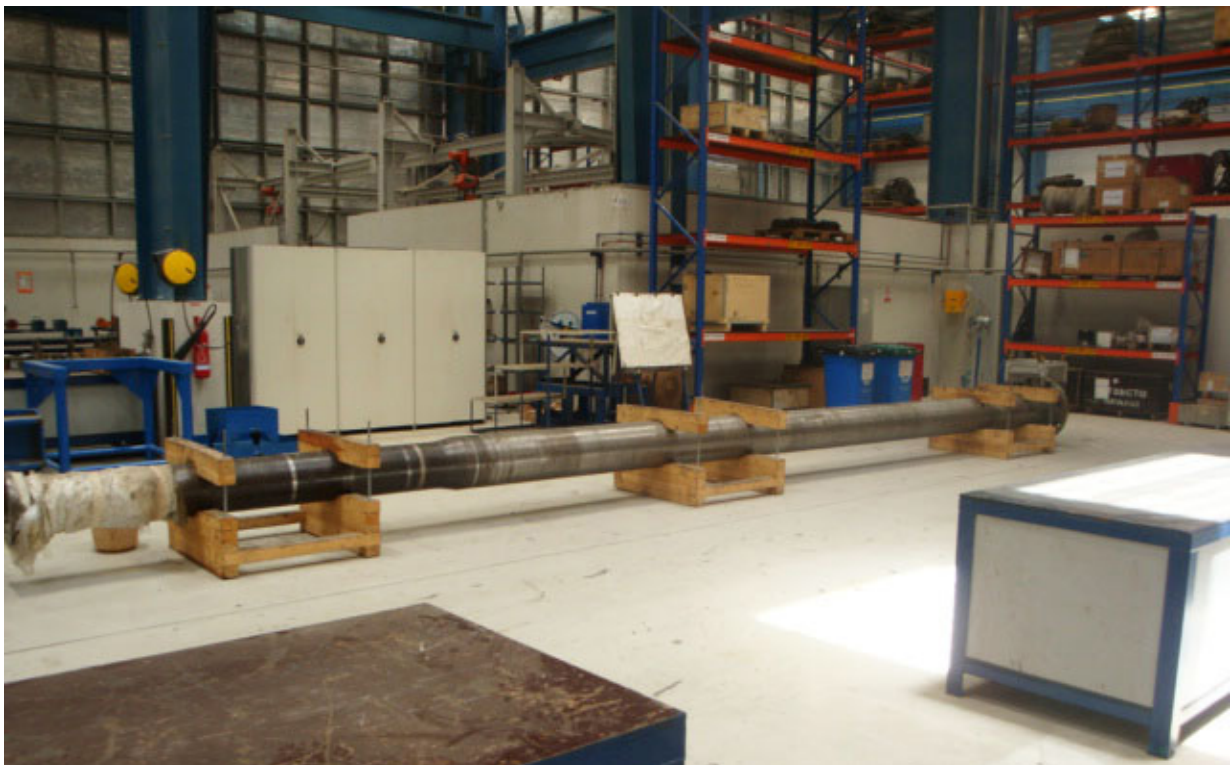
Application:	Rebuilding of corroded flange connection
Place:	Dubai, UAE
Date:	July 2009
Job and report done by:	Local Dubai workshop and Wencon technician
Wencon products used:	Rapid, Cleaner, appl. tools

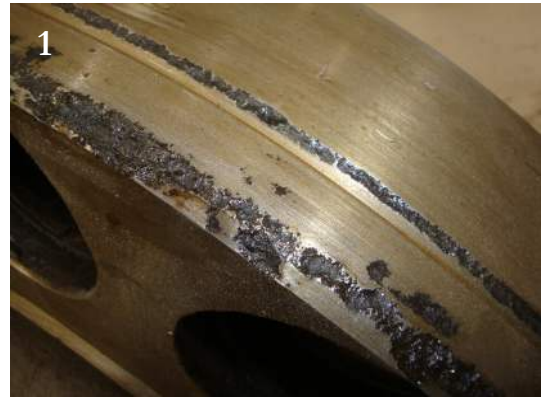
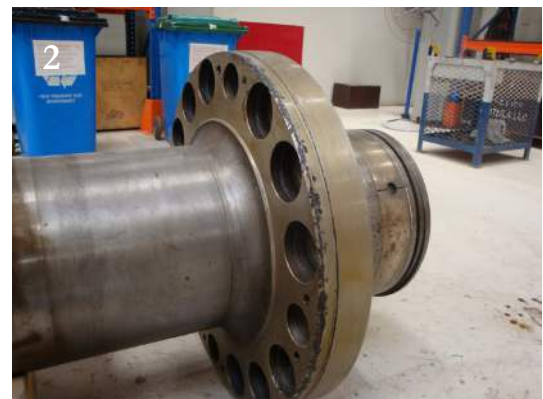
3. The Wencon Perago disc is used to make the surface as rough as possible.
