Sea Water Filter Strainer

1., 2., 3. & 4.

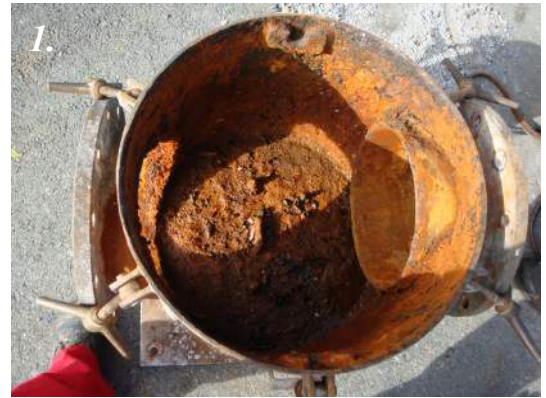
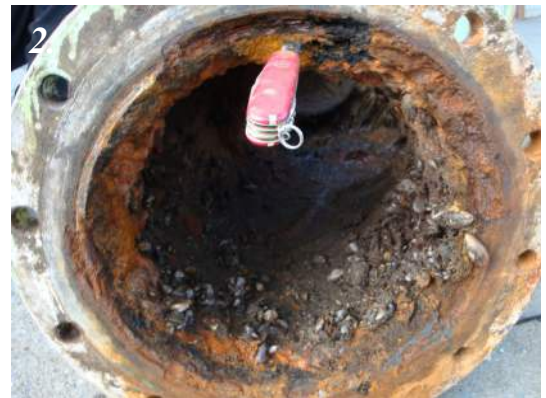
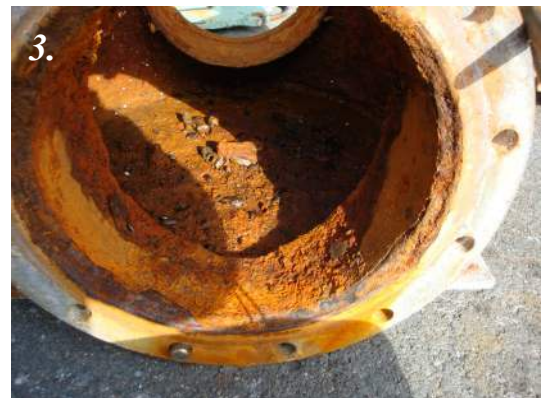
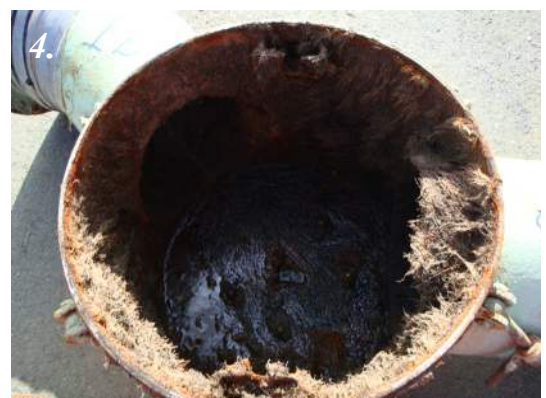
Housings, before sandblasting.

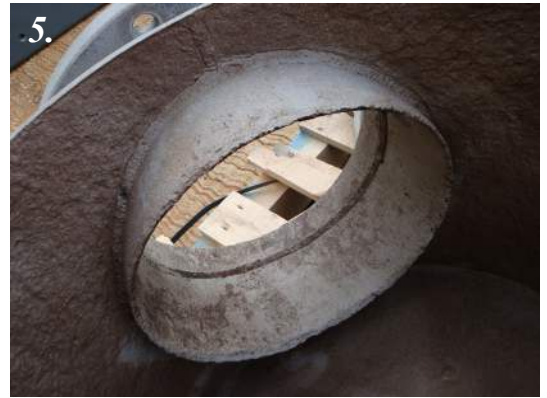
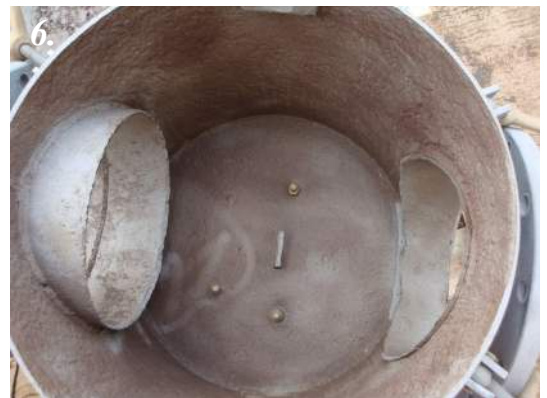
Condition of both housings, after first sandblasting, was very poor. After only ½ hour, the surface started to sweat salts and water (surface became brown-black).

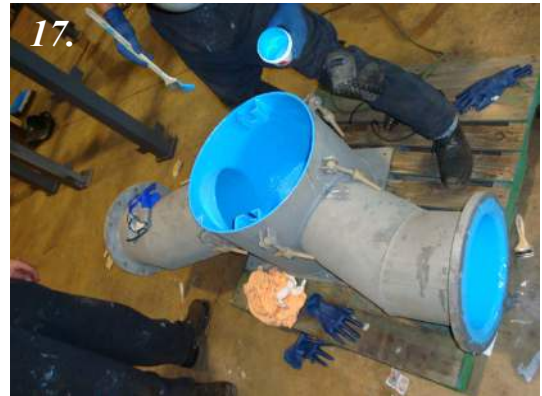
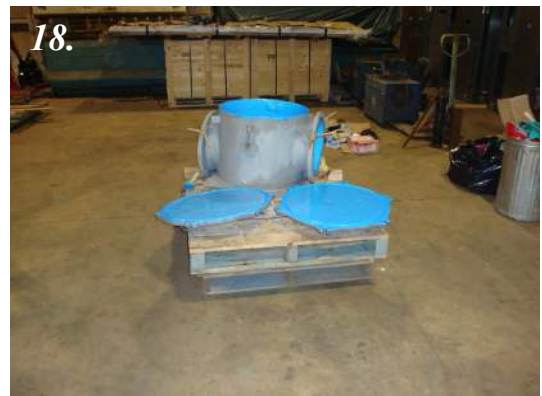
The housings are now ready for many years of service life, without any risk of attack from bi-metallic corrosion.
