Waterjet casing

Application:	Repair of Waterjet
Place:	Assens Shipyard - Workshop
Date:	October 2008
Job and report done by:	Assens Shipyard, Assens, Denmark
Wencon products used:	1088 Coating, Release Agent, Cleaner, appl. tools

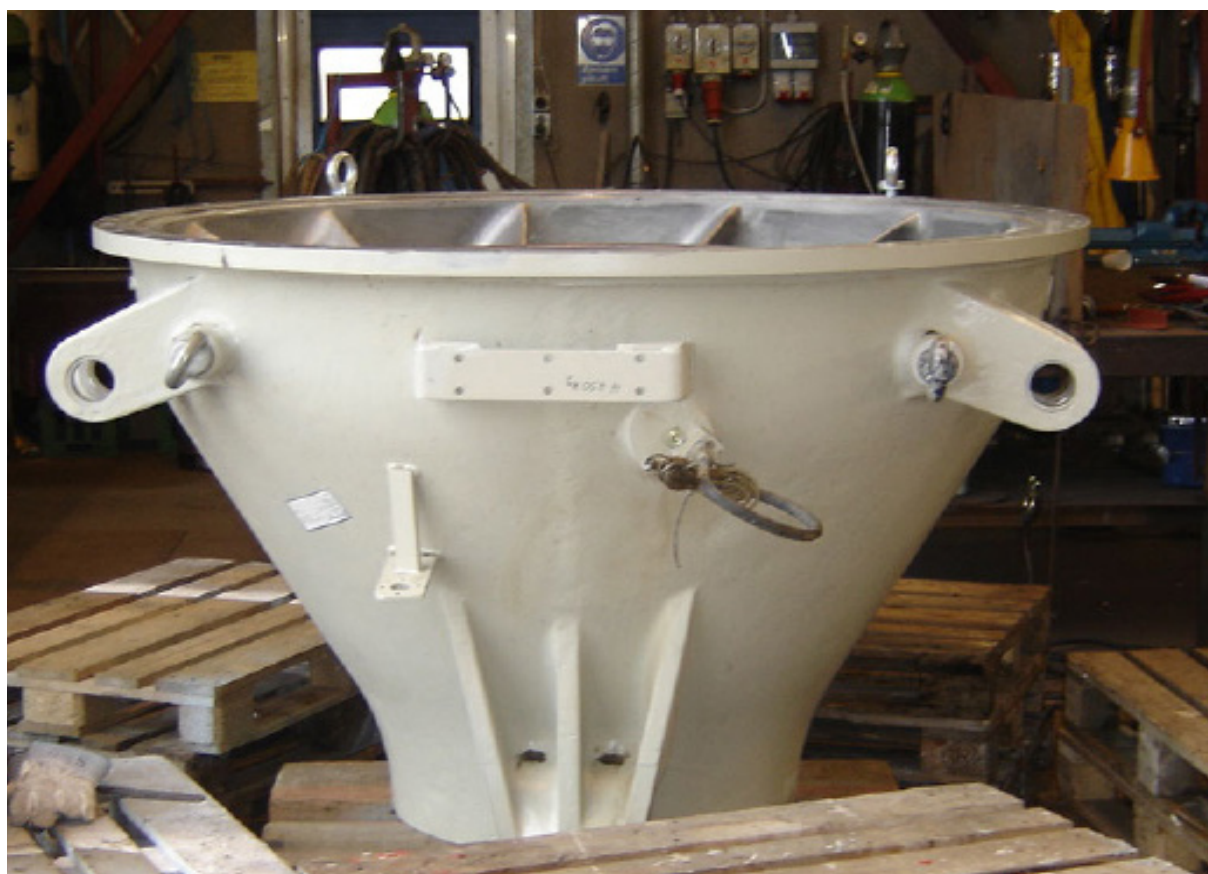
1. & 2.

The jet is worn, due to heavy water flow and sand in the shallow water, where the ferry operates. First repair with Wencon is 4 years ago, and the jets need an overhauling again.

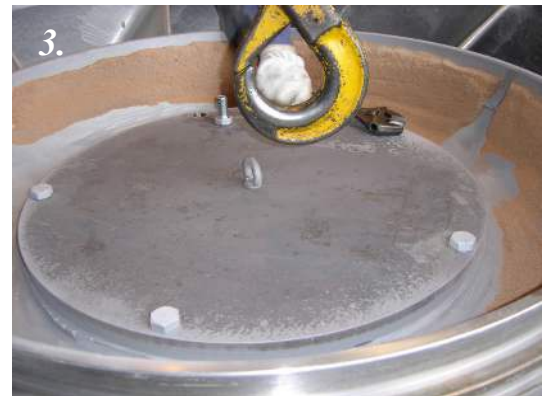
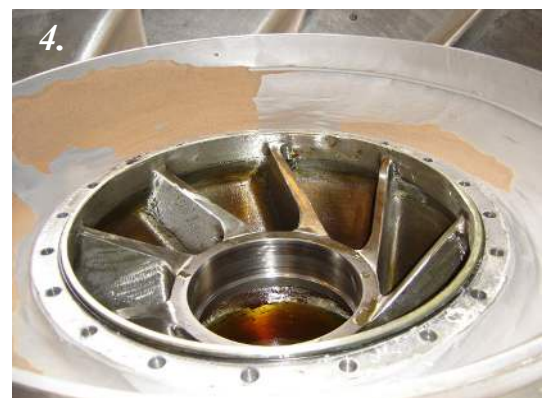
3. & 4.

The jet is sandblasted, sweated out and sandblasted again, in order to remove worn material and any liquids. A cover which has protected the bearing while blasting, is also removed.

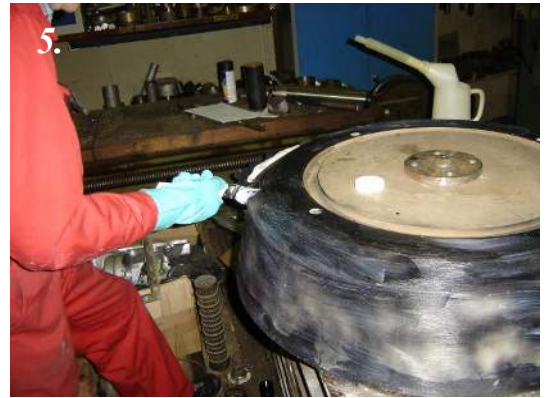
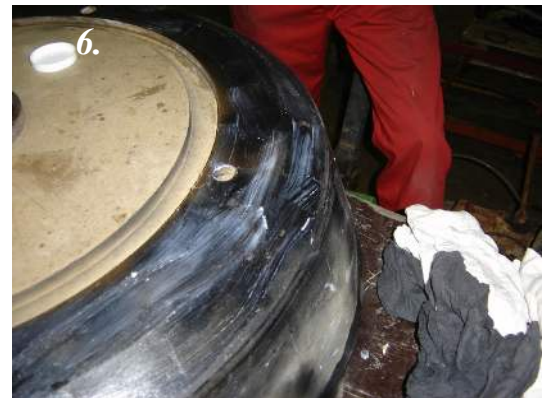
5. & 6.

A prefabricated mould which has been used more than 10-times, is covered with 1-layer Wencon Release Agent.

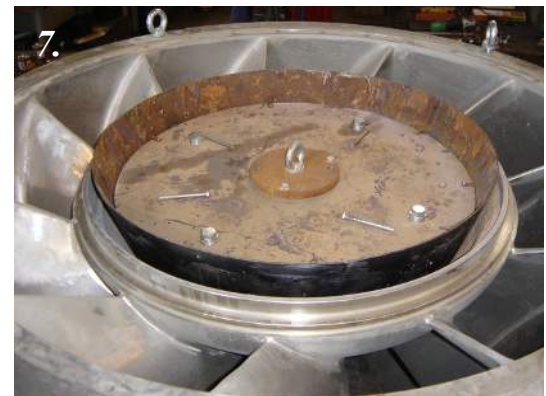
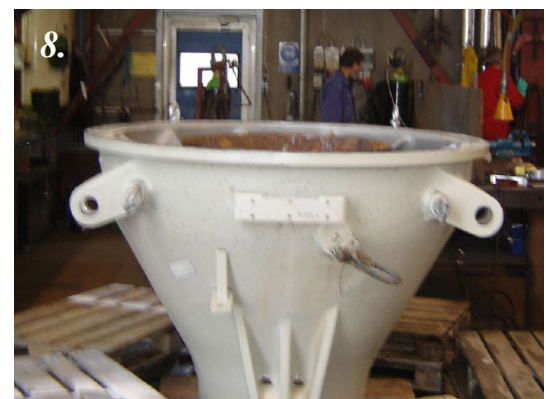
7. & 8.

To ensure good adhesion, the jet is cleaned and degreased with Wencon Cleaner. The Wencon Cleaner removes dirt and grease from the surface. The mould is fixed on the jet, with 4 bolts and the metal is heated to approximately 20° C by ventilators. The jet is ready for the actual repair.

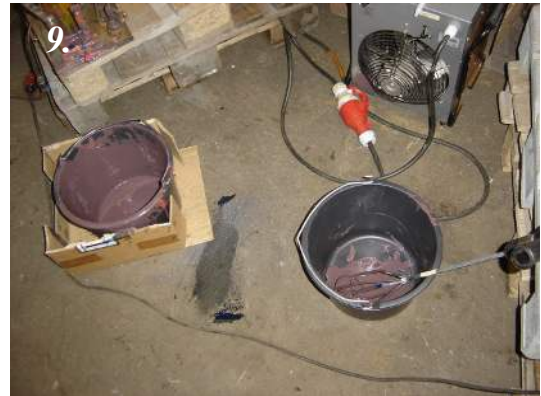
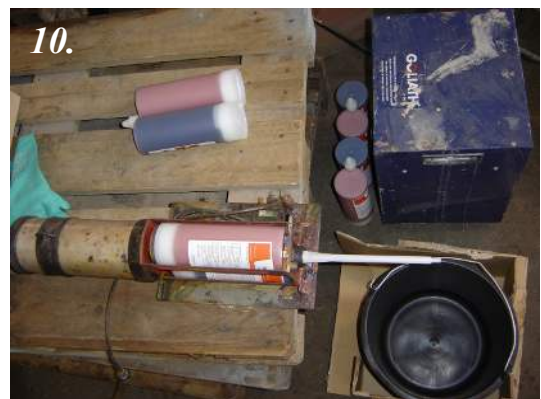
9. & 10.

Wencon 1088 Coating is mixed with zircon korund and silicium carbide, to give the coating additional durability.

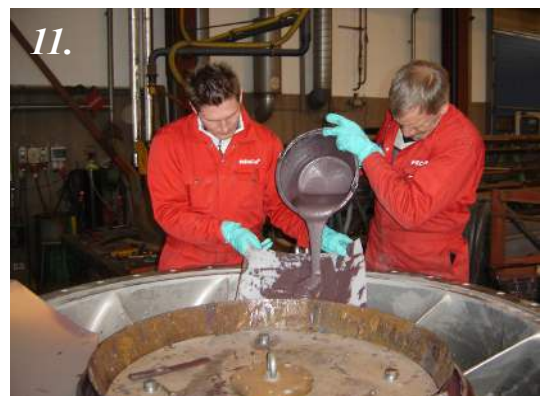
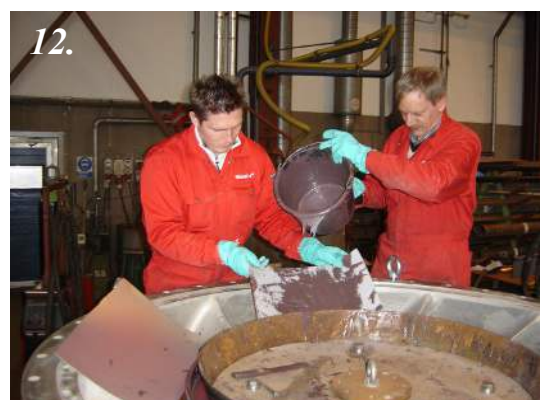
11. & 12.

The coating is applied in the gap between the mould and the jet.

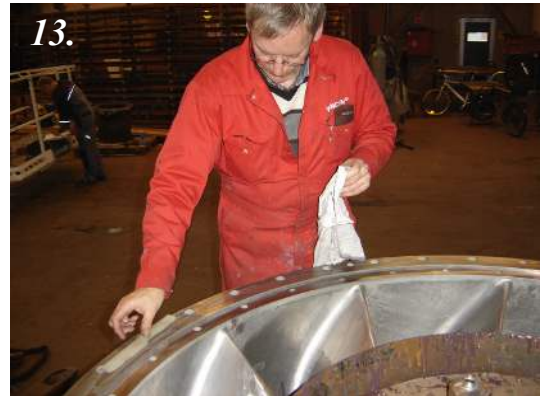
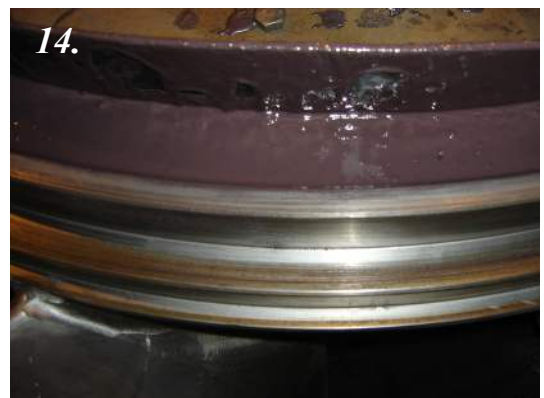
13. & 14.

The excess coating is removed with cloth and with Wencon Cleaner if necessary. The repair is left for curing, for approximately 12 hours. If needed, curing time can be speeded up with heat.

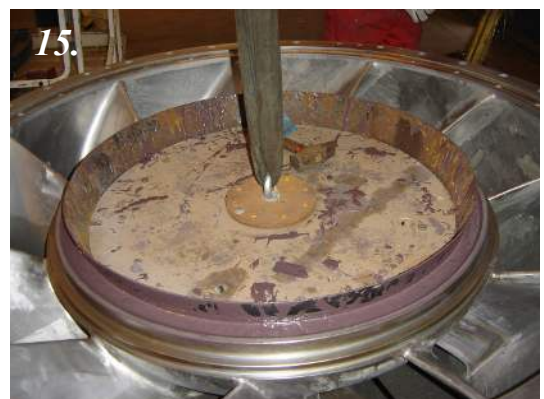
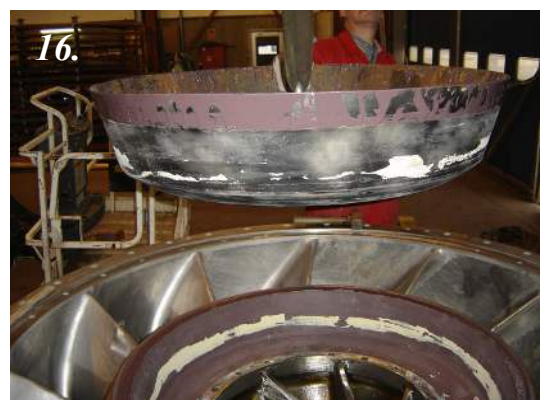
15. & 16.

After curing, the mould is removed and because of the Wencon Release Agent, it is easily done.

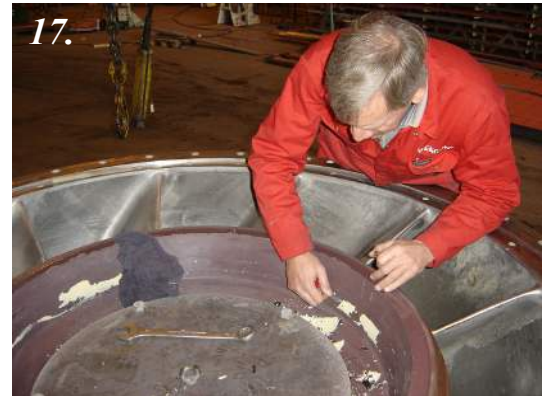
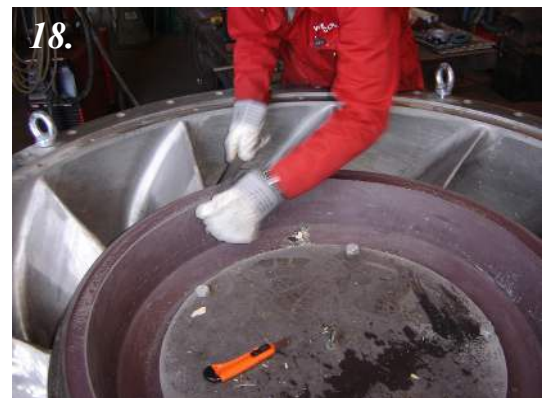
17. & 18.

The refurbished area is cleaned.

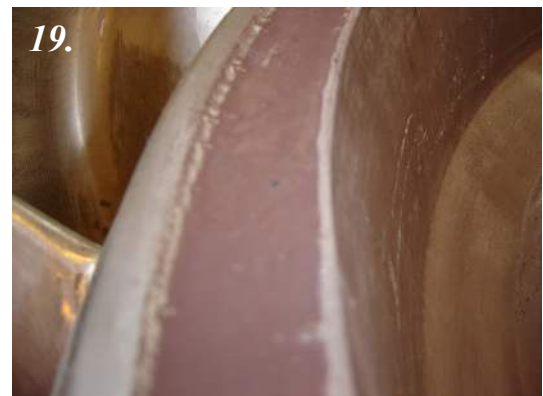
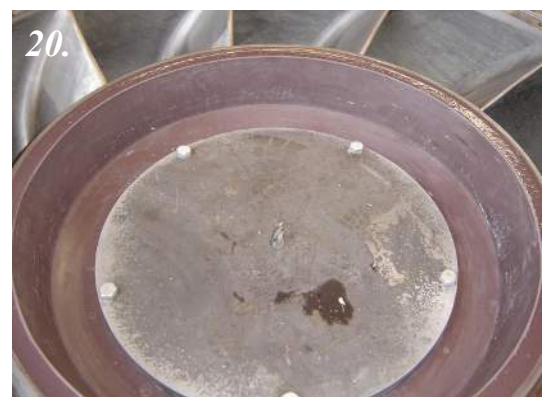
19. & 20.

Final result of overhauling and refurbishment.
