## Ballast Valve casings

1, 2, 3 & 4.

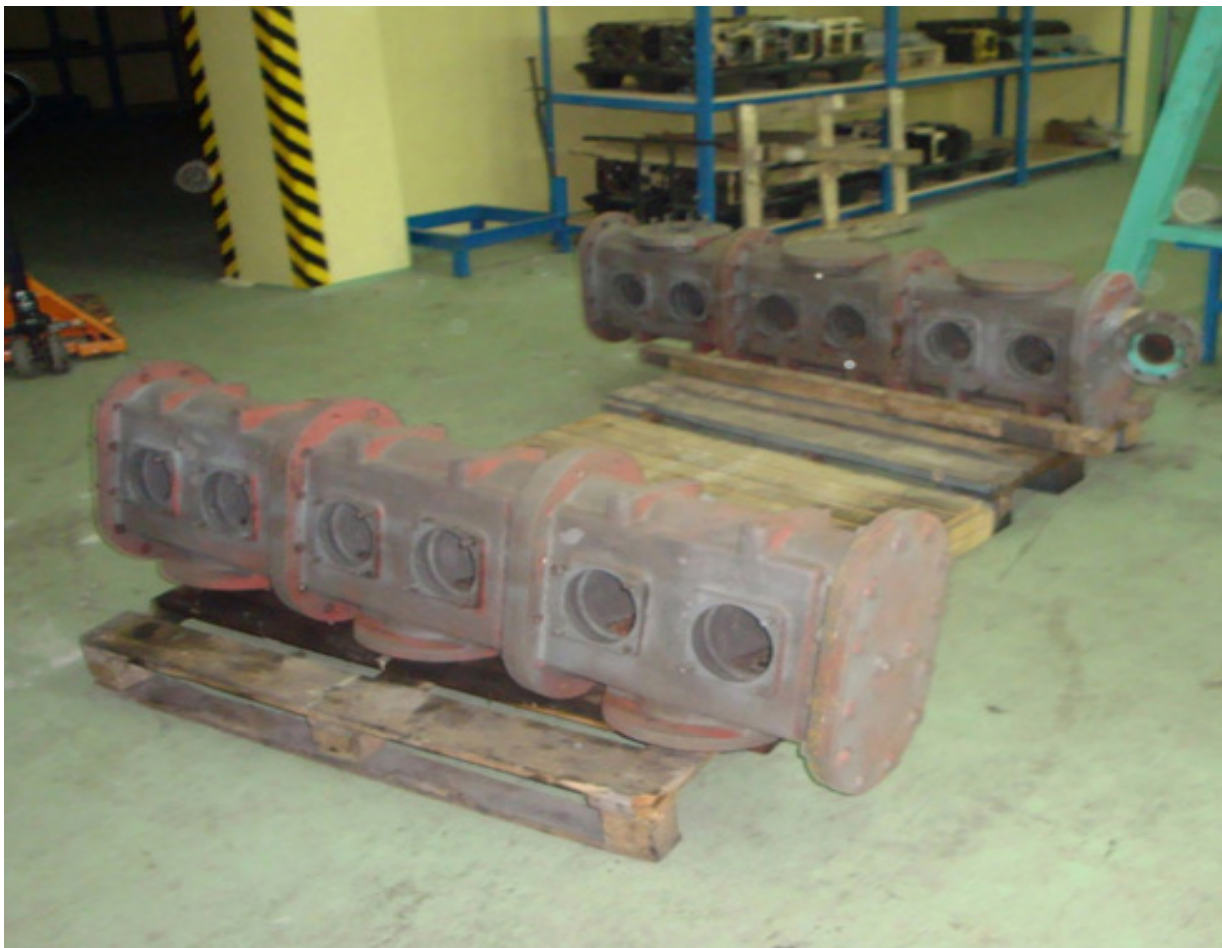
<b>Application:</b>	Ballast valve casings
<b>Place:</b>	Stettin, Poland
<b>Date:</b>	January 2009
<b>Job and report done by:</b>	Local workshop, Stettin and Wencon technician
<b>Wencon products used:</b>	Rapid, Release Agent, Cleaner, appl. tools

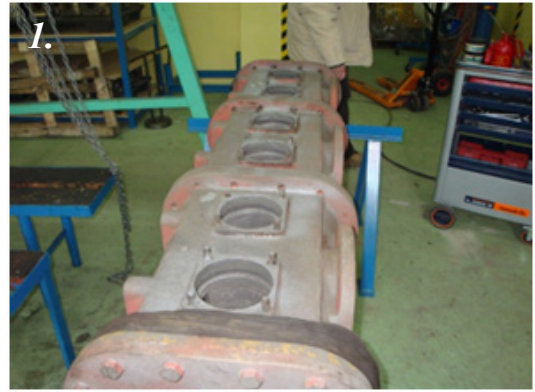
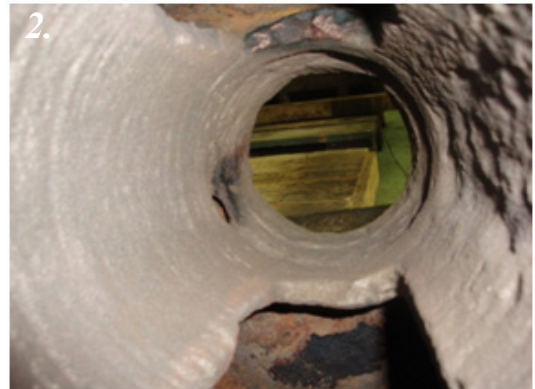
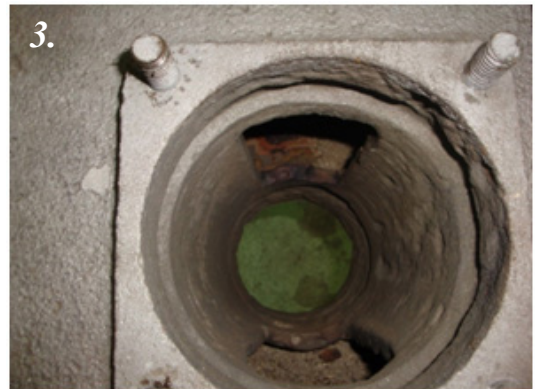
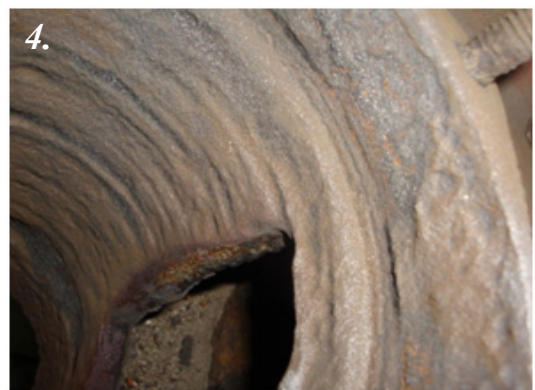
Then sandblasted again to avoid “new rust”.
