Thruster Tunnel - protection

Solution: protect the welding zones, hereby re-welding will not longer be required by ducking's
Cost-effective & preventive maintenance.

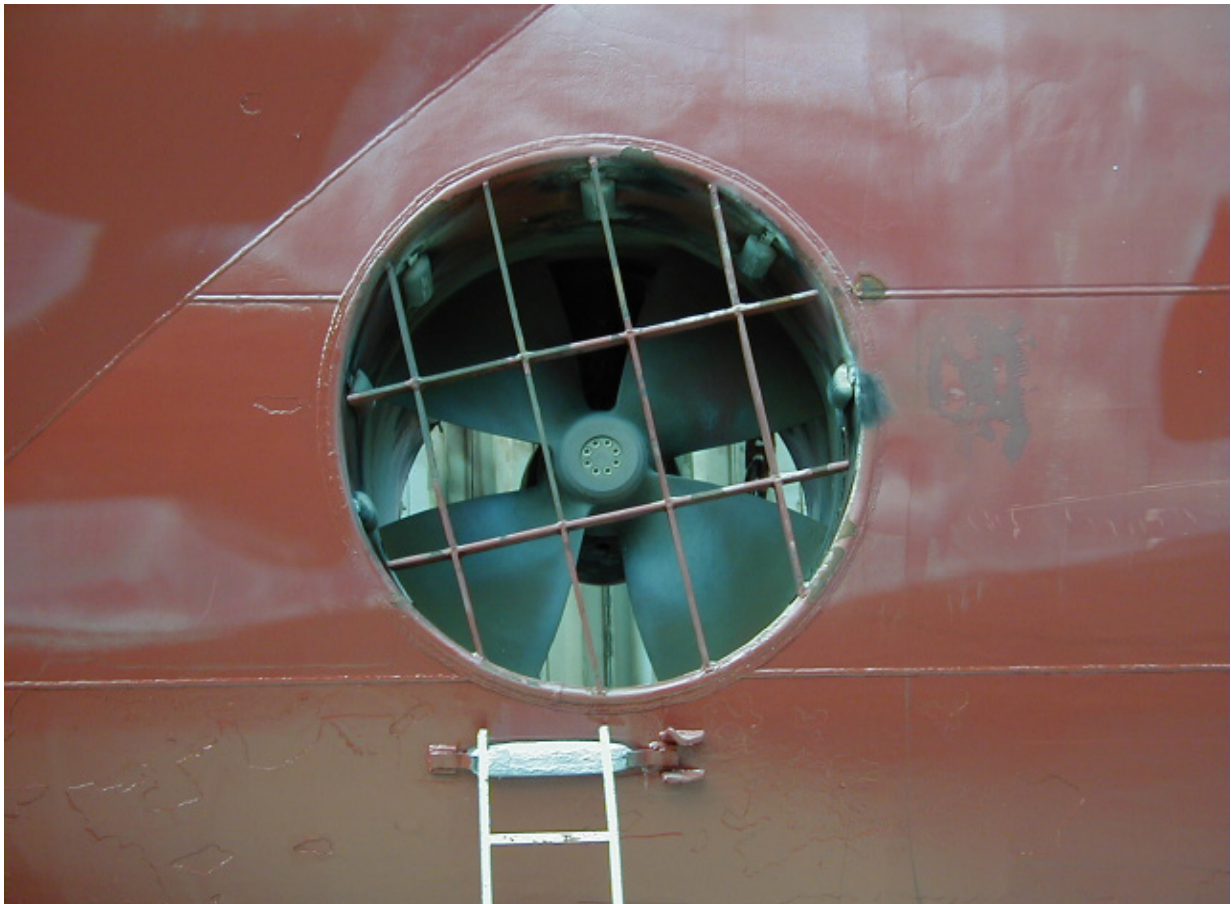
Most common arising problems in these tunnels, are bimetallic corrosion in the welding zones, beside the stainless steel ring and in the tunnel. Please keep in mind that Wencon will not bring any technical strength back, therefore it is recommended to re-weld attacked areas before protection. The bi-metallic element arises between the iron and the stainless steel, and coating must be laid approximately 10 cm. in on the rust-free belt, and outwards.

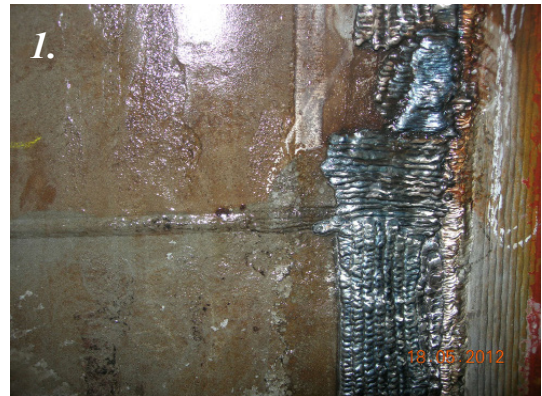
2. All areas to be protected, are grit blasted and degreased in Wencon Cleaner, before any further products are applied.

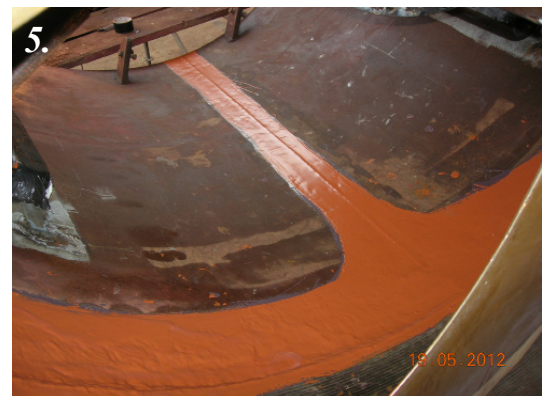
6. Depending on the propeller's daily operating conditions, partial re-protection might be necessary, at next dry docking.
