## Stern tube corroded

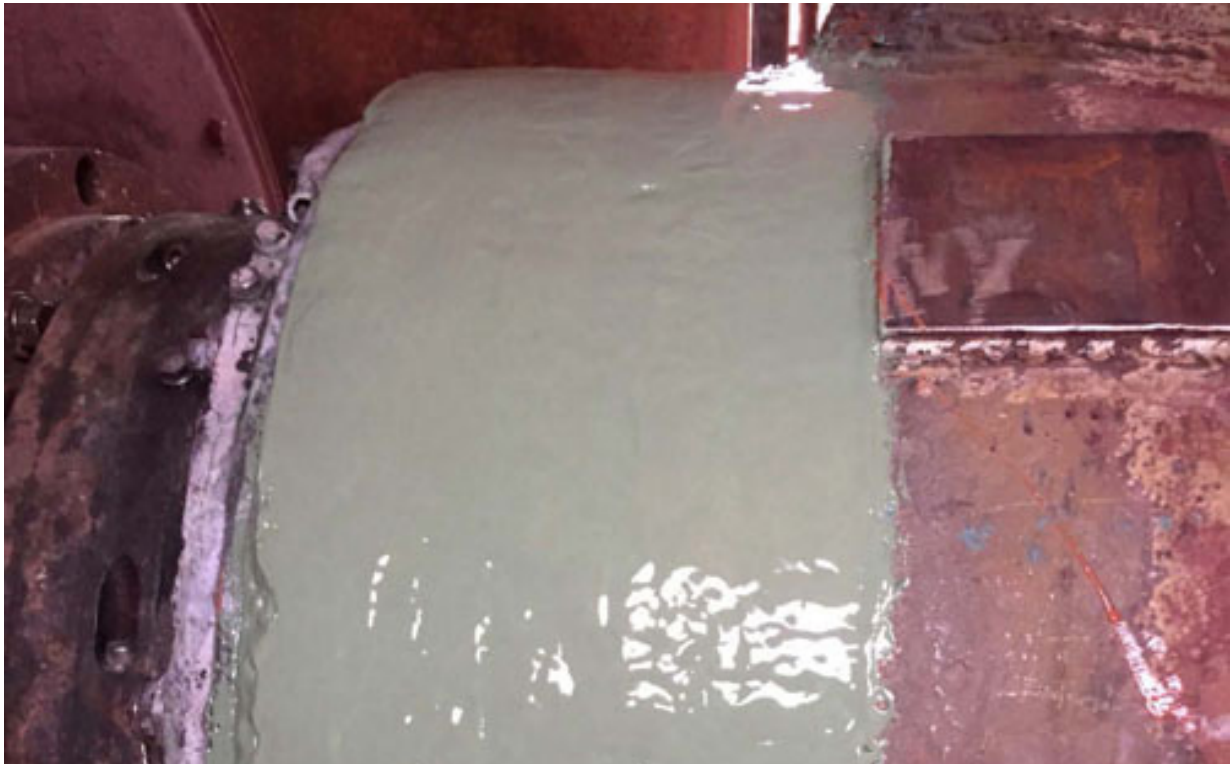
<b>Application:</b>	Rebuilding of corroded stern tube during dry-dock
<b>Place:</b>	The Netherlands
<b>Date:</b>	September 2017
<b>Job and report done by:</b>	Venus & de Waard as Wencon Service Partner in the Netherlands
<b>Wencon products used:</b>	UW Coating, Ceramic Cream, Ceramic Coating, Cleaner, appl. tools

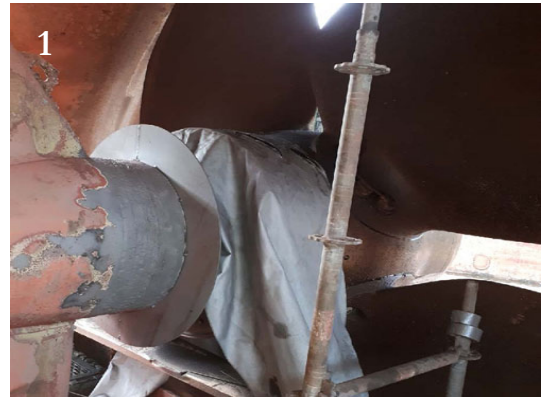
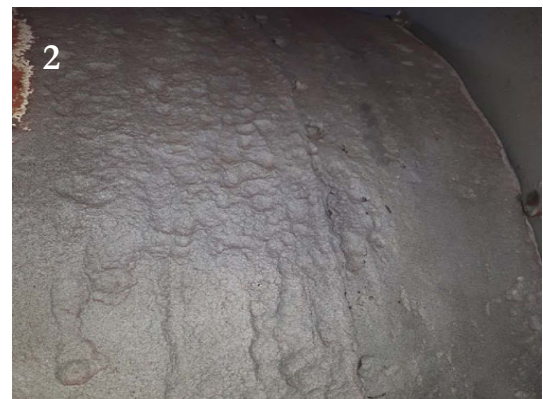
Stern tube found in very bad condition, due to bi-metallic corrosion. Cover has been attached to protect seals etc. before shot blasting of corroded area. Stern tube has been shot blasted to reach SA2.5, sweat out for water and salt by using a torch and shot blasted second time to reach 75 microns of roughness. All to obtain the best adhesion of Wencon products.

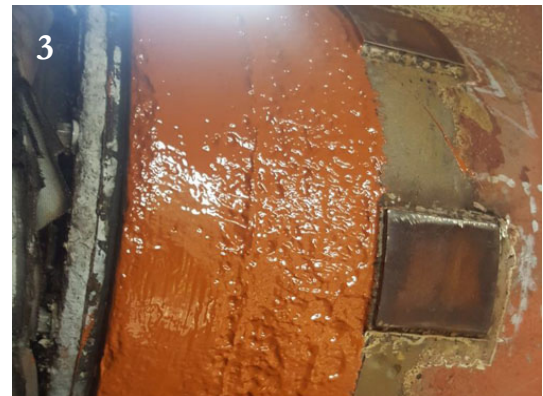
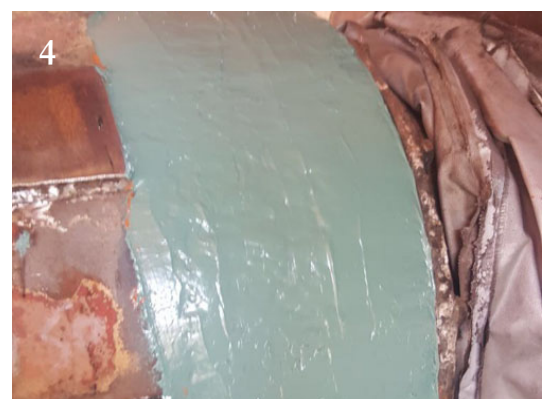
Note: To be applied wet in wet, meaning one layer must be sticky when next layer is applied.

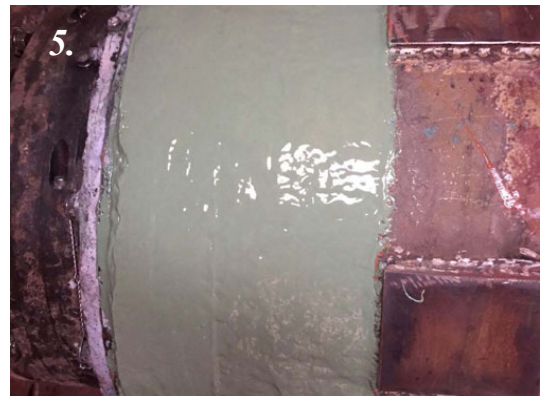
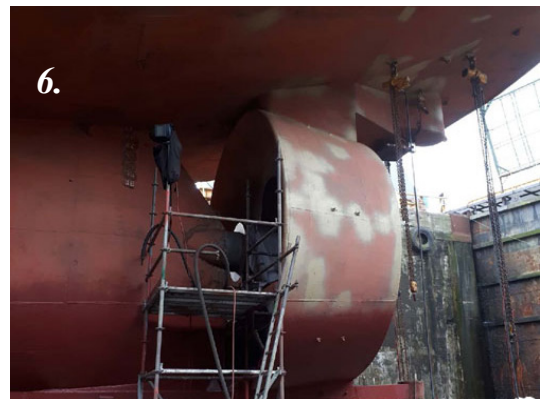
At last one layer of Wencon Ceramic Coating has been applied to achieve a smooth surface. The benefit of Wencon Ceramic Coating is the strength and wear resistance, which is as good as Ceramic Cream.
