## Rudder Refurbishment Protection

<b>Application:</b>	Reconstruction and subsequent protection of cavitation-damaged rudder edges
<b>Place:</b>	FA Yard
<b>Date:</b>	December 2019
<b>Job and report done by:</b>	Breki Ship Service ApS
<b>Wencon products used:</b>	Wencon UW Coating, Wencon Cream

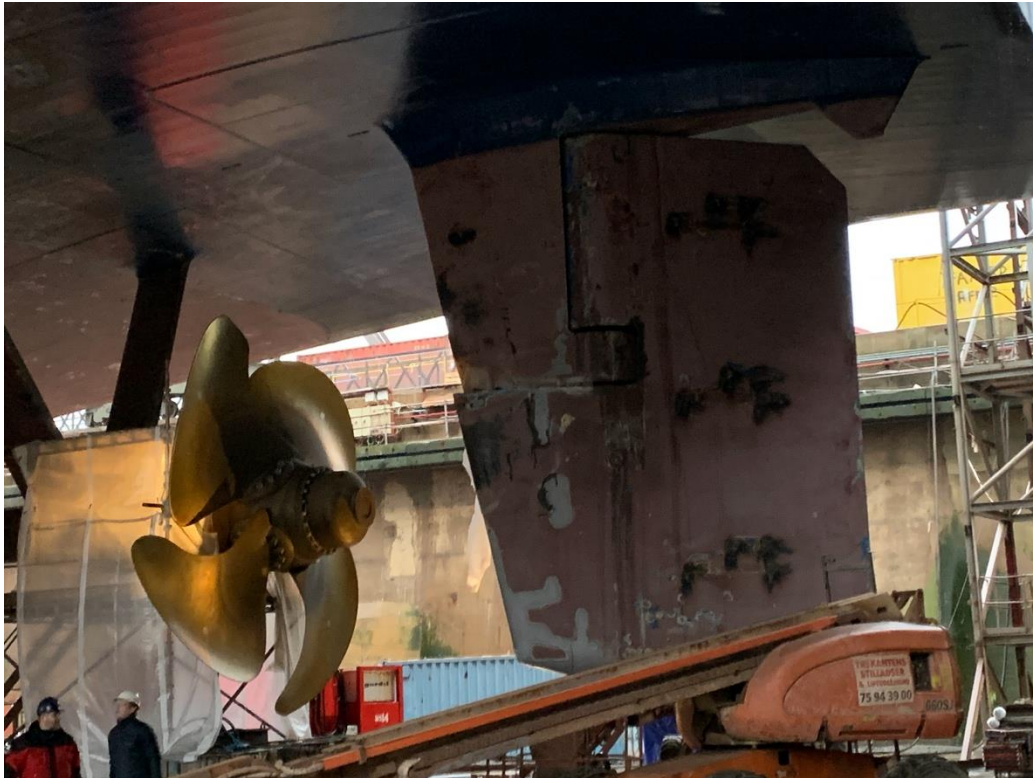
Semi-spade rudder with horn suffering from cavitation damages due to the environment at cruise speed.

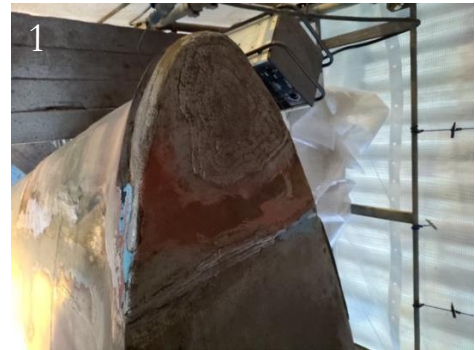
### 1. Rudder blade top view

Deep damages that have impaired the physical properties have roughly been re-welded according to class requirements.

Hereafter, surface will be prepared by grit blasting prior application of Wencon products.

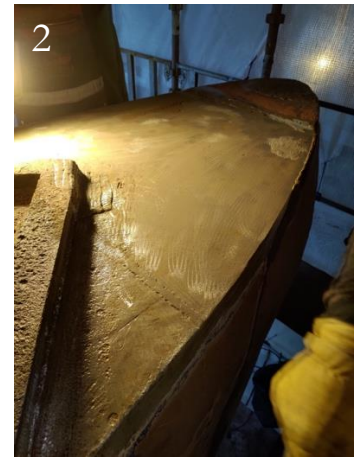
### 2. Rudder blade top view

Surface prepared and ready for applying Wencon products.

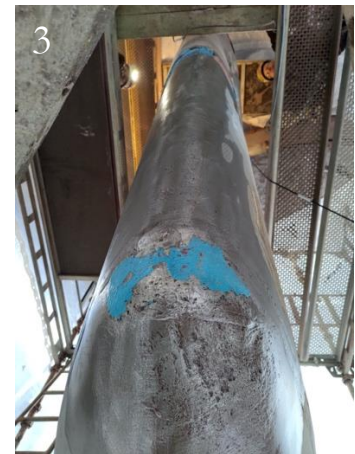
### 3. Front edge of the rudder

The image shows the coating from the last dry docking remains even after grit blasting.

Protection ability remains and should not be removed but remain as a protective layer.

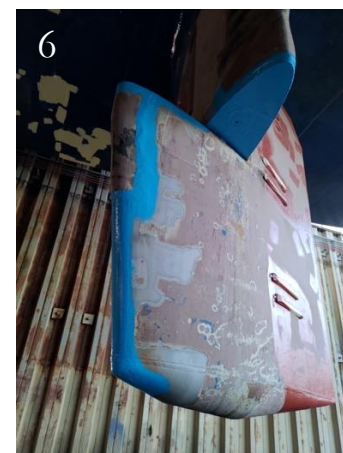
#### 6. Overview

The rudder is now protected in the best way possible, and ready for another 2 years in service, hopefully without suffering further damage to the metal and the physical properties will remain sufficient to achieve yet another class approval.

Since cavitation commonly occurs locally, the application is also executed locally only.
