### Rudder Link & Hinge system Refurbished

Vessel: RoRo / Passenger Vessel

Date: January 18<sup>th</sup> 2021

Type of repair: Rudder Link & Hinge system Service & Overhaul

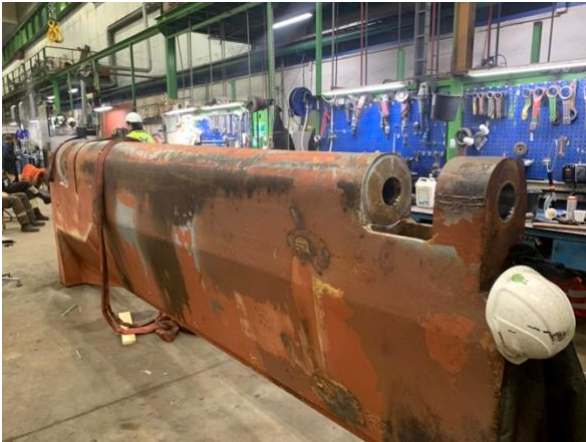
1. The Rudder Flap in Workshop.

Thrust & Wear Rings to be cast and sealed in fixed position.

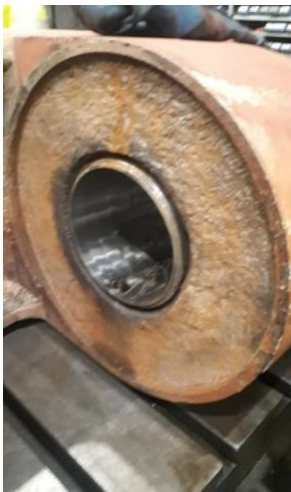
2. Rudder Flap Contact surface is prepared before casting and sealing using Wencon Cream.

Thrust & Ware Rings is fixed in the correct position by Hinge bushings.

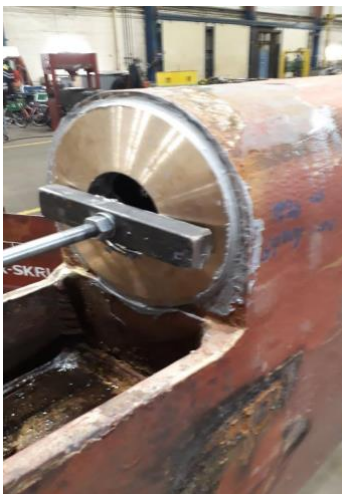
3. Rudder Flap Thrust Ring cast and sealed in fixed position.

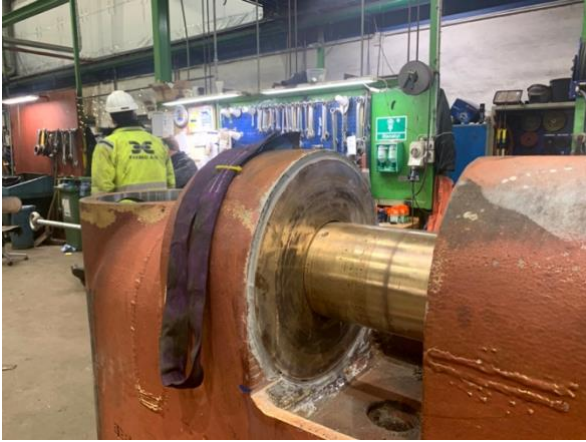
4. Rudder Flap Wear Ring cast and sealed in fixed position.

Hinge Pin installed.

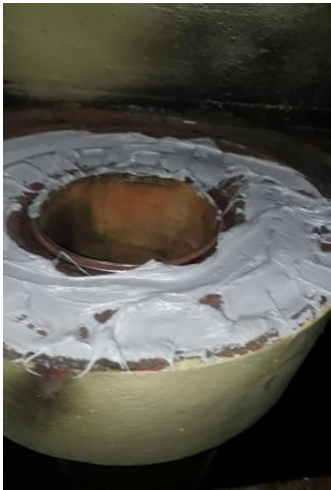
5. Wencon Cream applied on Rudder blade contact surface for Wear Ring.

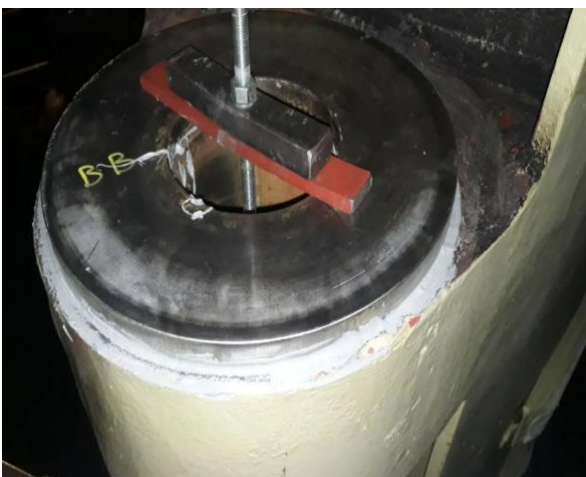
6. Wear Ring installed in position on the Rudder Blade

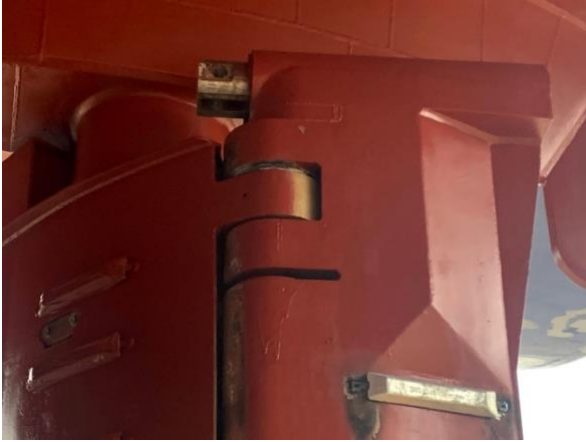
7. Rudder Flap installed - Upper Hinge

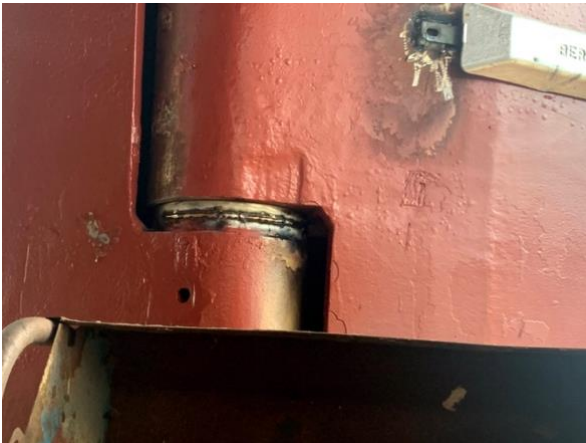
8. Rudder Blade installed – lower Hinge.

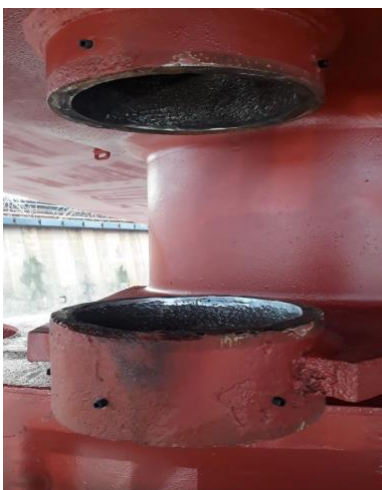
9. Upper and Lower Link Bushing housing are corroded, and Bushings became loose.

Here injecting holes drilled and threaded ready for installing bushings and inject Wencon Coating used as a casting compound.

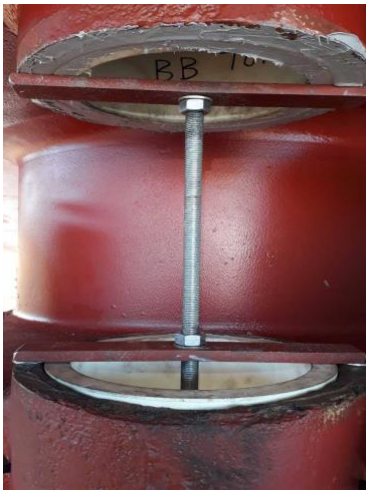
10. New Bushings installed and bottom for the Clearance gap is sealed – ready for casting in the Bushing using Wencon Coatings.

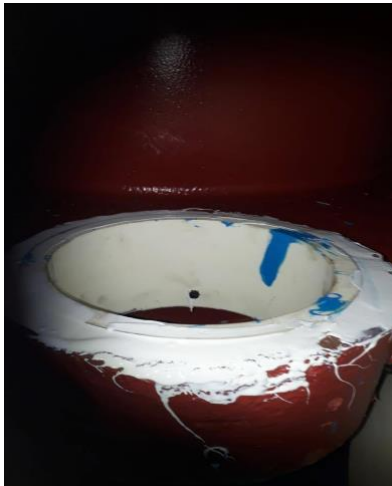
11. Wencon Coatings injected by using an injecting hose drilled in the bottom of the Bushing to ensure level rises slowly by injecting and ensuring that no air entrapments are present in the finished result.

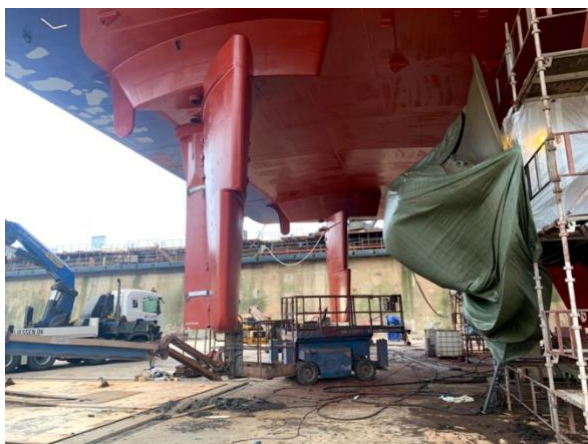
12. Rudder reinstalled with Flaps & Link Bushings.

Wencon Solution using Wencon's products by cast to fit method ensure a 100% fit and prevents water from penetrating between the bushing and housing contact surfaces.

Products are non-corrosive and future Corrosion risks are hereby eliminated. Time and money saved compared to traditional on-site machining and repair methods.
