Main Propulsion Propeller Blades- cavitation damage

Job executing contractor: FA-Yard

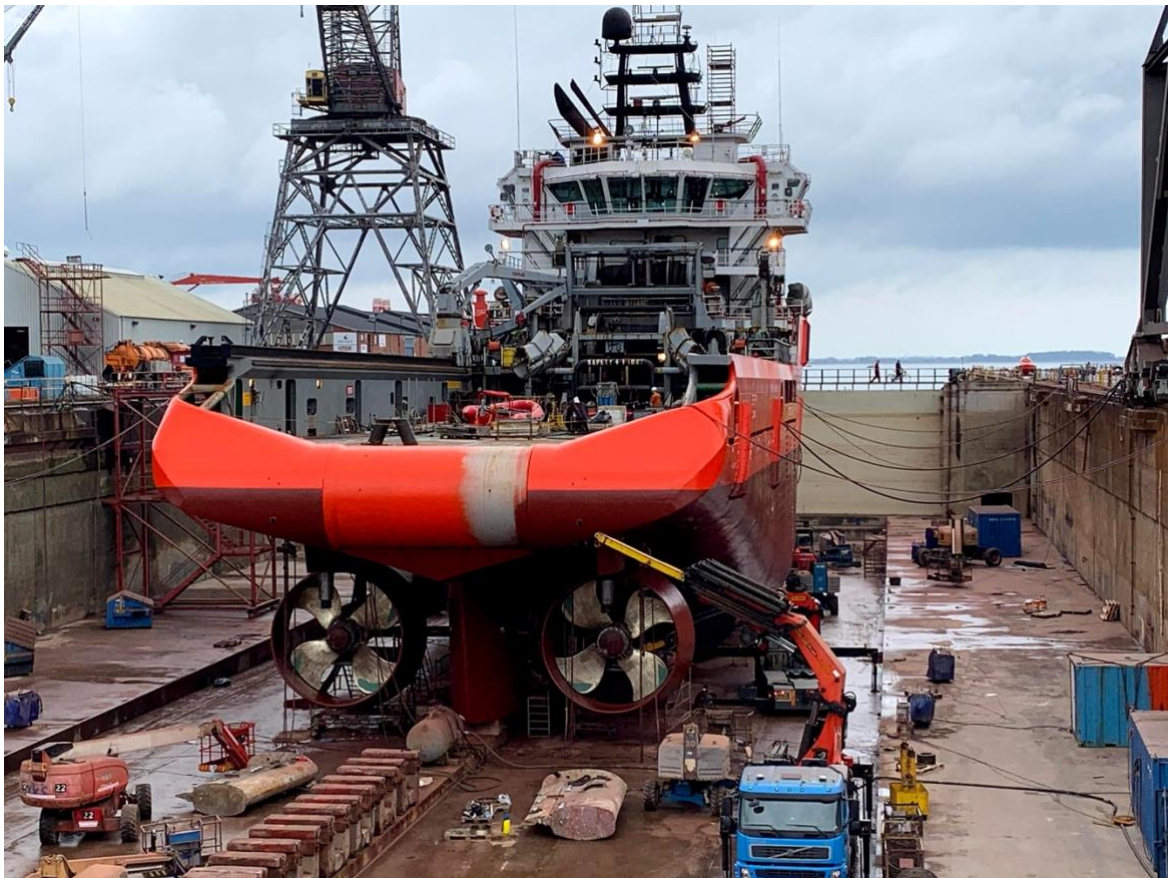
Main Propulsion Propeller Blades- cavitation damage

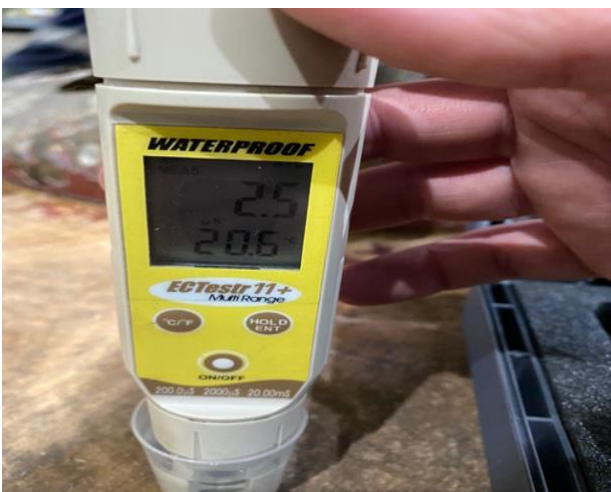
3. Measured salt content of the liquid before injection of the liquid into the patch – value 2.5 us/cm

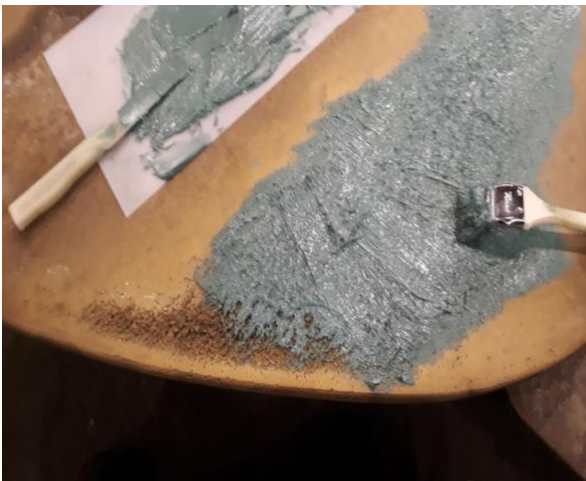
8. To optimize adhesion, the 1st layer Wencon Ceramic Cream are “worked toughly” into all pores and unevenness of the cavitated arias.
