Cast to fit of rudder pin bearing house

Place: Piraeus Drydocks, Greece

Date: June 2009

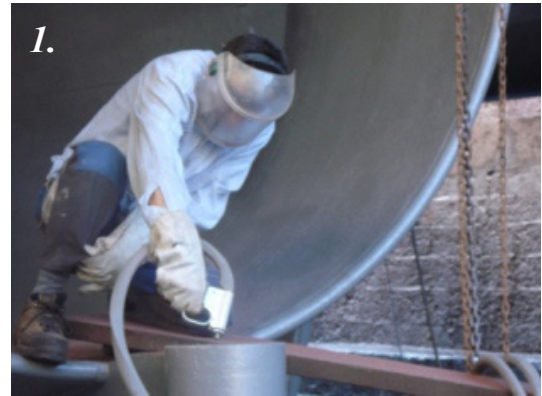
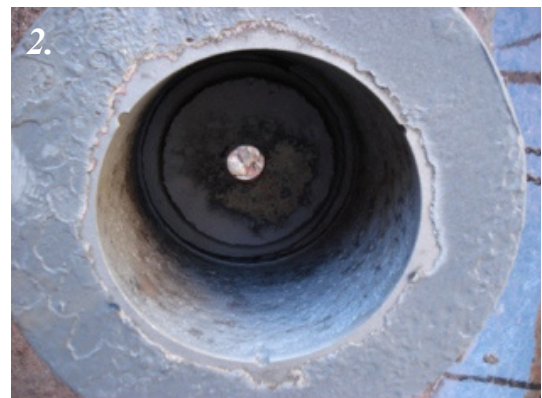
1. & 2.

Blasting of bearing housing using Wencon Blaster.

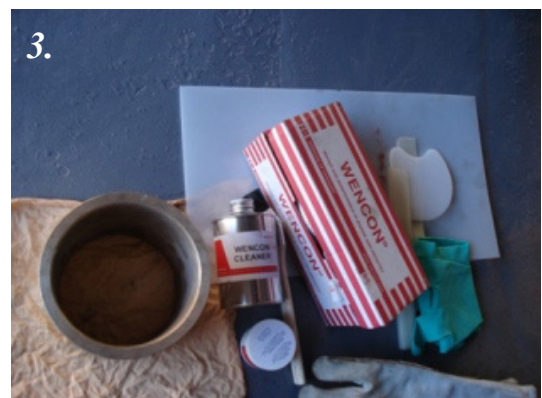
3. Cleaning of bearing housing using Wencon cleaner.

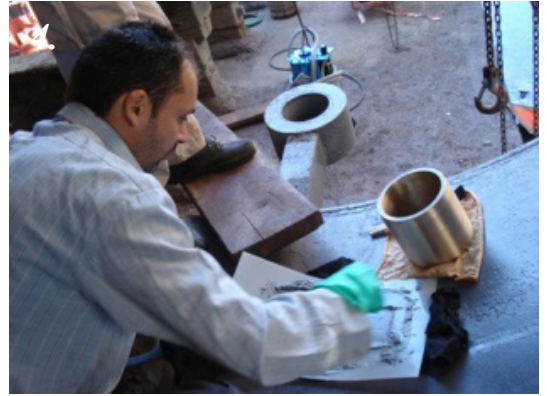
4. Apply Wencon Release Agent on the outside diameter of the bronze bearing.

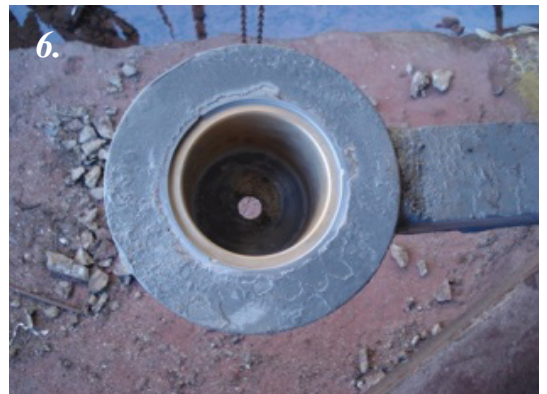
6. Assembly of the bearing into the bearing housing.
