Single Case Pump

Shows the surface before preparation. Condition of the pump house is very poor. Locally it is only a matter of months, before it starts leaking.

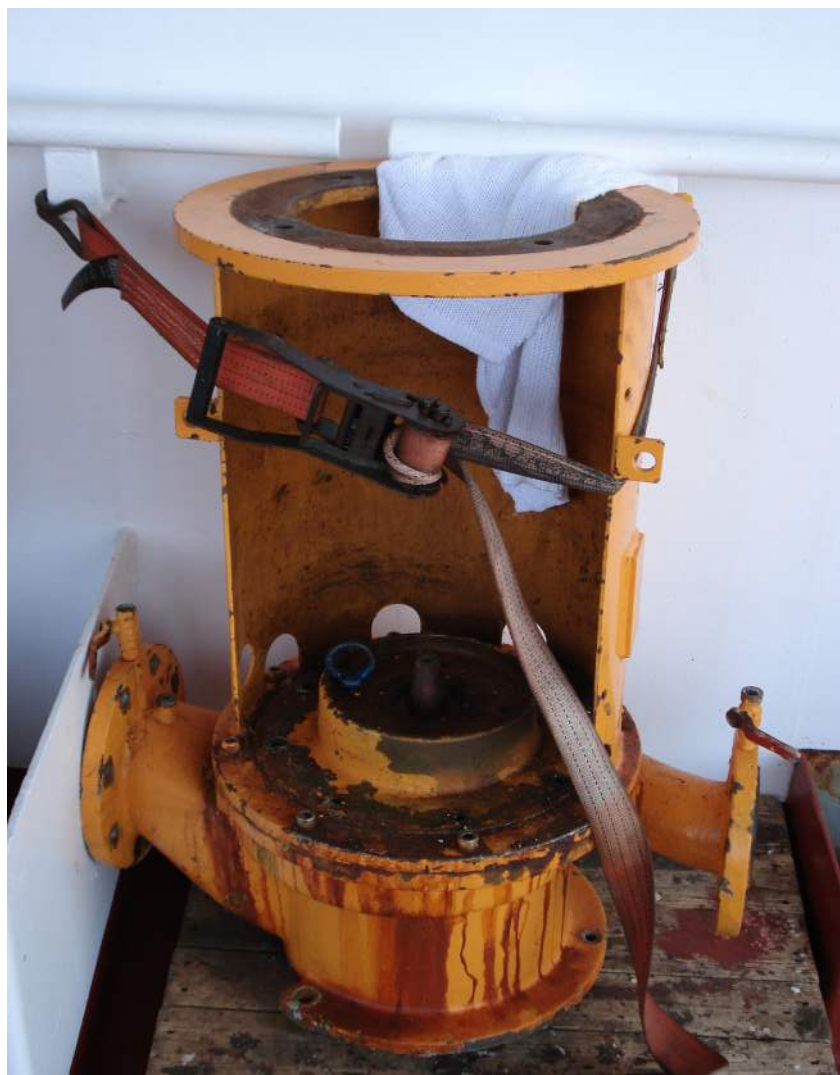
Application:	Rebuilding and protection of single Case Pump
Place:	Rotterdam, NL
Date:	May 2008
Job and report done by:	Wencon, Denmark
Wencon products used:	Putty, Cream/Rapid, Coating white & blue, Cleaner, appl. tools

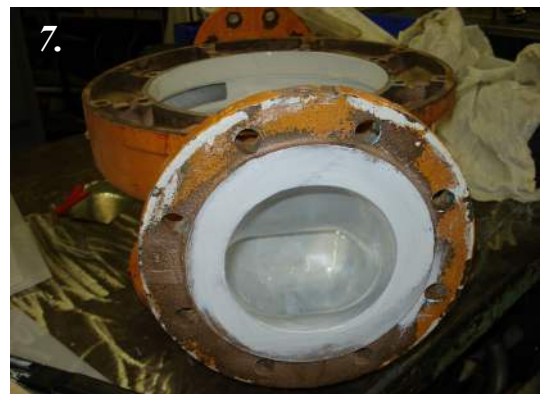
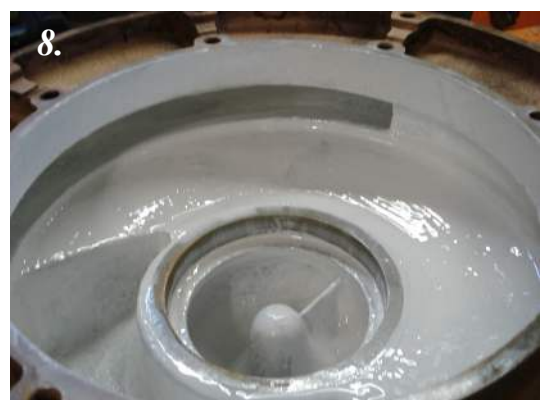
First layer of Wencon Coating white is applied.

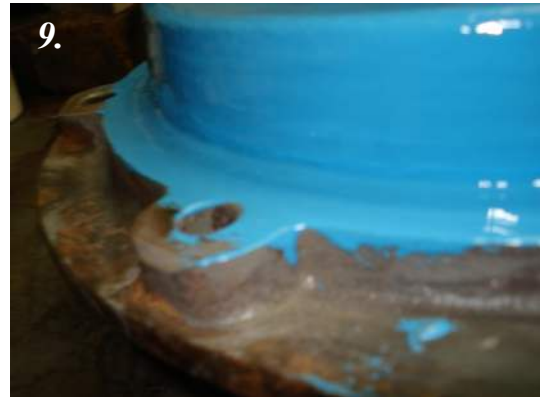
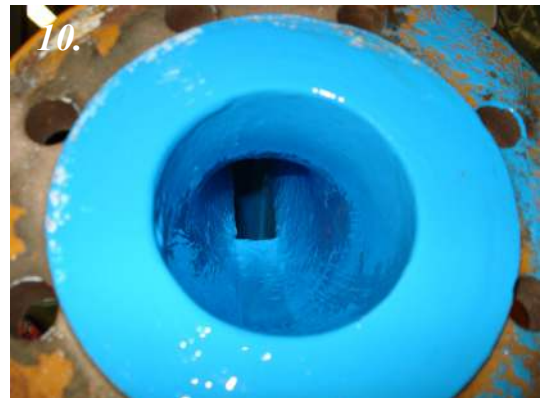
When protecting against bi-metallic corrosion it is very important, that all surfaces in contact with sea water, are protected. Here the sealing surfaces.

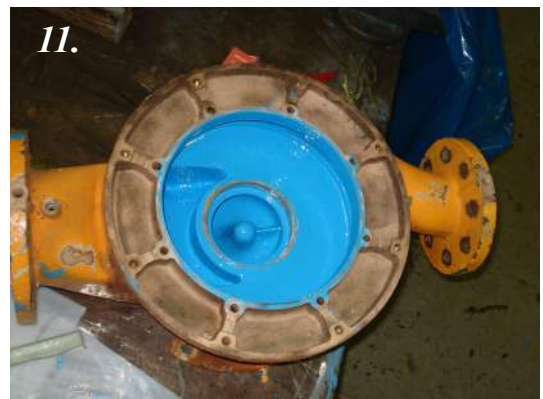
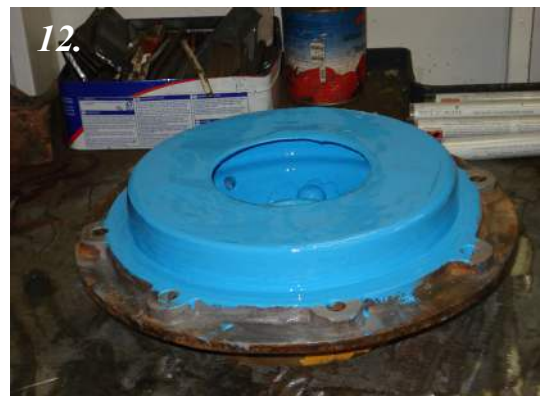
This repair of the old pump not only last longer than a new pump, it will also give a better flow, and save energy.
