Turbo charger housing water side

Application:	Rebuild and repair of leak at in-/outlet areas
Place:	France
Date:	April 2007
Job and report done by:	ETS Tiano & Wencon, Denmark
Wencon products used:	Hi-Temp Green, Cleaner, appl. tools

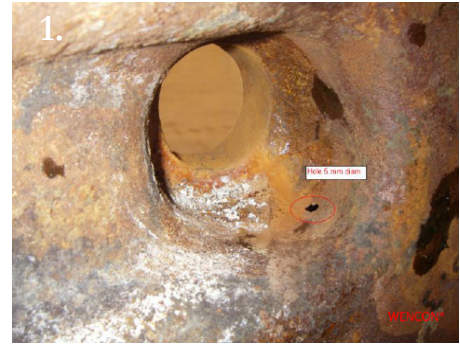
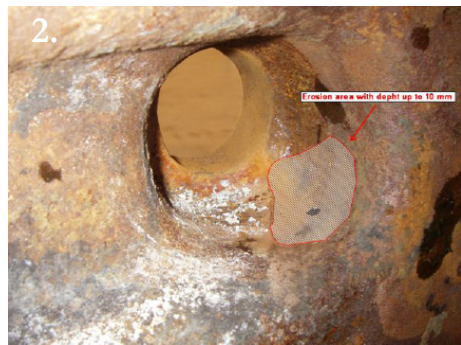
1.& 2.

5mm holes found at the in/out's and erosion areas, in about 10 mm depth.

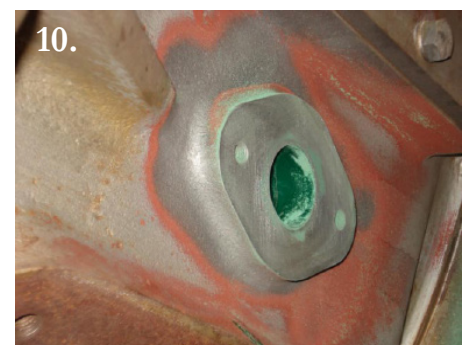
10. Final result.

Ready for many years of service again.
