Rebuild of Propeller Blades

- Application:** Refurbishment of Propeller Blades
- Place:** Istanbul, TR
- Date:** July 2022
- Inspection:** Esko Marine
BTMteknik
- Application:** BTMteknik
- Wencon products used:** Rapid, Coating White, Coating Blue, Cleaner, appl. tools.

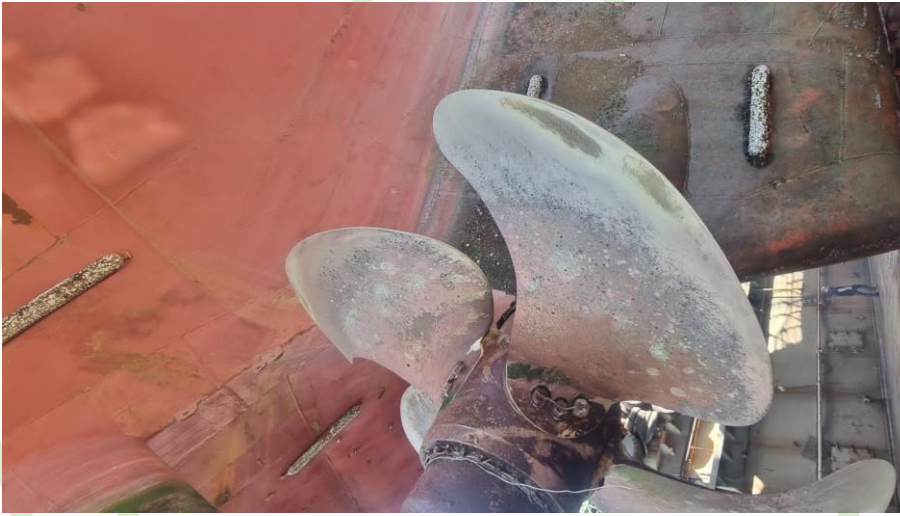
Picture 1

1. Main propeller has been detected with cavitation for all 4 blades. The surface is prepared using UHP water jetting to remove all salt and uncleanness's out if the metal surface.

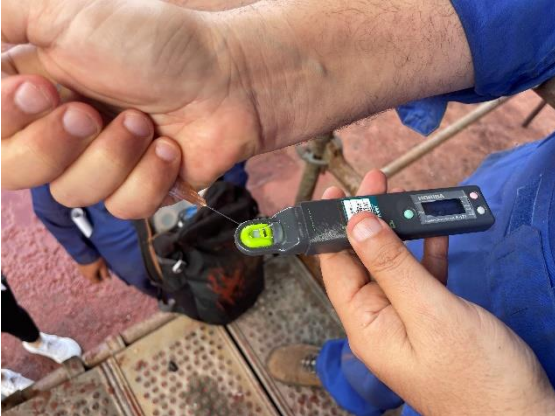
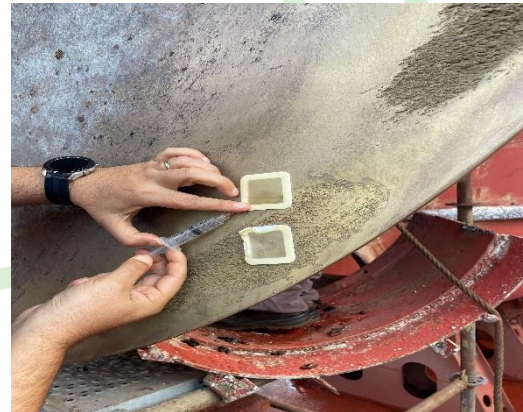
2. & 3. Measured salt content of the liquid before injection of the liquid into the patch

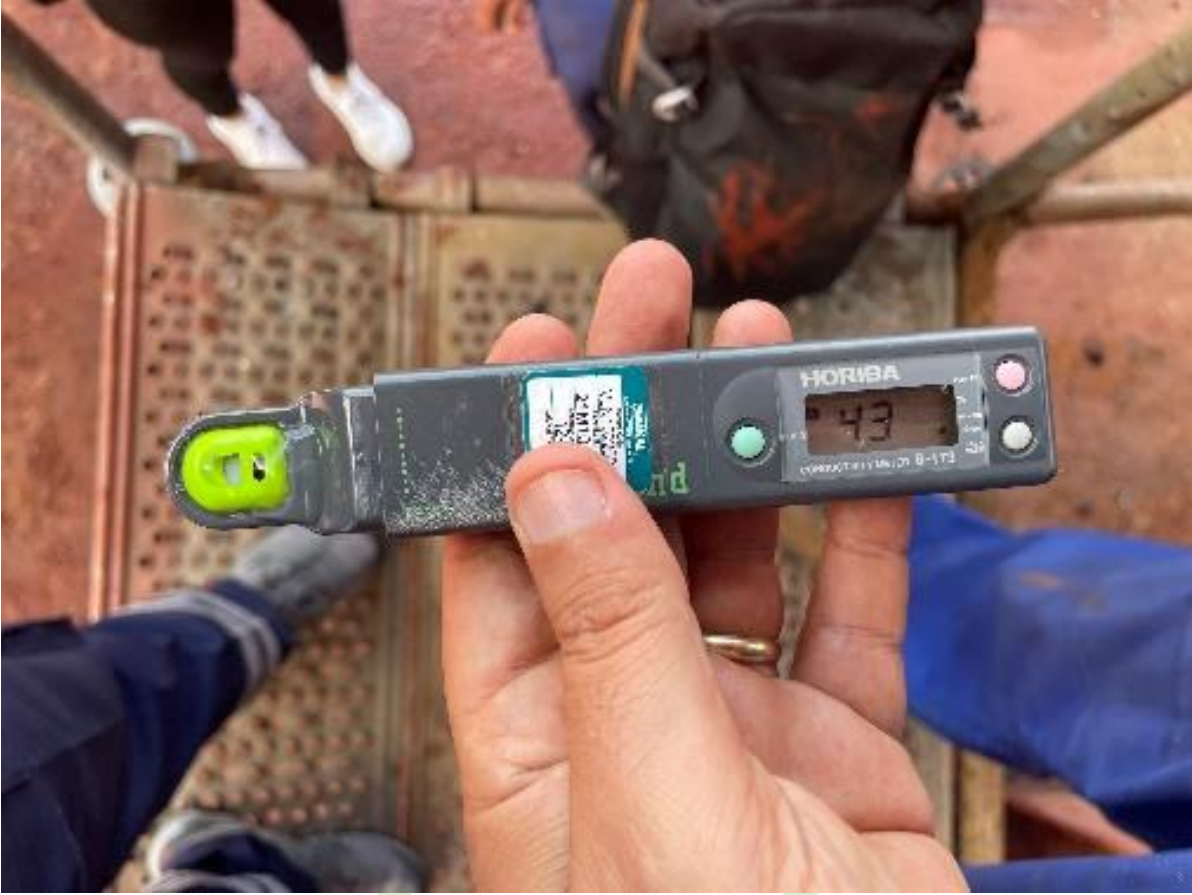
Picture 4

4. The final value: $45 - 13 = 32$ us/cm.

According to the most common standards as seen on picture on the left, it will meet even the toughest standards.

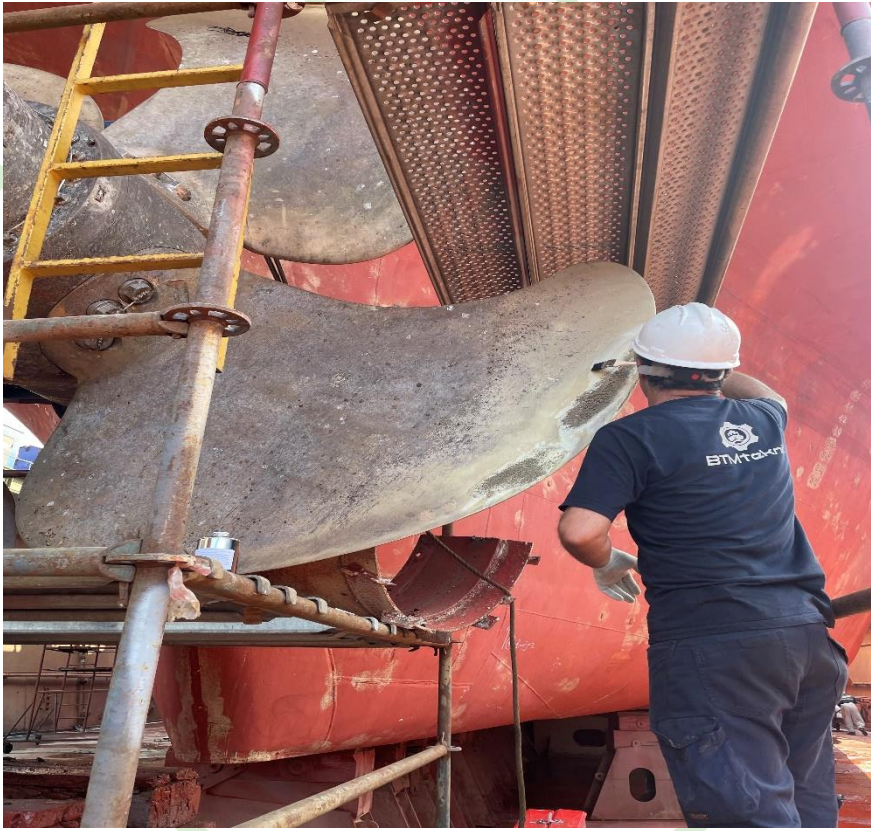
Picture 5

5. Due to the extent of cavitation and damage to the propeller blades, the surface is already rough and suitable for applying Wencon Ceramic Cream. Grit Blasting seems therefore superfluous, and degreasing using Wencon cleaner will achieve the best conditions for proper adhesion.

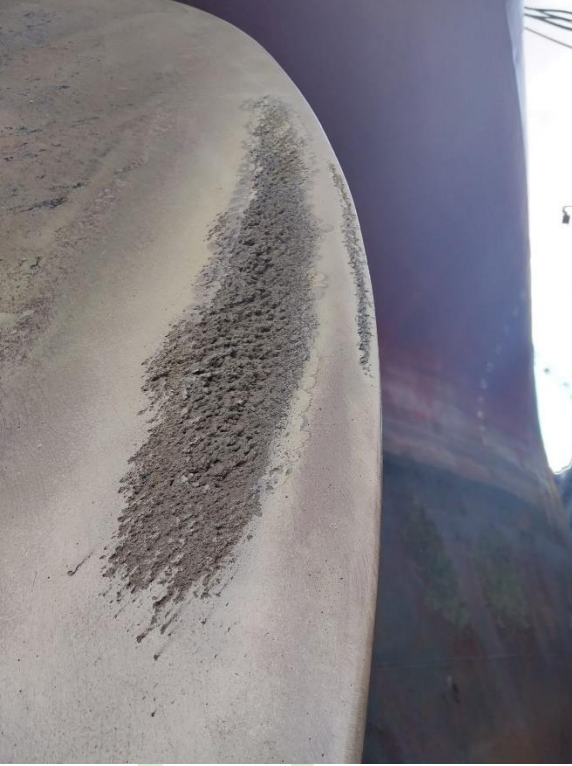
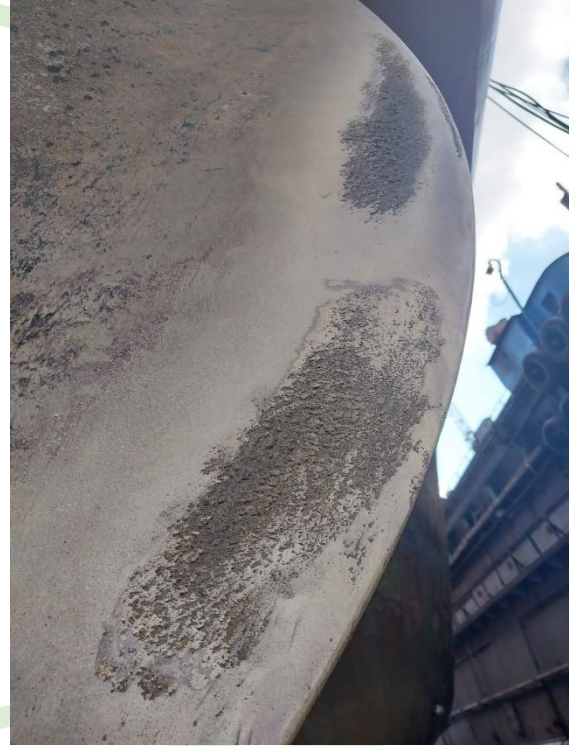
6. & 7. Cavitation damage on the propeller Blades.

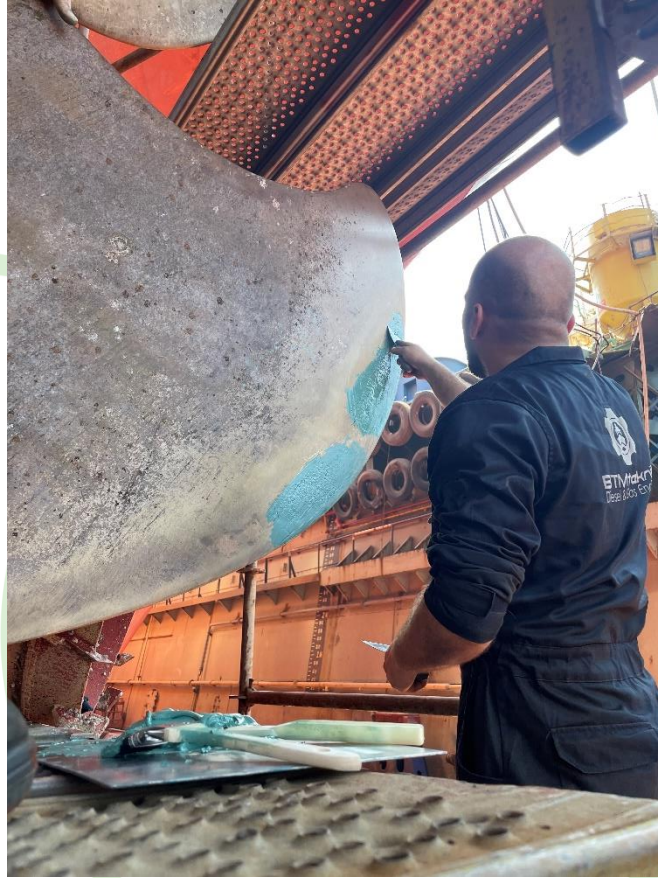
Picture 8

8. To optimize adhesion, the 1st layer Wencon ceramic cream are “worked toughly” into all pores and unevenness of the cavitated areas.

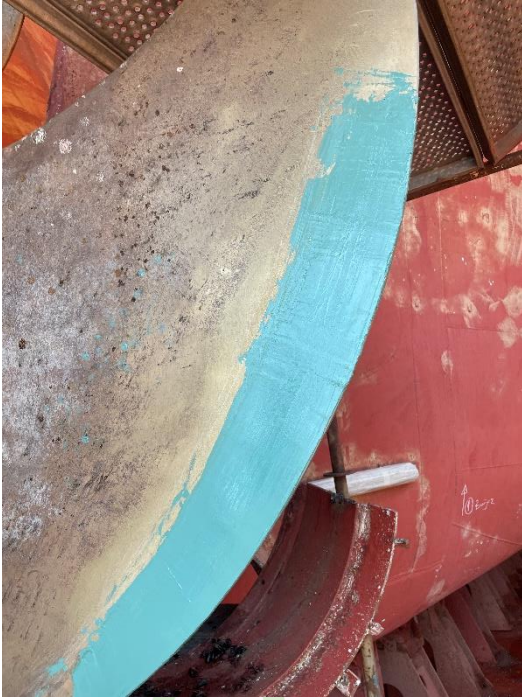
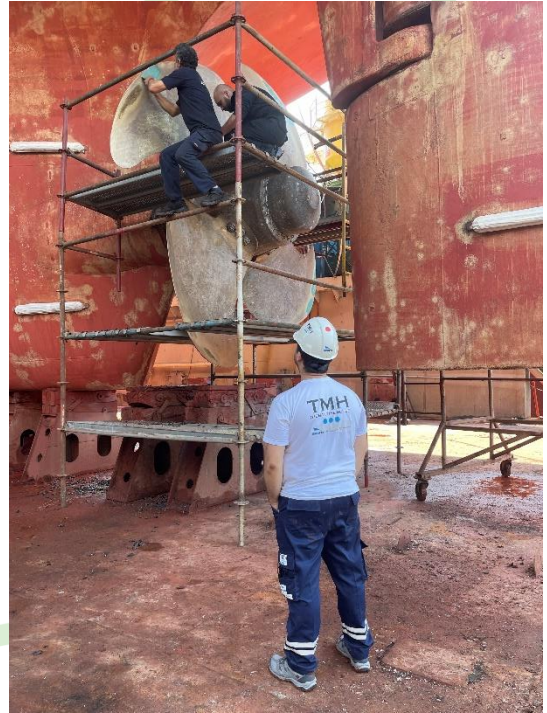
9. & 10. 2nd and final layer of Wencon ceramic cream applied in layer thick enough to ensure level above to original surface has been obtained.

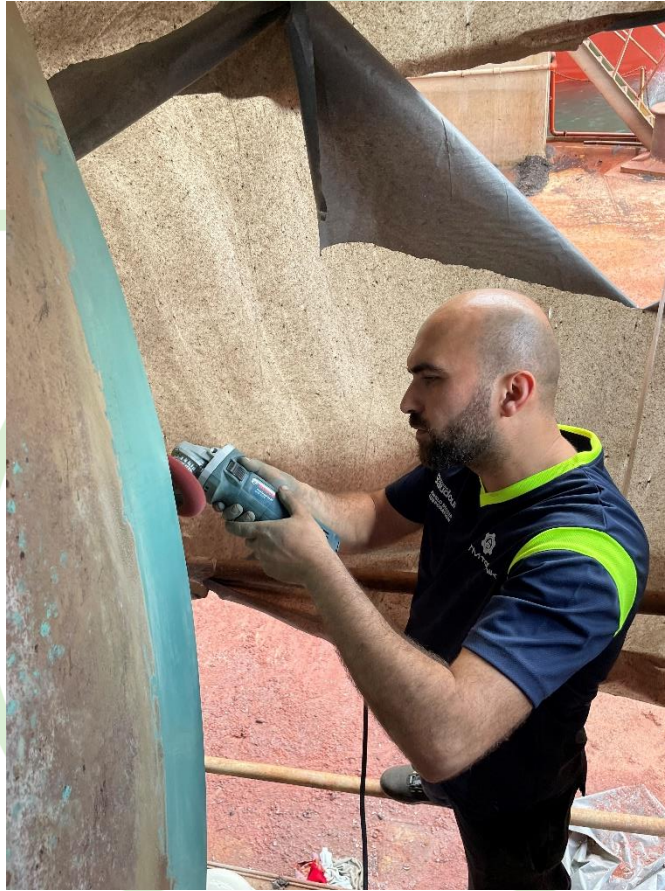
Picture 11

11. Subsequent to final curing has occurred, the original shape and size of the Propeller Blades is recovered by using grinding tools and ordinary polish tools as normally used to polish the Propeller Blades.

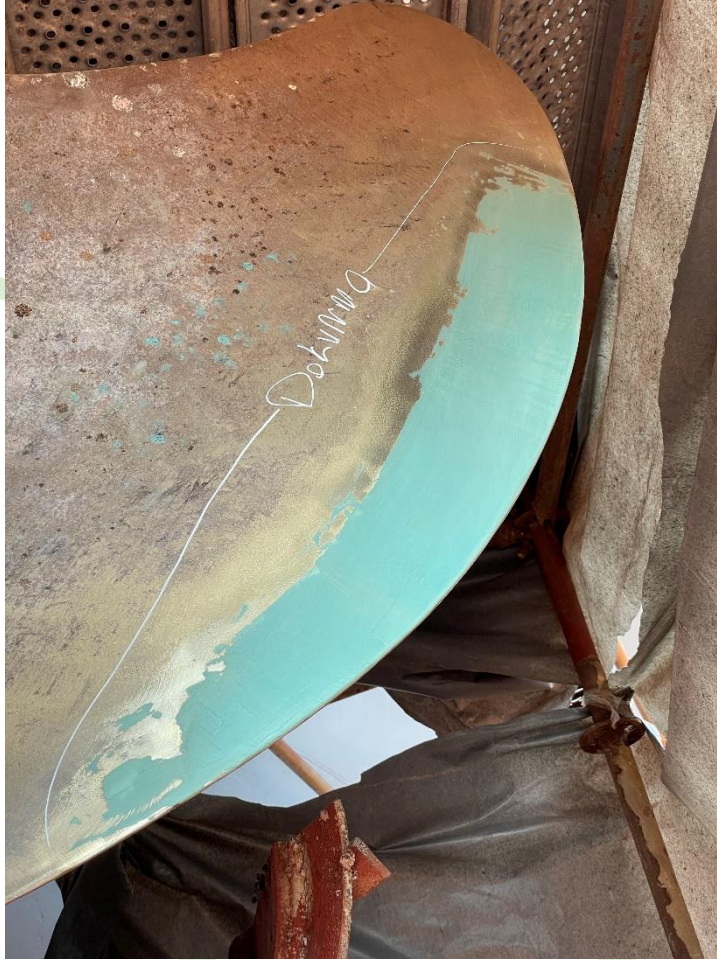
Picture 12

12. Final result.
