# Heating Coils manifold

**Application:** Heating Coils manifold suffering from external corrosion.

**Place:** Tuzla, Turkey

**Date:** November 2014

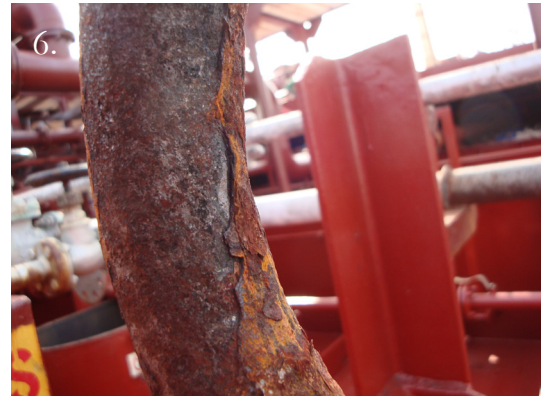
6. By chipping it is very clear, that piping locally suffers from heavy corrosion.

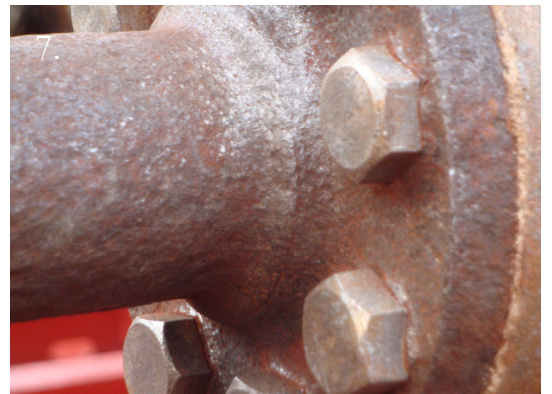
7. Close up picture during chipping.

It is important, to obtain as rough surface as possible during Chipping, to ensure the best adhesion.

Therefore, do not use wire brush or similar, since this will only polish the surfaces.

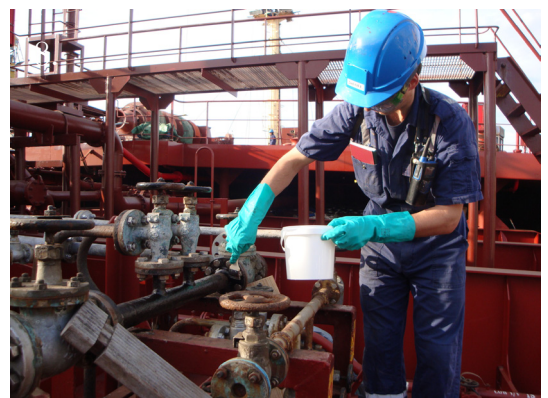
8. Wencon Cleaner applied with a brush, to degrease pipings, prior to application.

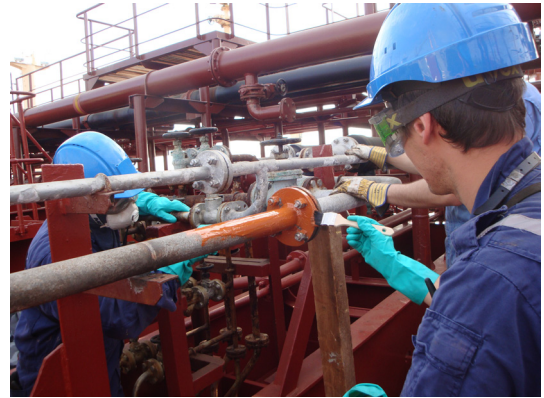
9. Wencon 1050/1060 Hi-Temp applied as the first layer, using a brush. To ensure the best adhesion, it is important to rub the Wencon Coating into the dry surface, and hereafter distribute a thick layer of Coating.

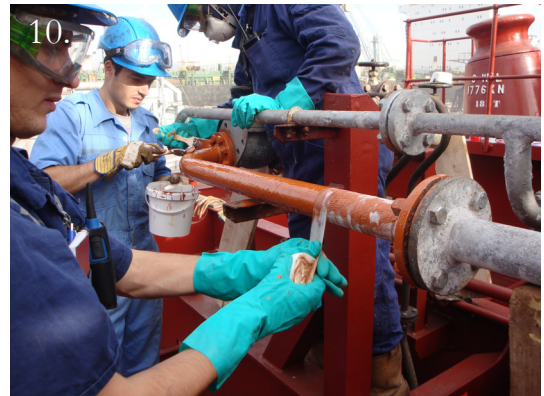
10. While 1050/1060 Hi-Temp is still wet, Wencon Reinforcement Tape is wrapped with 50% overlap. Wencon 1088 Light will penetrate the pores in the tape, and will divide to a smooth surface when using a brush. Afterwards, left for semi curing in approx. 1½ hour before applying second and final layer.

Place a finger in the coating, that leaves a fingerprint - **without sticking to your finger**. You are then ready for second layer.

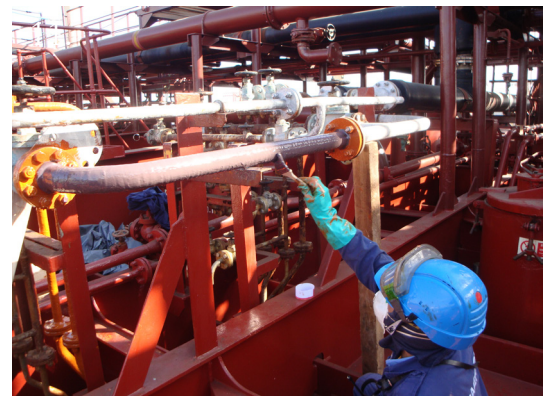
11. Second and final layer, the Wencon 1050/1060 Hi-Temp applied, using a brush. After ended application, please allow minimum 12 hours curing, before opening steam valves from the Engine Room.

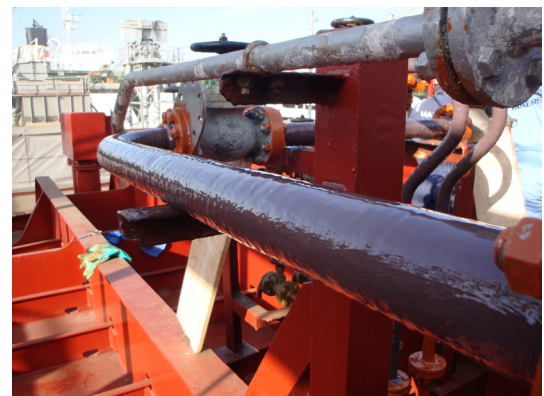
12. Final result.
