Rebuilding of Screw Pump

Application:	Rebuilding of Screw Pump
Place:	ASMAR, Valparaiso, Chile
Date:	April 2011
Job and report done by:	ASMAR and Danish Business Ltda, Chile
Wencon products used:	Rapid, Coating white & blue, Cleaner, appl. tools

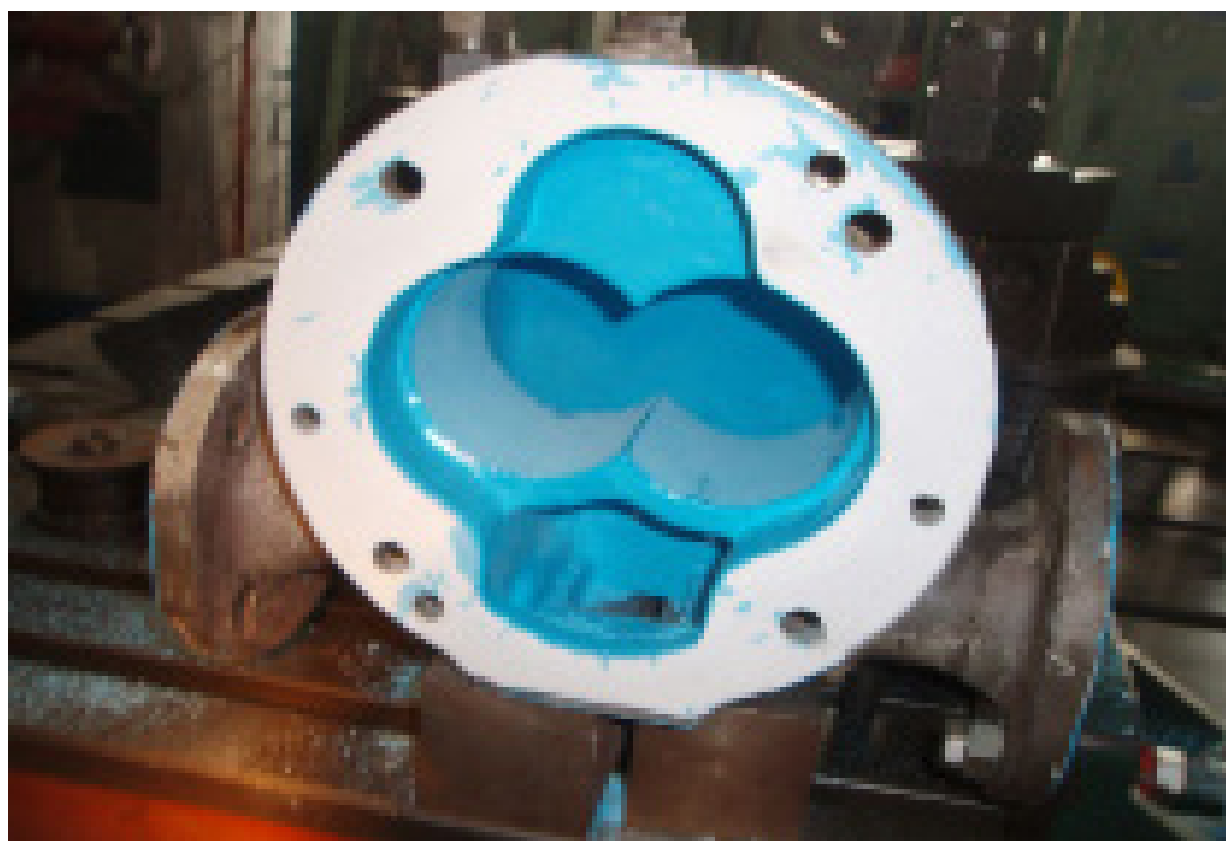
Due to heavy corrosion the screw pump had lost pressure, and therefore not able to pump waste oil, from ship to the pier.

Job was to rebuild the pump using Wencon products.
