Pipe Tape pressure tested

Surface prepared with Wencon Perago Disc around the small hole in pipe. To ensure, that surface is as rough as possible.

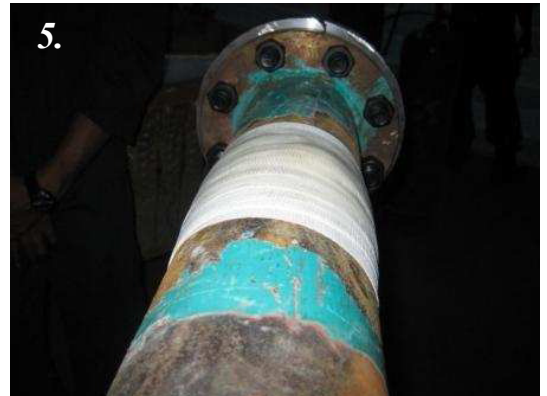
Pipe tested with Hydro Pressure Test after fully curing. Conclusion: Wencon application can withstand at least 40 bar during test, without leaking.
