## Pipe Tape pressure tested

Surface prepared with Wencon Perago Disc around the small hole in pipe. To ensure, that surface is as rough as possible.

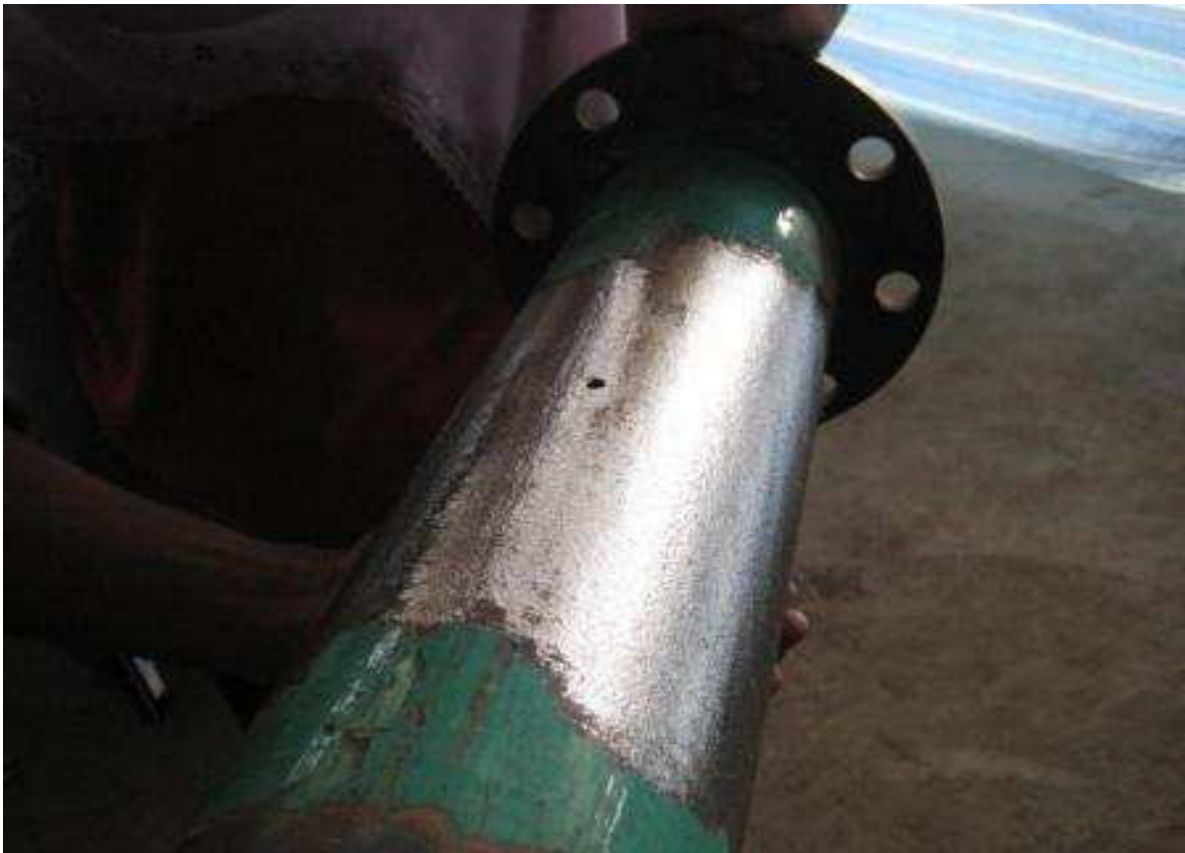
<b>Application:</b>	Repair of hole (Ø7mm) on pipe and con- duction of Hydro Pressure test.
<b>Place:</b>	Malaysia
<b>Date:</b>	March 2011
<b>Job and report done by:</b>	Local workshop and Wencon technical Supervisor.
<b>Wencon products used:</b>	Putty, Pipe Tape, Perago disc, Cleaner appl. tools

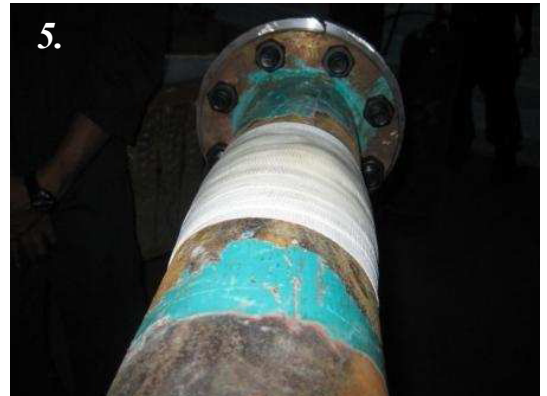
Pipe tested with Hydro Pressure Test after fully curing. Conclusion: Wencon application can withstand at least 40 bar during test, without leaking.
